LIFE09 ENV/FI/575 ABSOILS

Report of civil engineering and environmental survey 2012

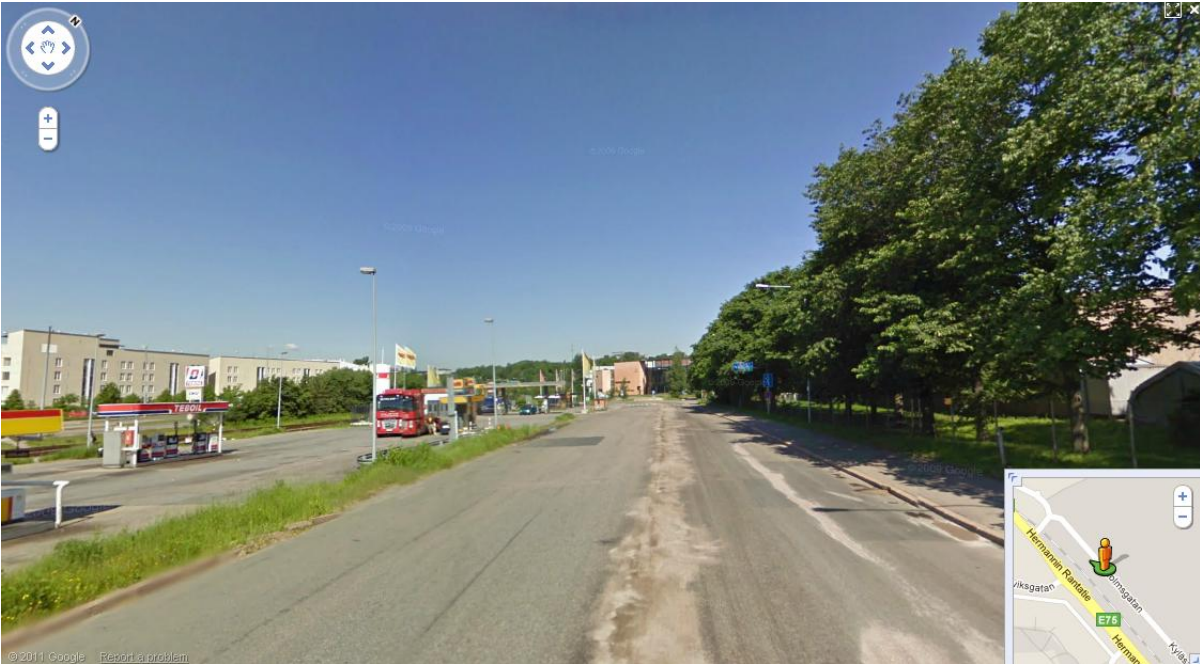
Figure 1. Arcada 2 before construction. (Google maps)

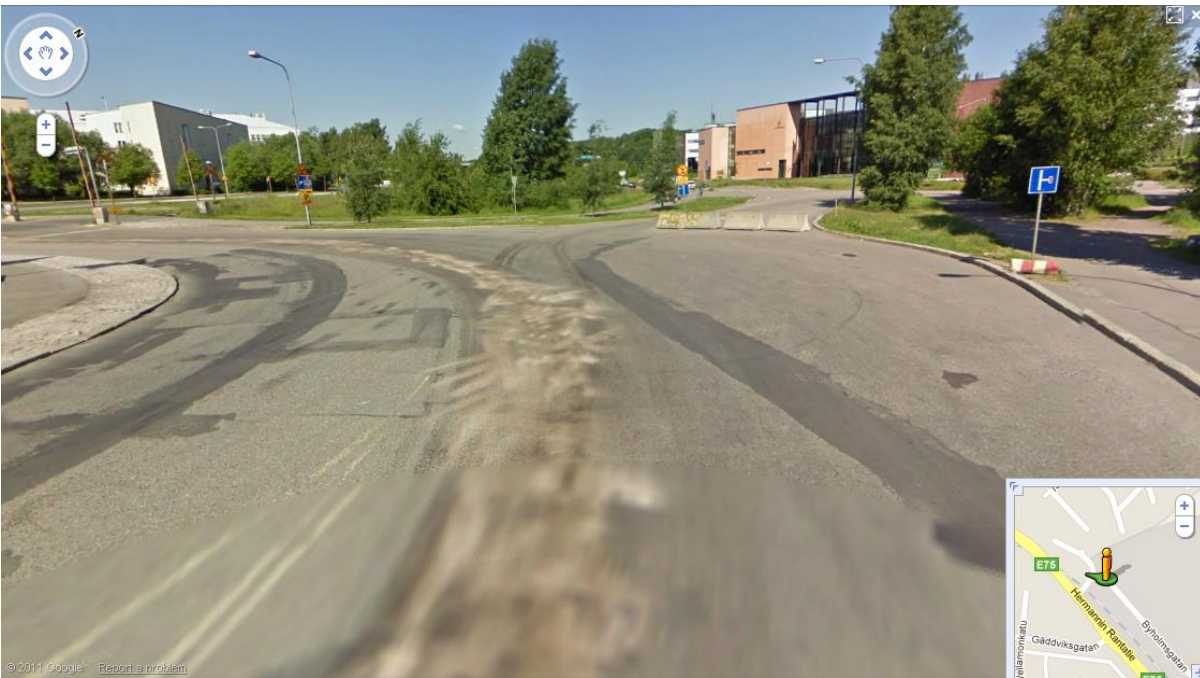
Arcada II is located in Kyläsaari, Helsinki. The site is an old road, which was built on top of soft soil by using crushed aggregate. The area has low stability and load bearing capacity. The weight of the aggregate together with the low load bearing soils has caused e.g. the settlement of the mains about one meter lower from the original position even though it was based on friction pile. This has caused deflection on the sewage pipeline and the breakage of a pipe. The mistakes made in the original construction work are now being repaired.

On Figure 2 it can be seen that some of the road has been "pached" with asphalt and the last part of the road has been blocked for entrance.

Figure 2. The last part of the road blocked for entrance and the road has been pached with asphalt. (Google maps)

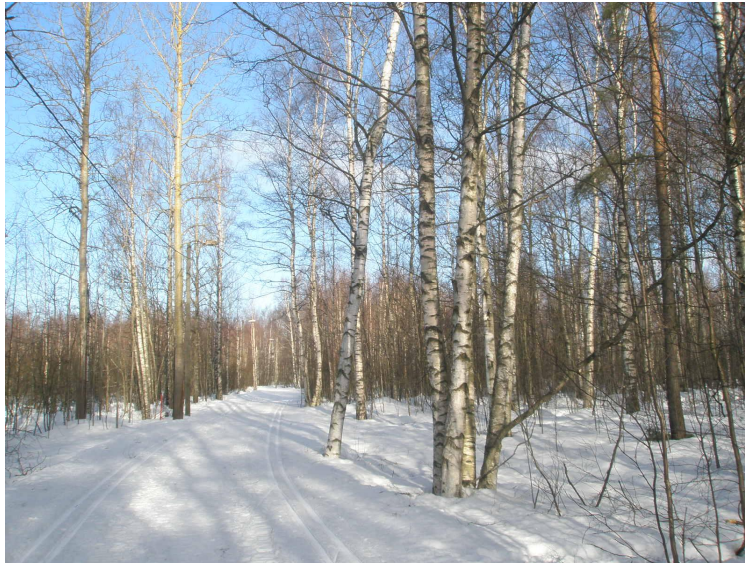
On the Figure 3 the outdoor route surrounding the Dog park area can be seen. It can also be seen that the vegetation of the area is quite bushy with young trees.

Figure 3. Outdoor route surrounding the dog park area.

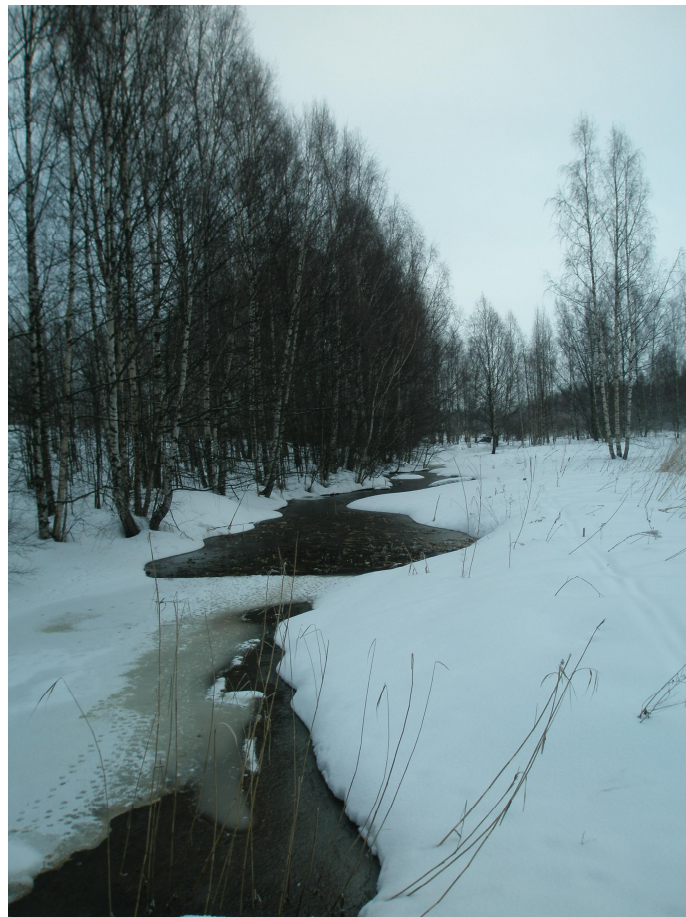
On the south and west side of the park are some outdoor routes and on the east side of the park is an embankment (level +6). Between the park and the embankment is a flume filled with water. On the northern and southern side of the park are some ditches. Some low ditches are on the future dog park area. The flooding water rises rapidly to these ditches and flumes but they don't have a runoff towards the sea.

On the Figure 4 is the ditch surrounding the dog park area.

Figure 4. Ditch surrounding the dog park area.

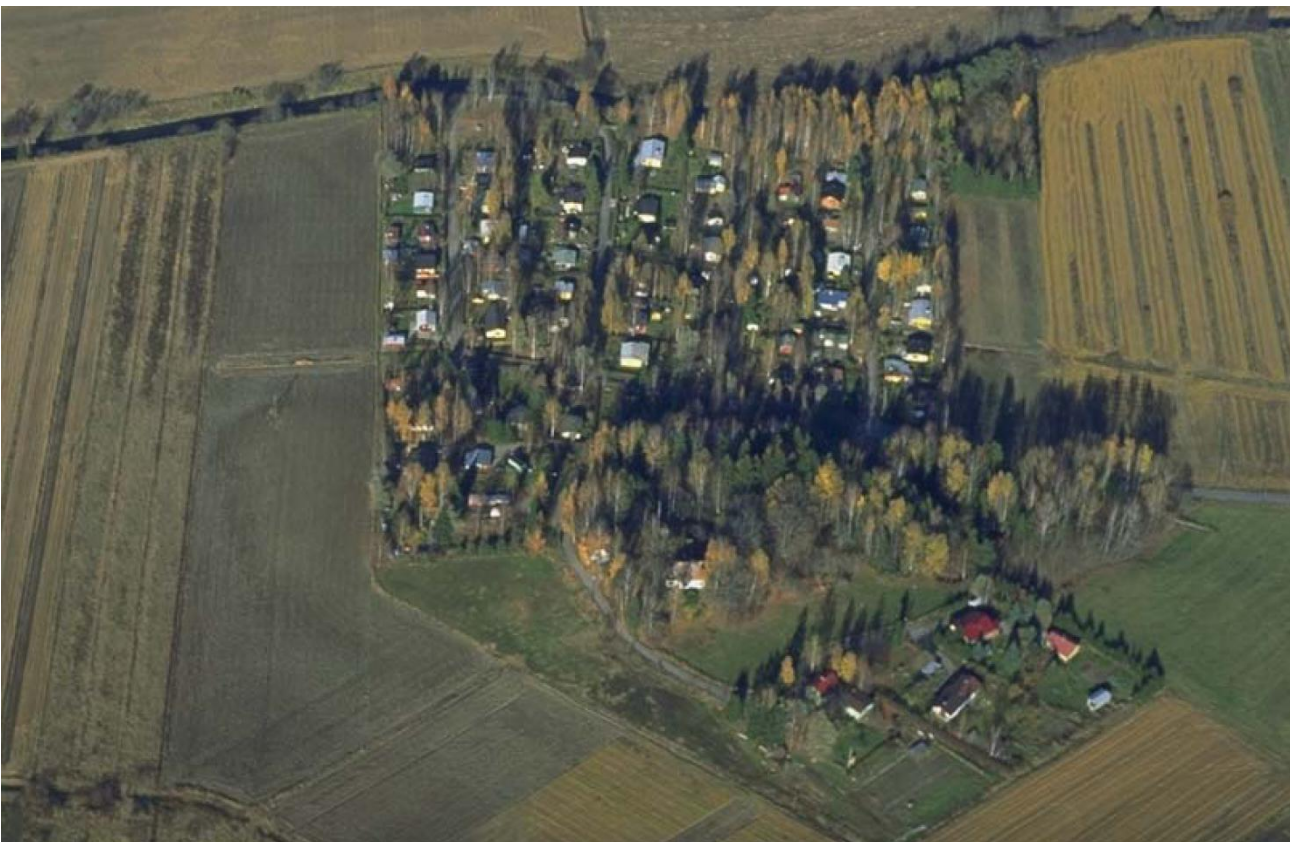
Pirttiranta pilot was built on a site that flooded yearly and the houses on the area were exposed to the flood. On the area a flood embankment was built on abandoned soils.

Figure 6. Pirttiranta site before building the flood embankments on dry time.

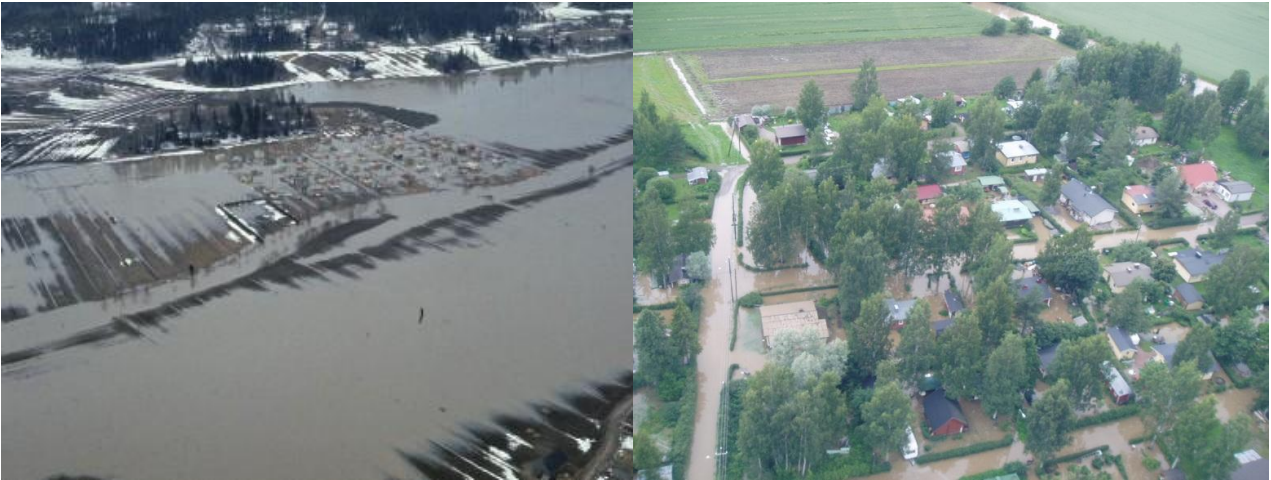
Figure 7. Pirttiranta on two different flooding periods on the left side spring flood 1966 and on the right side flooding in 2004.
