LIFE02 ENV/FIN/000329: Kukkia Circlet
REPORT ON TECHNICAL AND ENVIRONMENTAL FOLLOW-UP
OF PILOTS 2002 AND 2003
2002 – 2004
ANNEX (1) of the Final Report

FINNISH ROAD ENTERPRISE
RAMBOLL FINLAND LTD

7.3.2005

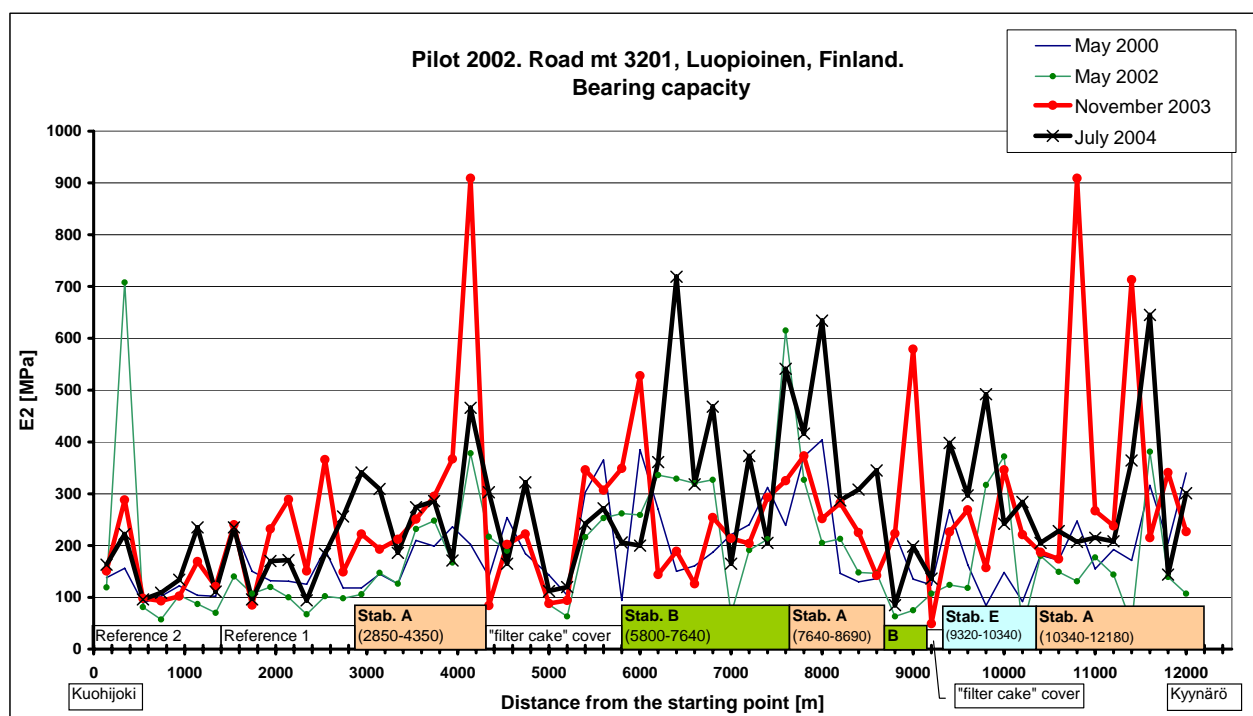
By looking at Figure (1) and Table (3) one can see that the bearing capacities of stabilised sections have increased considerably. In Reference 1 (“autumn renovation”) the increase

has been slight and in Reference 2 and “Filter cake” cover sections the average bearing capacities have stayed at the same level.

Due to the short-term results the range of bearing capacity is wide especially in the stabilised sections, but as a whole the Pilot 2002 has been a success. In springtime 2003 and 2004 there were no load limits for the traffic at the road while in past years the load limit has been required every other year. Of course the follow-up time of two years is too short for the further conclusions and the follow-up should be continued.

Figure 1. Pilot 2002. Bearing capacity between years 2000 and 2004.

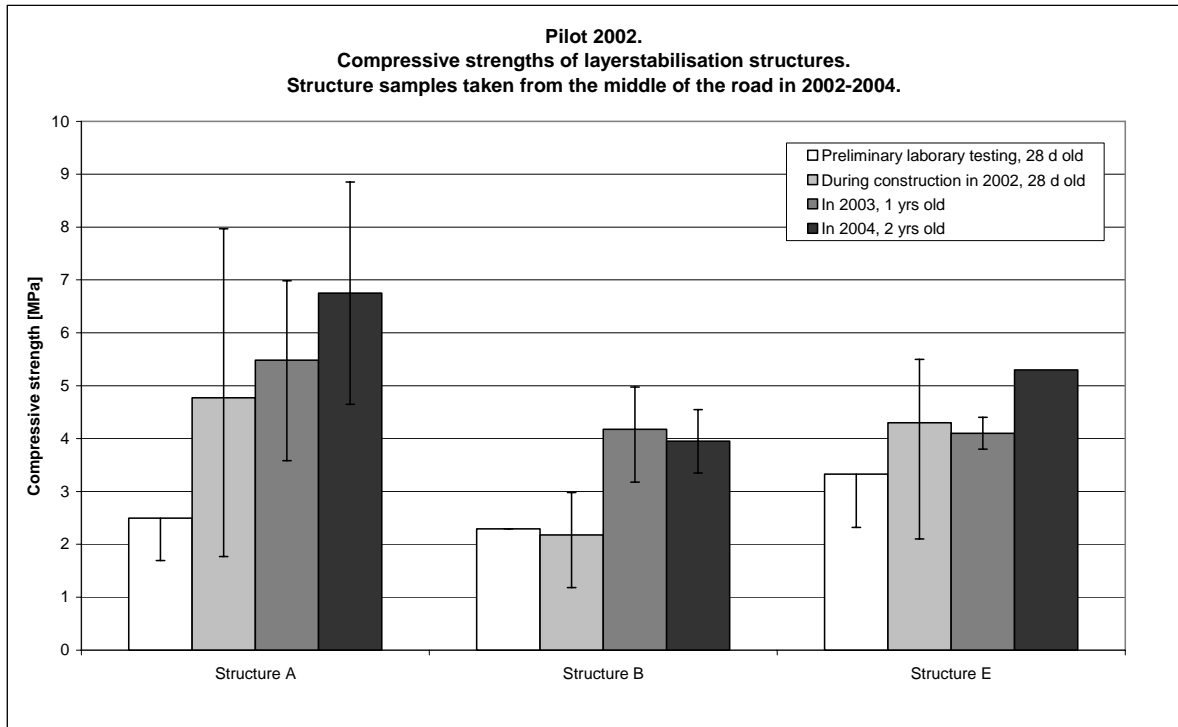
Figure 2. Pilot 2002. Strength development in structure samples taken from the middle of the road in 2002-2004.

In Figure (2) there is no downward trend of strength development and based on that fact the structures should be functioning as planned. In Figure (3) the lower strength of the road edge as well as the wide range of values might be result of some problems during the construction (too light compaction, mixing of stabilisation and subsoil at the roadside). The strengths of structure samples have been around 4-5 MPa and noticeable better than reached in preliminary laboratory tests (tests before construction).

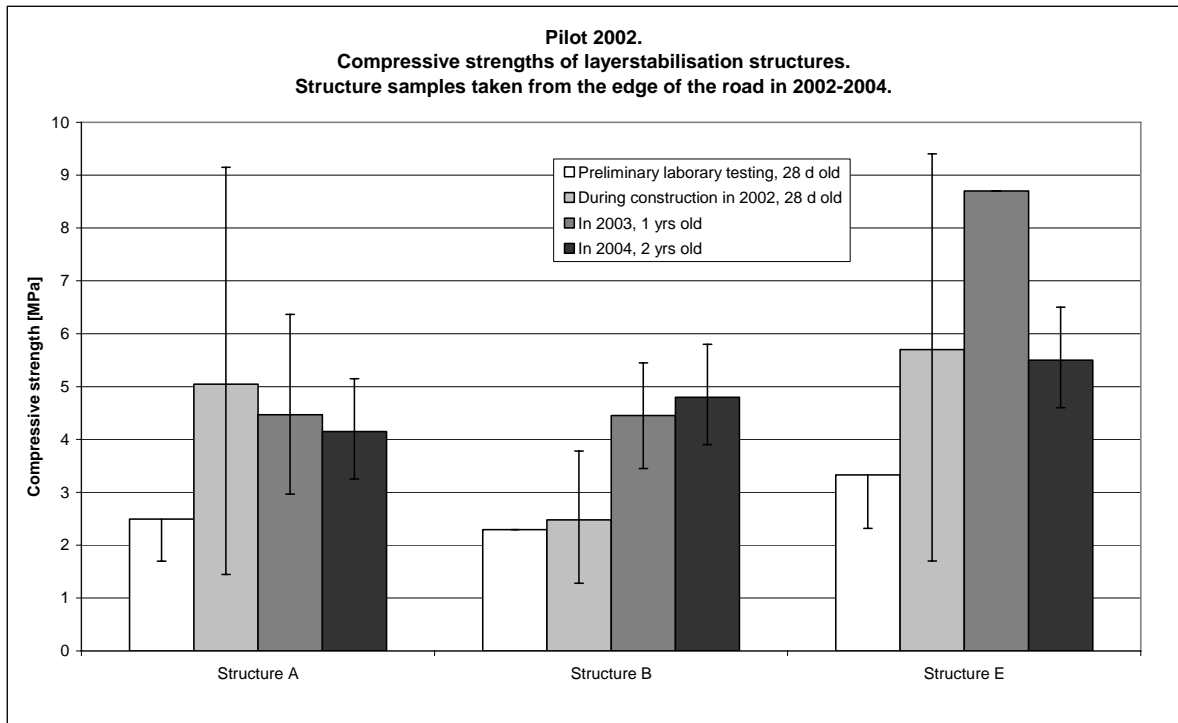
Figure 3. Pilot 2002. Strength development. Strength development in structure samples taken from the edge of the road in 2002-2004.

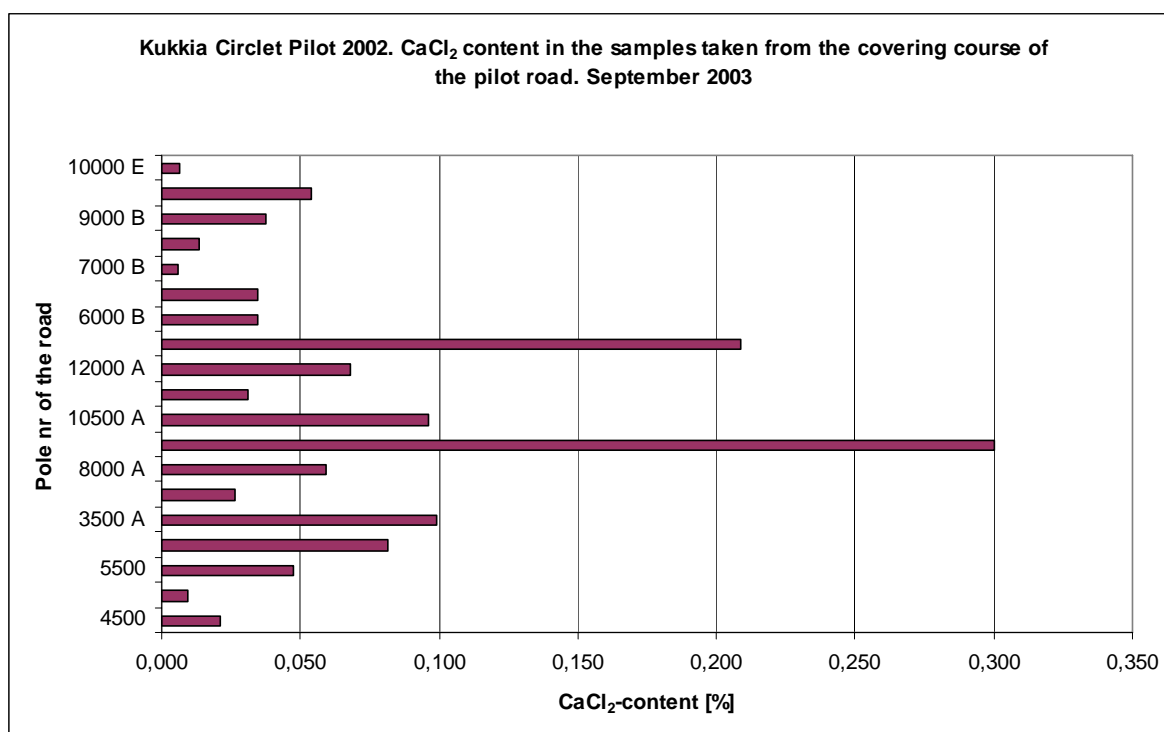
Figure 4. Pilot 2002. Calcium chloride concentrations in samples taken from the covering course.

The CaCl₂ content of covering course samples was measured one year after the construction. The target level was 0,6 % in 2002 (21 % of CaCl₂ in filter cake, 3 % of filter cake in covering course material) and in 2003 the levels varied between 0,004 % and 0,314 % (average 0,06 %). According to the TIEL2230013 (Maintenance and renovation of gravel roads, FinnRA; in Finnish) the needed amount of CaCl₂ is 0,15 % in springtime; so there might be need for extra CaCl₂ in the spring 2005. Covering course samples were taken also in 2004, but the results have not been available for the final report.

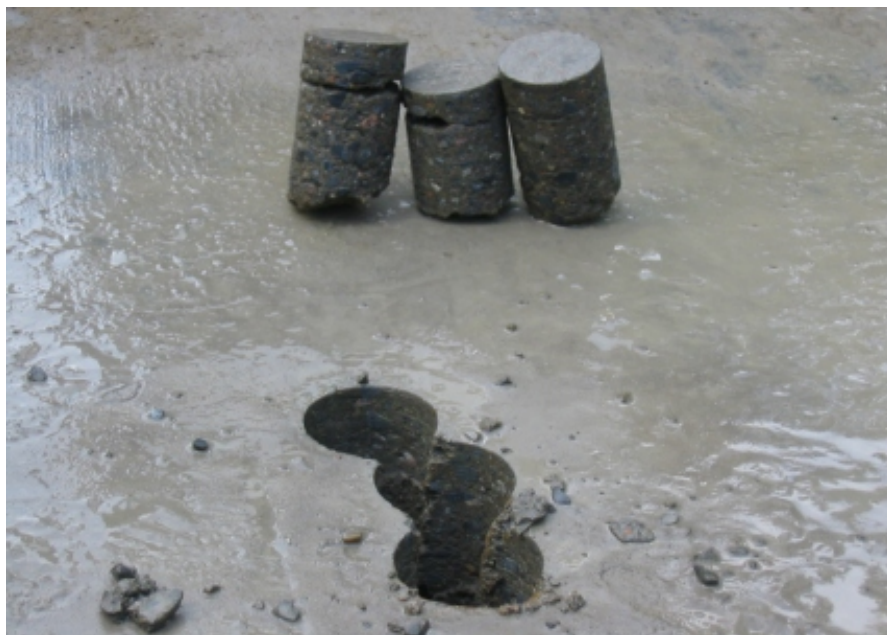
Figure 5. Pilot 2002. Drilled samples from a stabilised section.

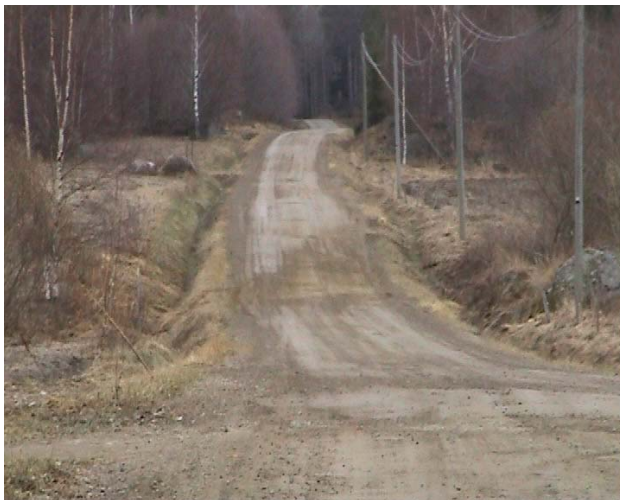
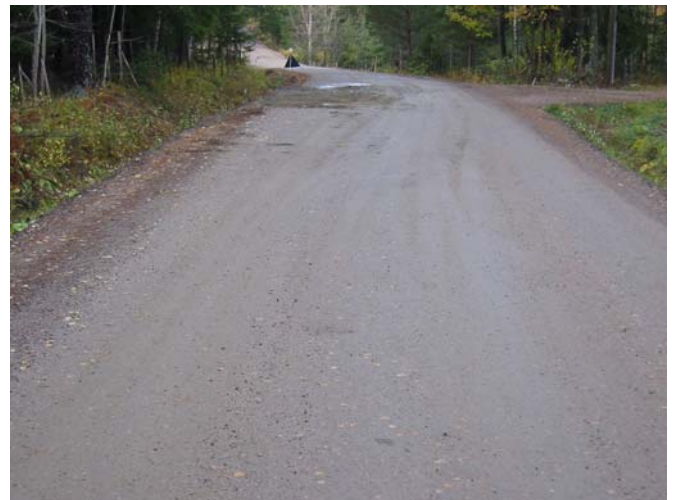
Figure 6. Pilot 2003. The pilot road before and after renovation in 2003.

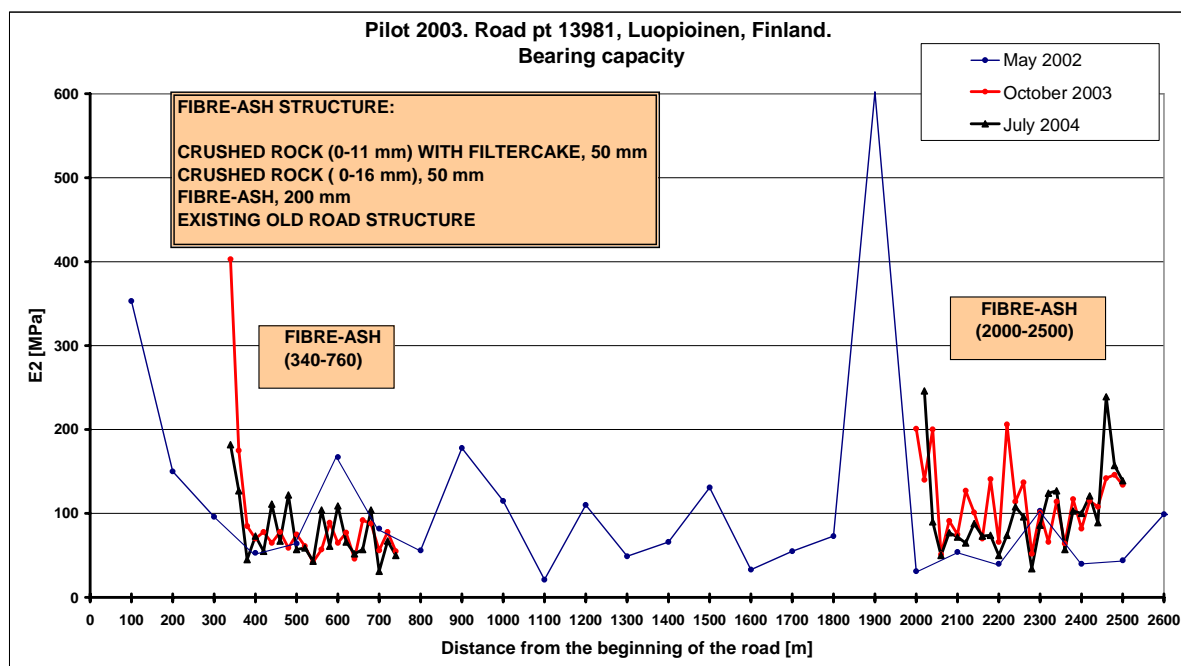
Figure 7. Pilot 2003. Bearing capacity between years 2002 and 2004.

The bearing capacity has remained about the same or improved a little. The main point of using fibre clay is not the increasing of bearing capacity but to prevent the damaging frost heave. The fibre clay forms an insulating, separating, and elastic layer, which reduces frost penetration, prevents mixing of subsoil and covering course, and diminishes frost heaving.

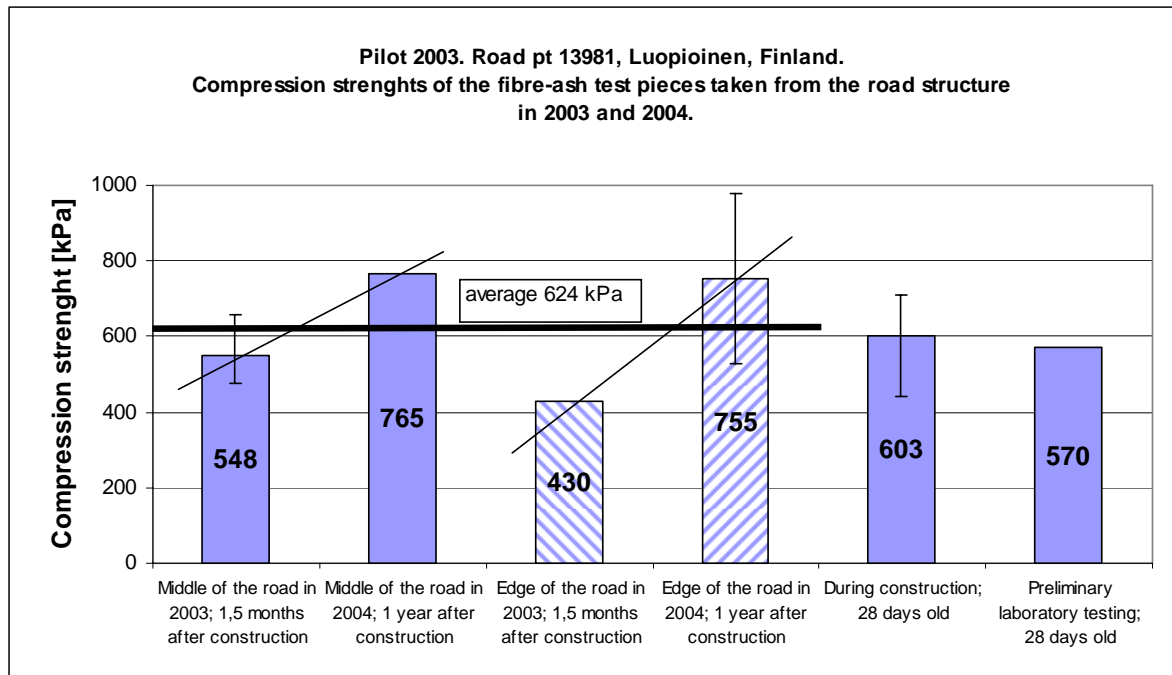
Figure 8. Pilot 2003. Strength development in structure samples taken from the road in 2003 and 2004.

The strength values fulfil the expectations and the strength development has continued in the samples taken from the pilot road. Structures are in good condition (firm, not mixed with covering course) and seem to work according to expectations and plans.

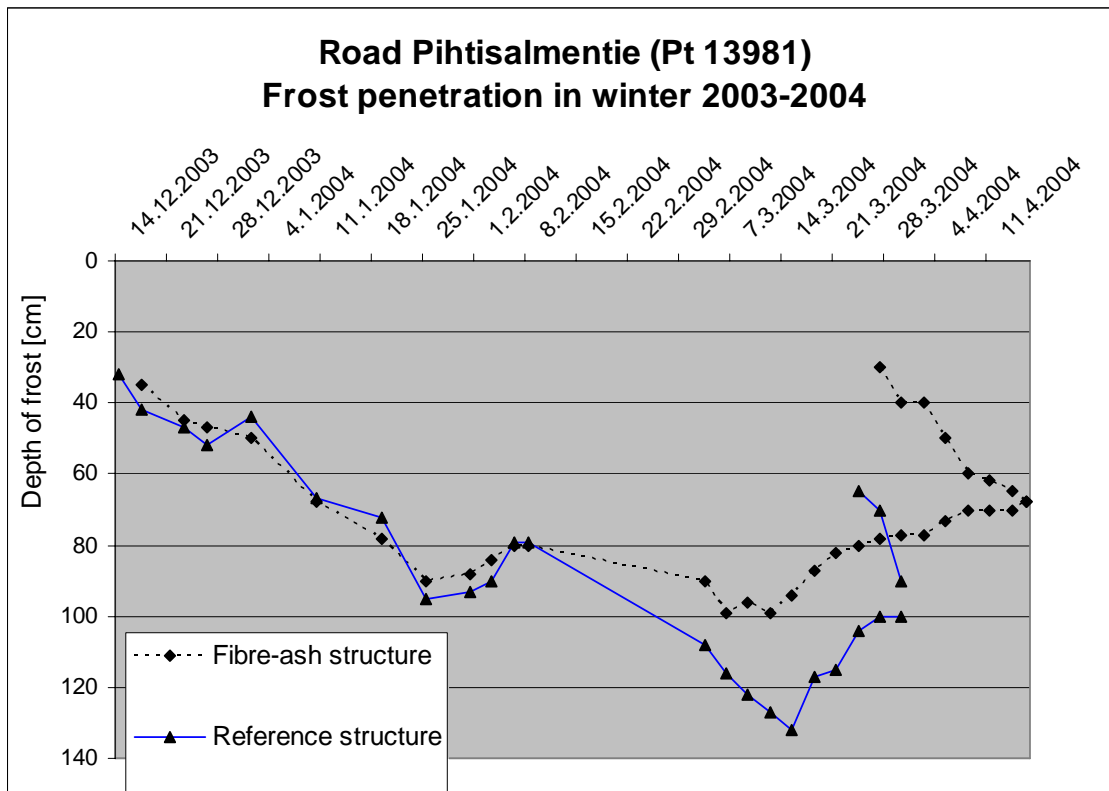
According to the temperature measurements done in fibre ash section and in reference section, it seems that fibre ash structure has both reduced frost penetration and delayed the melting of frost. Temperature curves are shown in Figures 9, 10, and 11.

Figure 9. Pilot 2003. Frost penetration in road Pt 13981 in winter 2003-2004. During few weeks of spring there are two frost penetration depths, because the melting of frost starts also from the top after snow has melted.

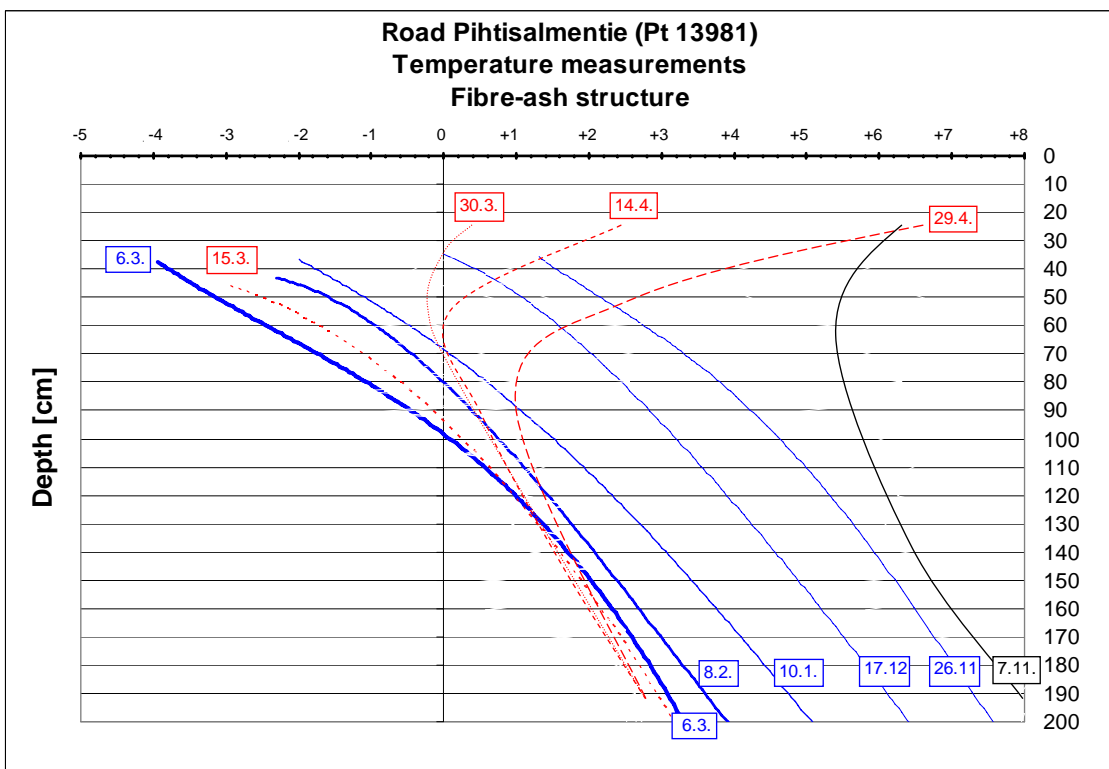
Figure 10. Pilot 2003. Temperature measurement curves at the fibre ash structure of the pilot road.

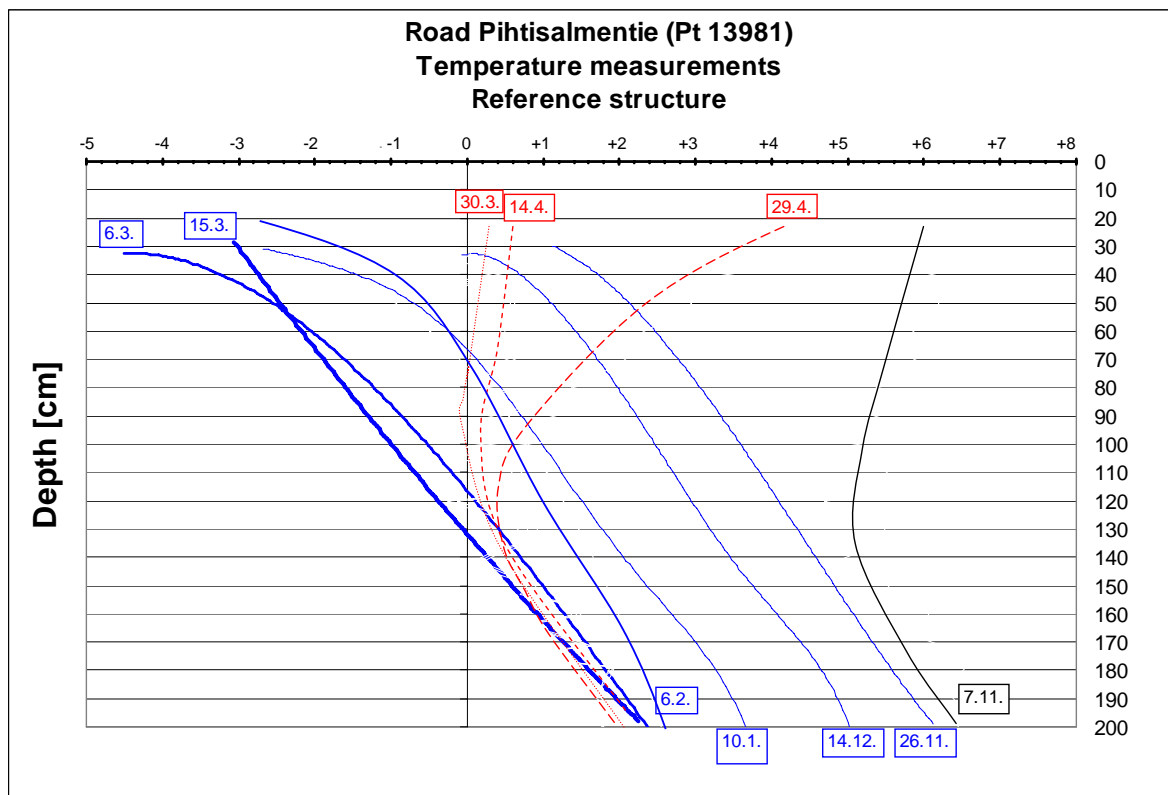
Figure 11. Pilot 2003. Temperature measurement curves at the reference structure of the pilot road.

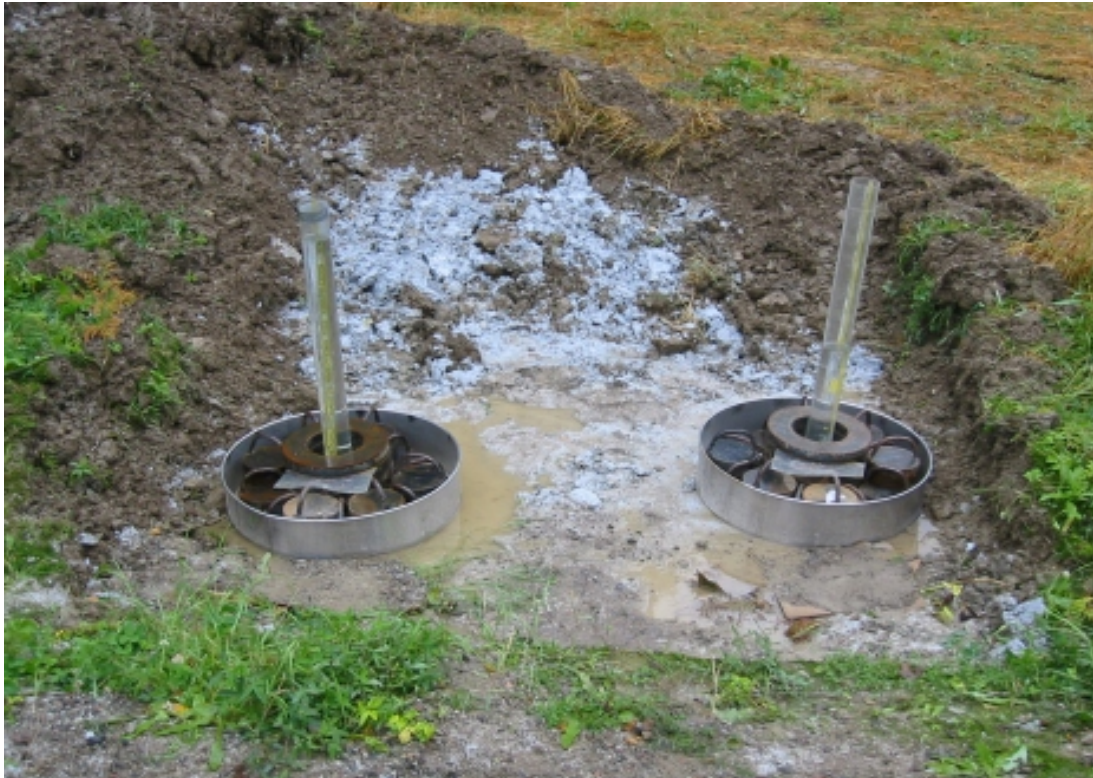
Fibre clay has been used as covering material for closing dumping sites. With a careful compaction the water permeability (k-value) of a fibre clay layer could be even lower than 10^{-10} m/s. In this pilot project the measured k-values were too high, about 10^{-7} m/s, which was probably due to feeble and too light compaction work. Also the top soil layer was too thin and, thus, too light to generate any longer term loading embankment for the fibre clay layer. The permeability was determined with help of a infiltrometer (Figure 12).

Figure 12. Pilot 2003. Infiltrimeter measurement done in the fibre clay groundwater structure.

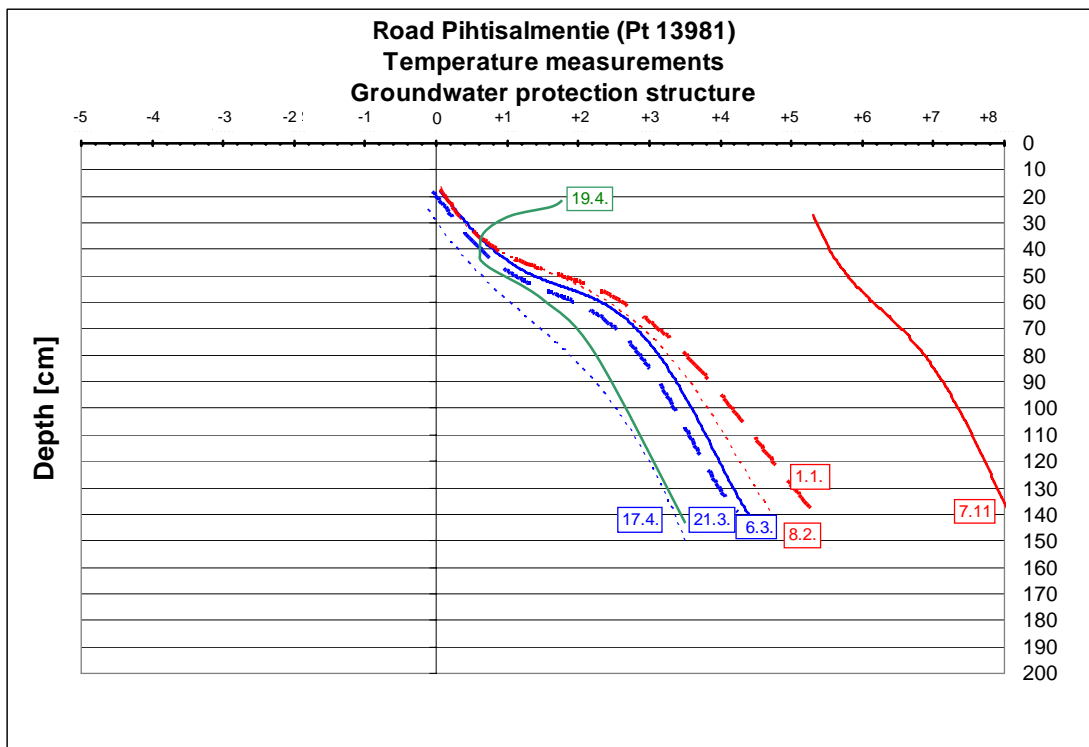
Thermo-measuring elements were placed above and under the fibre clay groundwater protection structure. Daily temperature measurements were taken via GSM link. As seen in Figure (13) the insulation of fibre clay and snow cover prevented the subsoil from freezing.

Figure 13. Pilot 2003. Temperature measurement curves at the fibre clay groundwater protection structure.

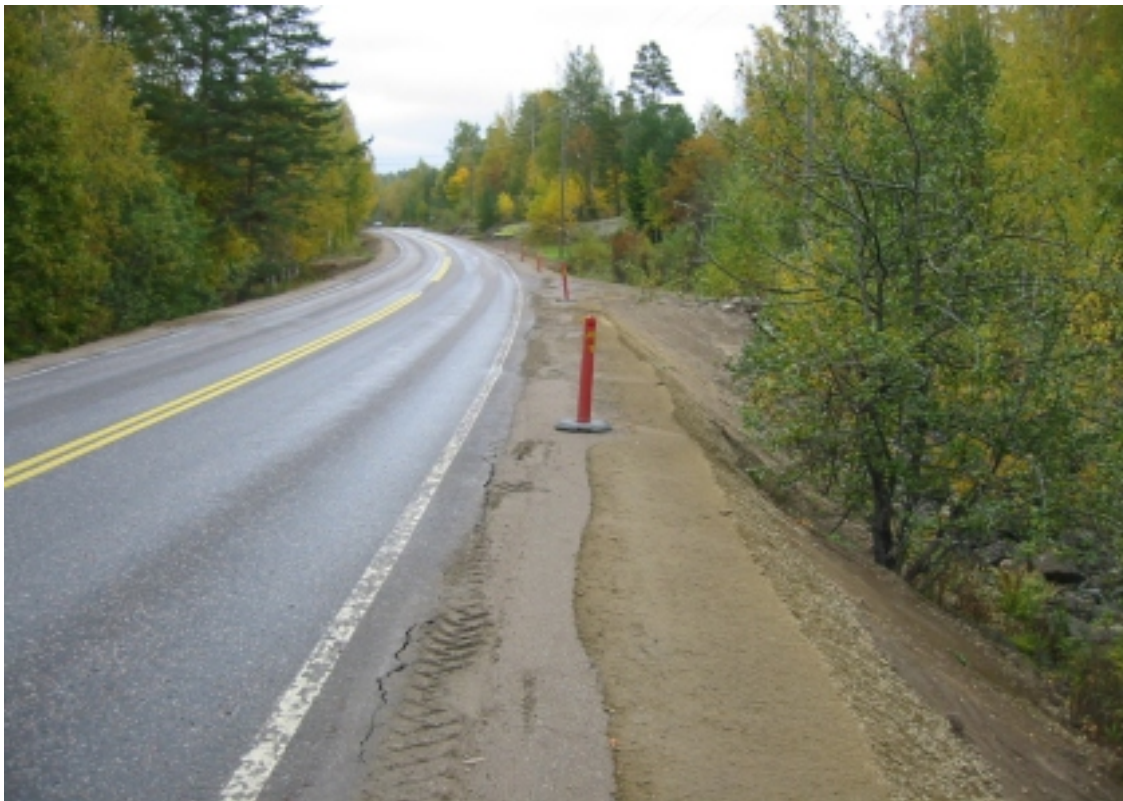
Figure 14. Pilot 2003. Safety lane in connection to the main road Kt 322, during construction in 2003.

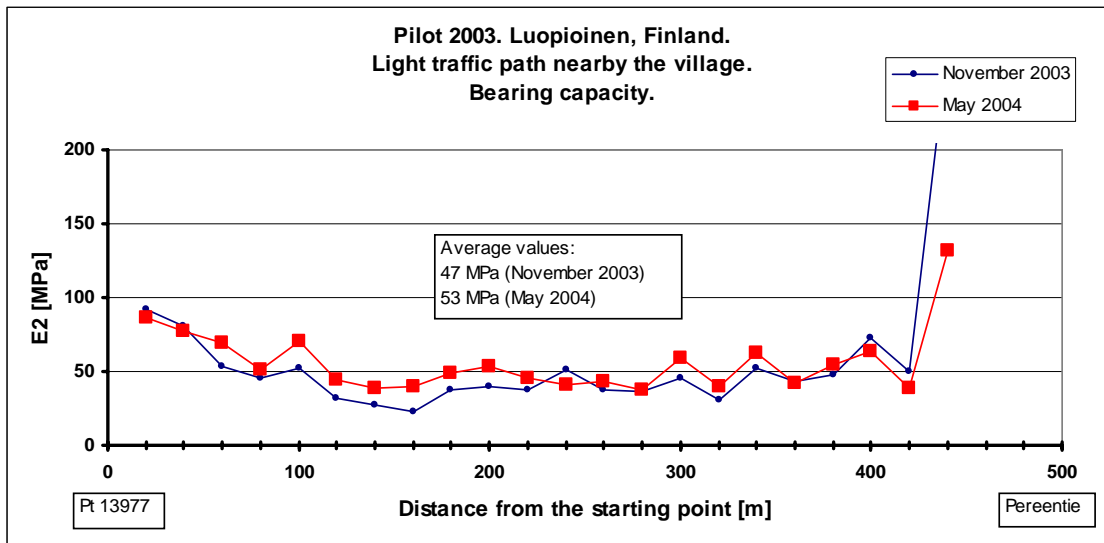
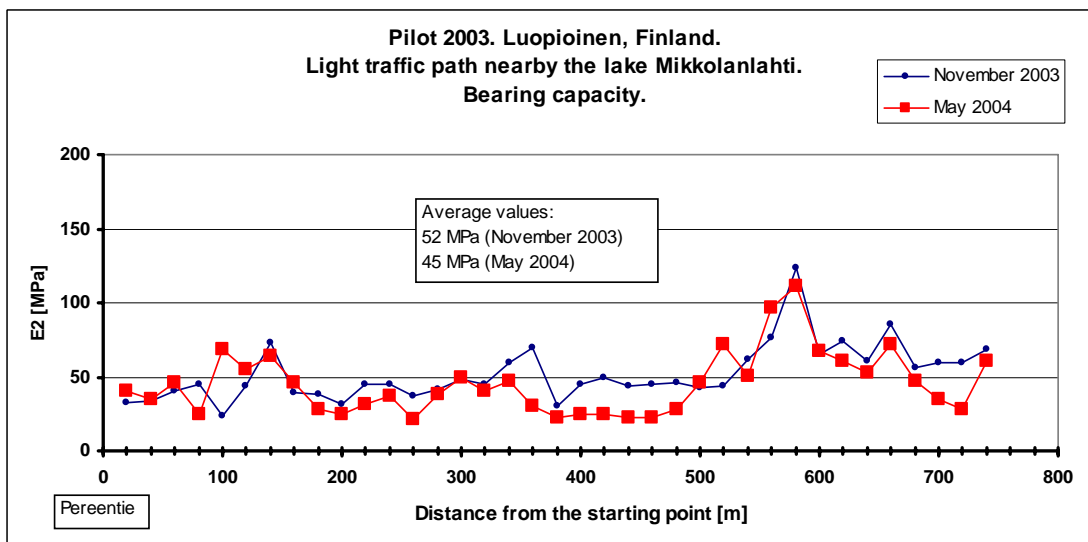
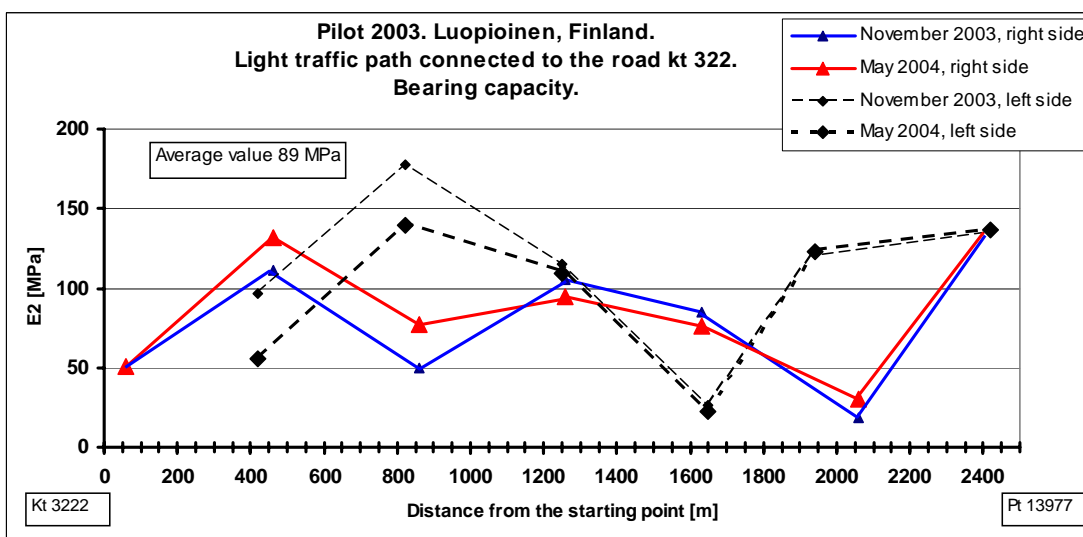
The bearing capacity was low in both sections (about 50 MPa), but that was like expected. The fibre clay works as an insulating, separating, and elastic layer and therefore the high bearing capacity is not necessary for a satisfactory result. Strengths of the samples taken from the road were lower than the strengths measured in preliminary laboratory testing (tests before construction), but the strength development has been satisfactory.

Safety lanes were monitored already about one and a half months after the construction in the autumn 2003. The fibre ash structure was softer than expected. The structure was harder close to the driveway than closer to the roadside or in the middle of the structure which is caused by problems in compaction. Strengths in samples taken from the road were noticeable lower than the strengths measured in the preliminary laboratory testing. Also the bearing capacity was low (about 90 MPa).

Figure 15. Pilot 2003. Bearing capacities of the light traffic lanes in 2003 and 2004. Above and middle the results of the separate light traffic lanes and below the results of the safety lanes.

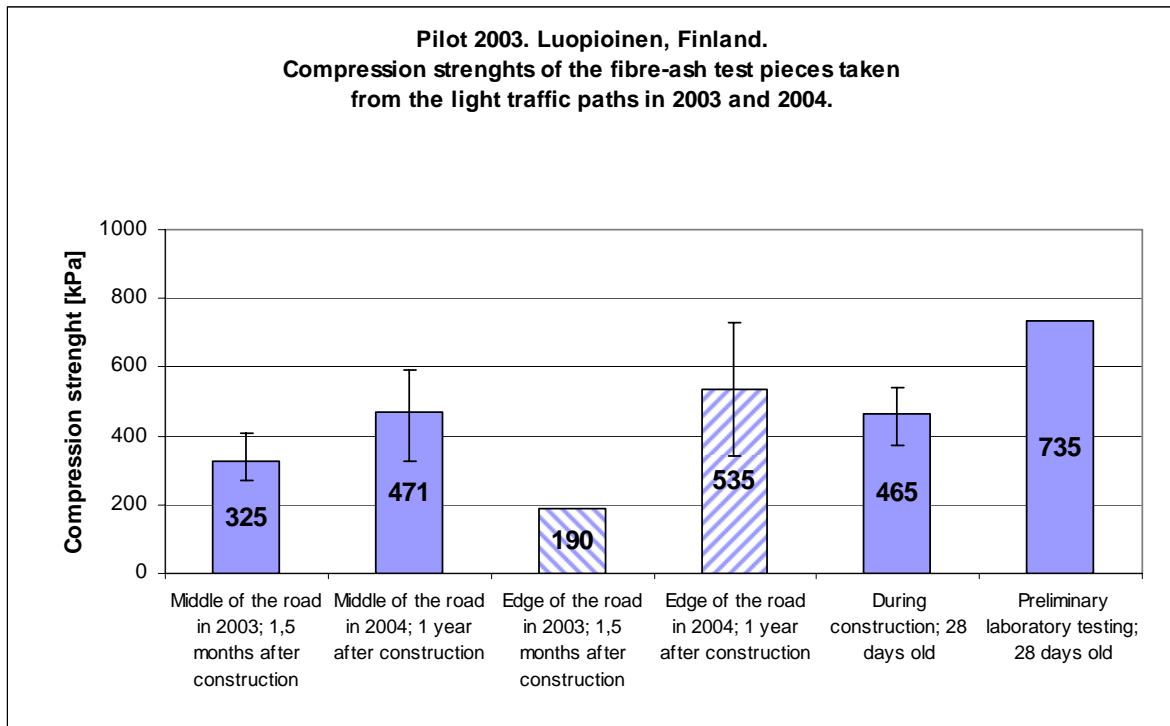
Figure 16. Pilot 2003. Strength development in structure samples taken from the light traffic lanes running nearby the Kukkia Lake and the village in 2003 and 2004.

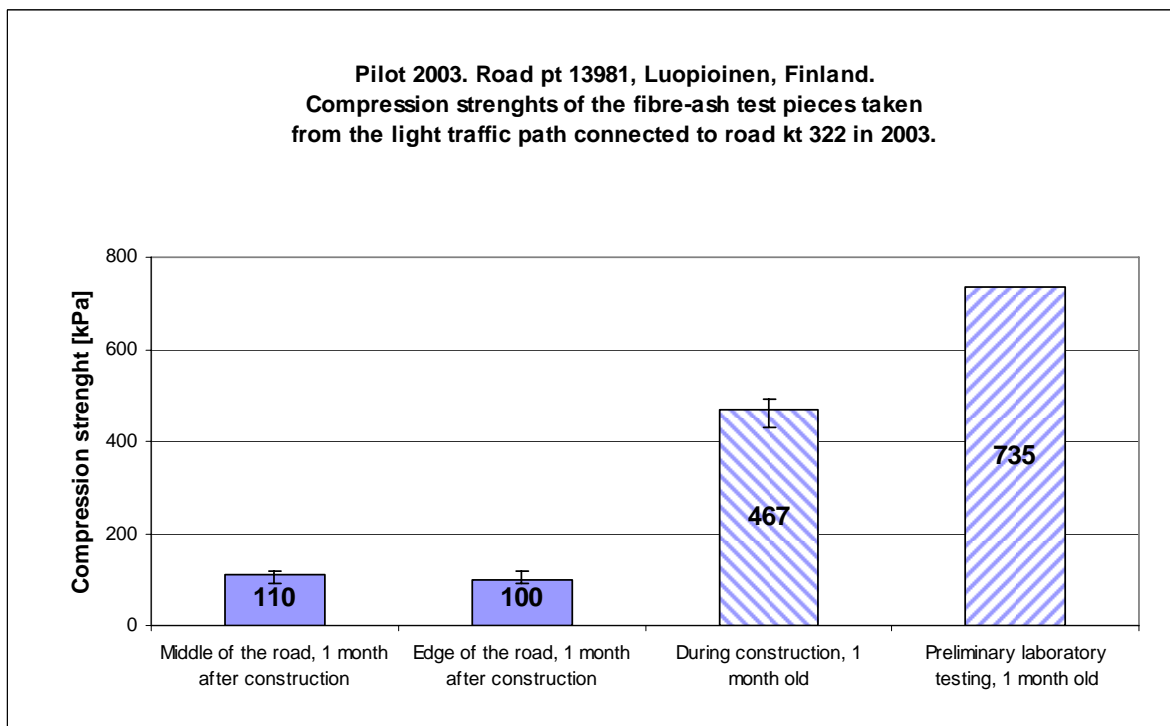
Figure 17. Pilot 2003. Strength development in structure samples taken from the safety lane connected to Kt 322 in 2003 and 2004.

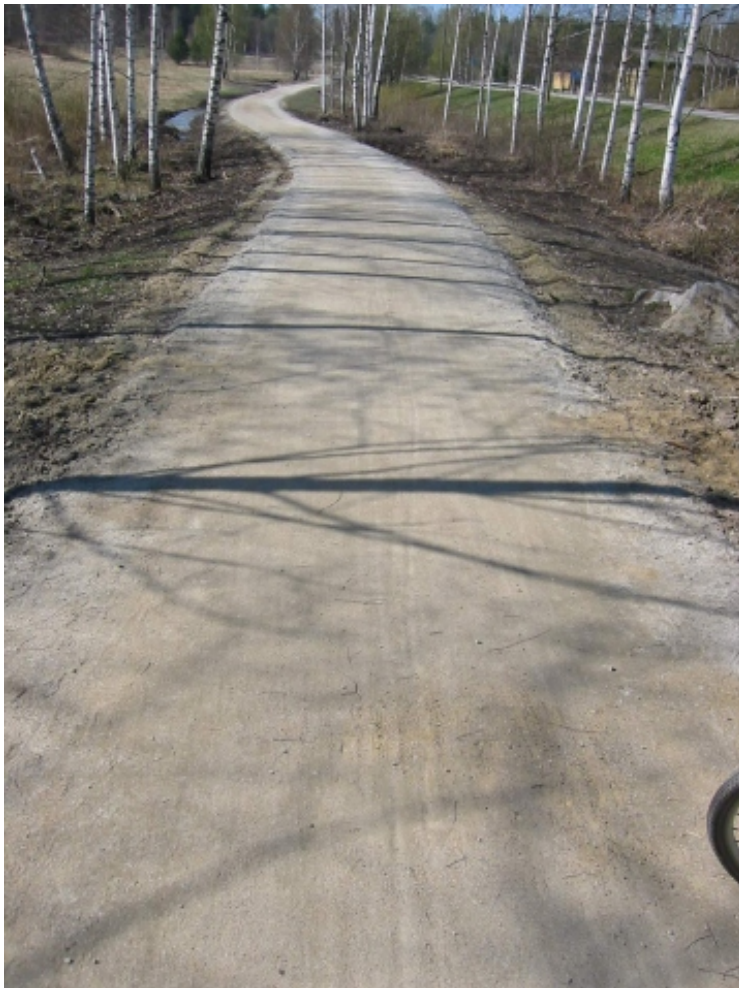
Figure 18. Pilot 2003. Light traffic lane passing by the village in spring 2004.
