LIFE Project Number
LIFE02 ENV/FIN/000329

PROGRESS REPORT No. 2
Covering the project activities from 1.3.2003 to 30.9.2003

LIFE PROJECT NAME
Kukkia Circlet:

Environmentally friendly systems to renovate secondary roads

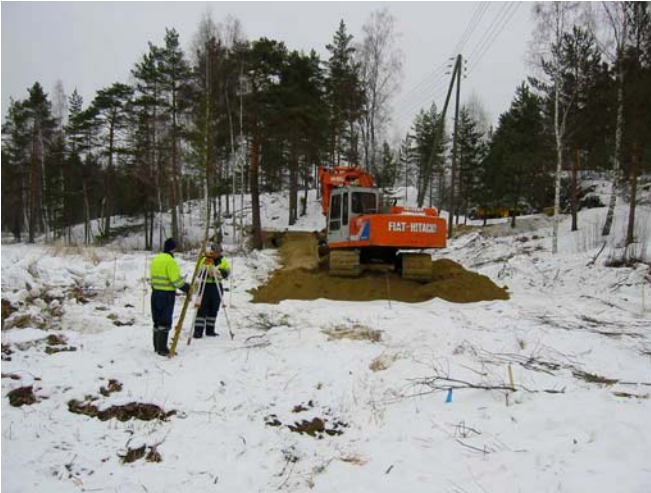
Figure 1: Pre-loading for the light-traffic lane running on a soft peat area. Pilot 2003

The preparations included, for example, clearing of the construction site and special pre-loading for the separate light-traffic lane planned to run on a soft soil (peat) area (**Figure 1**). More of these are described below in relevant sections.

The pre-loading to strengthen the soft ground for the light-traffic lane had to be made on two 100 metres long sections in February – March 2003 (see above and Figure 1). A filter cloth was spread on the levelled and frozen ground, and on the cloth two about 200 mm thick layers of moraine. Additionally, a 600 mm thick load embankment was spread on the former construction.

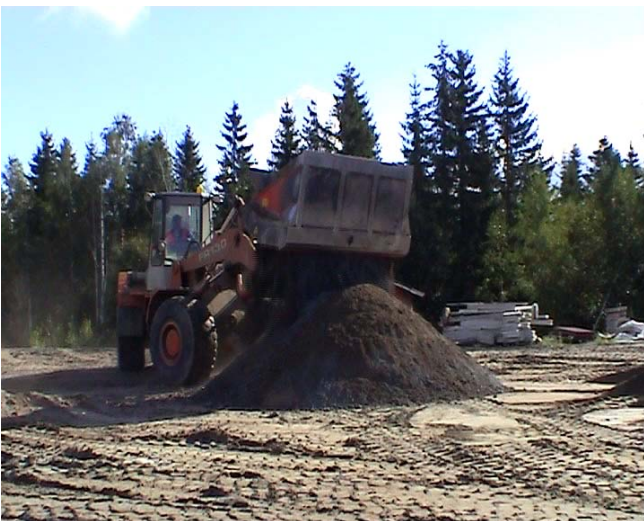
Figure 2: Mixing shovel at work to mix crushed aggregate with filterwaste. Pilot 2003

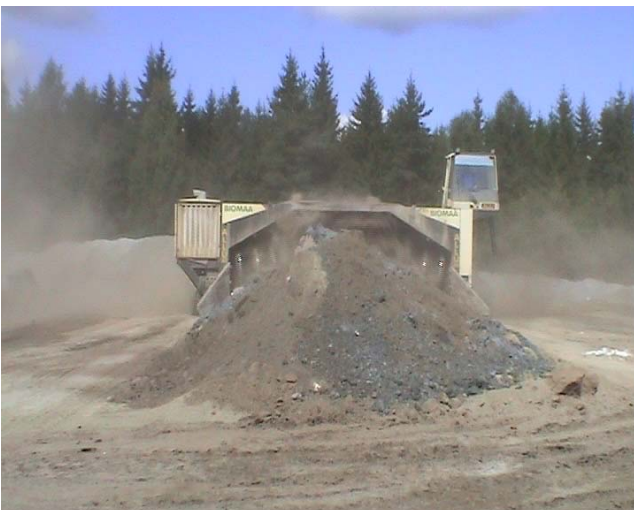
Figure 3: Stack mixer at work to mix fly ash and fibre clay. Pilot 2003

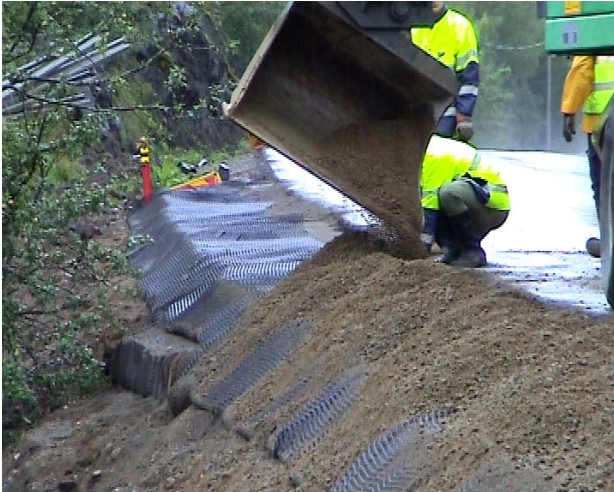
Figure 4: Crushed aggregate to cover the geonet containing the fibre-ash course. The compaction will be made on the crushed aggregate. Pilot 2003

The safety lanes were constructed in general as follows: The surface layer at the road edge was cut down. The levelled base was covered with a geonet, and filled in with fibre-ash (about 500 mm). The loose sides of the geonet were folded on the fibre-ash course, and the structure was covered with a thin course of crushed aggregate. The compaction was carried out on the crushed aggregate course. **Figures 4 and 5** explain more.

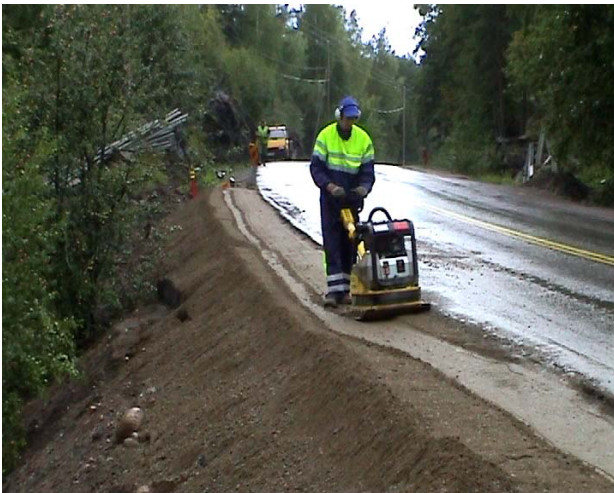
Figure 5: Compaction on the safety lane. Pilot 2003

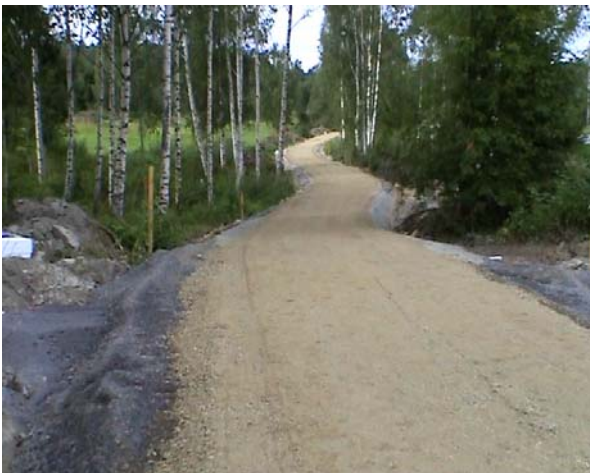
Figure 6: A section of light-traffic lane before finishing. Pilot 2003

The works started at the end of July. First steps were the removal of topsoil and the levelling of the ground with help of natural aggregates (not the pre-loaded sections). The levelled ground was covered with a filter cloth, and this with 100 mm of crushed aggregates to make it possible to move with the power tools. Edge supports were constructed in order to prevent the fibre-ash spreading wider than the targeted width, and to make also compaction at edges possible. 300 mm of fibre-ash was spread on the aggregate course with help of a lorry and planer. The fibre-ash was covered with 50 mm crushed aggregate and 50 mm with filtercake-stabilised aggregate. See **Figure 6**.

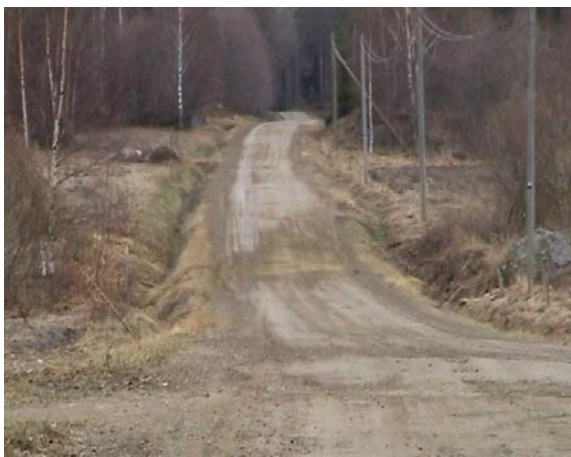
Figure 7: The village road in the spring 2003, before renovation. Pilot 2003

A photo of the starting condition of the badly damaged village road was taken in the spring 2003, **Figure 7**. The road is much better after construction, **Figure 8**, and we hope that this is a lasting situation. The construction of this short section (500 metres) was carried out in three days at the beginning of August 2003. The covering with filtercake stabilised crushed aggregates was made on 11th August. The process was as follows: The surface was cut and the edge supports for the fibre-ash were formed out of the surface material. Fibre-ash was transported with a lorry to the site, and spread as a 300 mm thick layer with a planer on the ground. This layer was covered with a thin course of crushed aggregate to make the compaction with a roller as effective as possible. After compaction, the fibre-ash course was 200 mm thick. Finally, the compacted structure was covered with 50 mm filtercake stabilised aggregate and compacted again. The finishing of the road edged finalised the job.

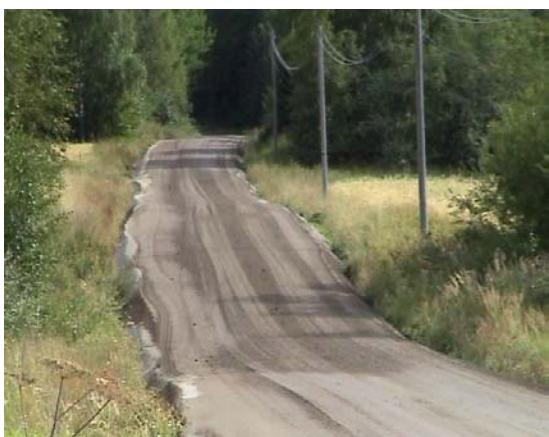
Figure 8: The village road in the autumn 2003, after the renovation operations. Pilot 2003
