KUKKIA CIRCLET
Interim Impact Assessment Report 2003

Annex of Progress Report 3
1.10.2003 – 31.3.2004

FOLLOW-UP OF PILOT CONSTRUCTIONS
1.10.2002 – 31.12.2003

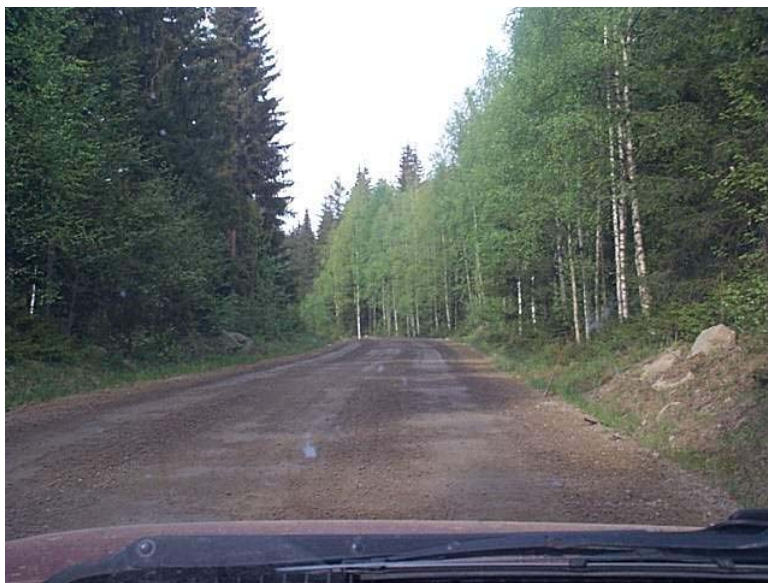
Figure 1: Frost damage of a gravel road section in the spring 2002. Luopioinen

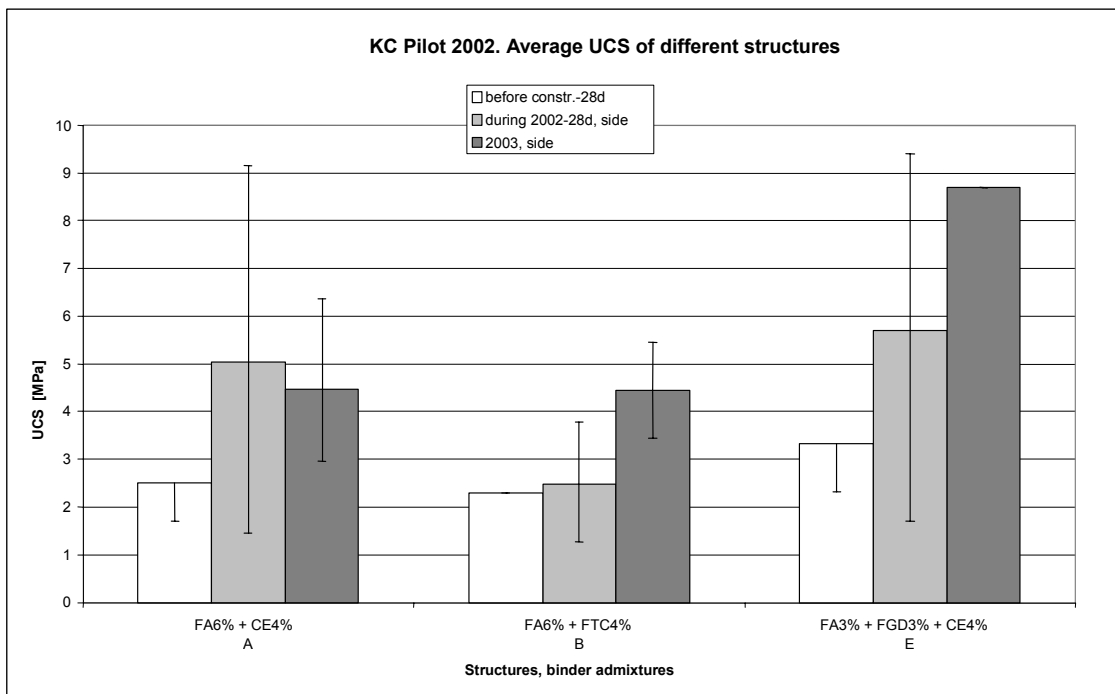
Figure 3: UCS of stabilised sections in 2003 (2003, road side), test pieces made for the determination of recipes before construction (before constr. – 28d) and test pieces made of the corresponding mixture used for the construction (during constr. – 28d). FA = Fly Ash, CE = cement, FTC = a commercial mixture of process gypsum and lime, FGD = flue-gas desulphurisation residue from the semi-dry system. Ramboll Finland Oy 2003.

The results of the laboratory measurements are compared with the results of the test pieces made of the corresponding material mixtures during the construction in the laboratory (UCS after 28 days stabilisation in the room temperature), and with the corresponding laboratory test results for the determination of the binder admixture recipes before construction. The latest results are given in the Figures 2 and 3.

The figures 2 and 3 show that the tests made for the determination of recipes give not too good results when compared with the results from the actual construction. However, the tests before and during construction have been made on 28 days old test pieces, but the drilled test pieces are from a more than 12 months old construction.

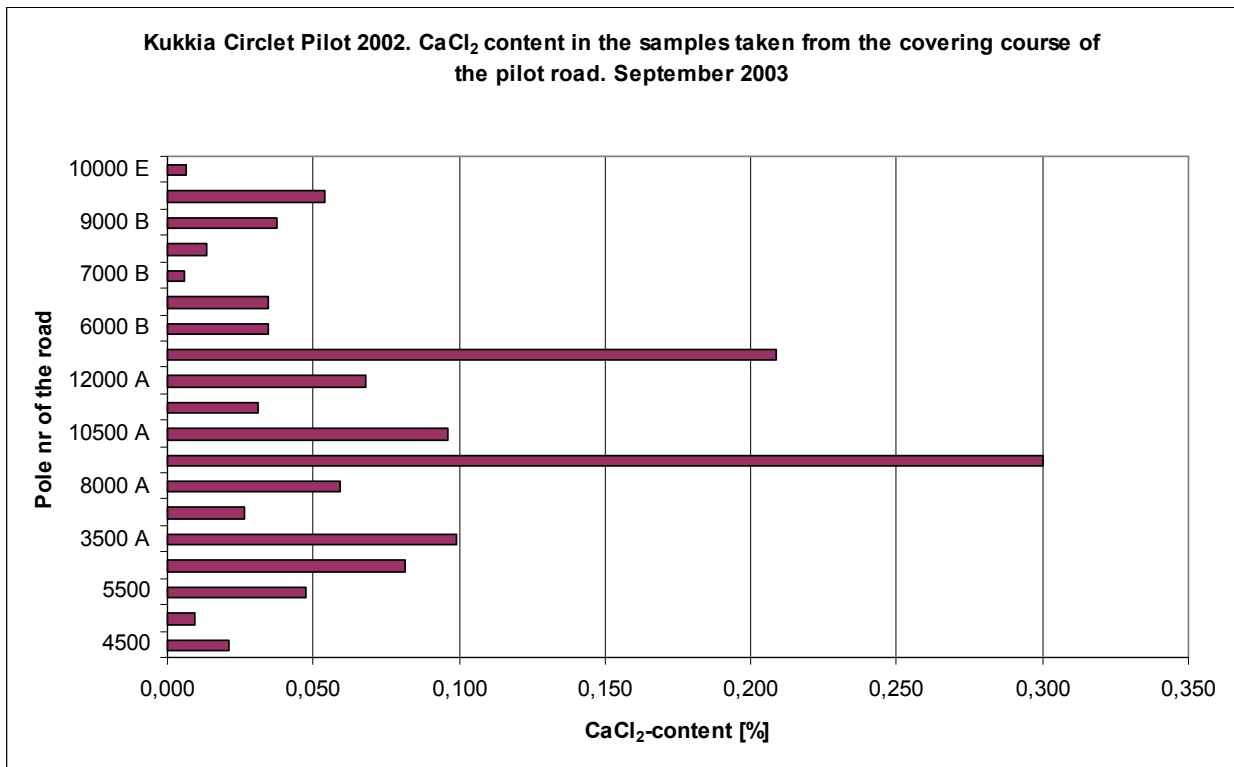
The filter cake is a by-product from the manufacture of calcium chloride, and contains also calcium chloride. The demonstration of the covering course mixture should show, that this kind of method is a long-term dust prevention method for a gravel road. The granulate used in the mixture with crushed aggregate in 2002 contained about 21 % CaCl_2 , and the amount filter cake granulates was about 0,006 % in the covering course mixture. The samples taken from the covering course in the autumn 2003 were analysed in the laboratory of Kemira Oyj. The results show that the calcium chloride content varies between 0,004 – 0,314 % one year after the construction (Figure 4).

Figure 4: Content of CaCl_2 in the covering course of Pilot 2002 road, at different places indicated by the pole-number. Ramboll Finland Oy 2003.

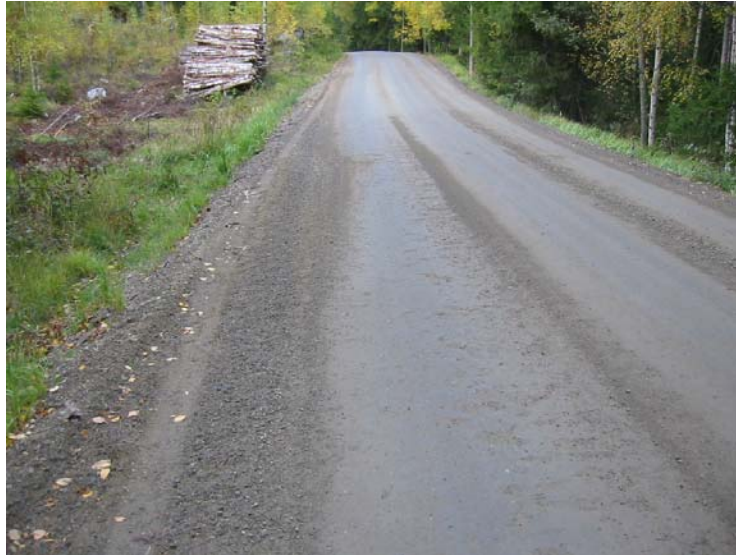
Also the thickness of the covering course was checked during the sampling. The covering course was not quite even on the road; the targeted thickness was 100 mm, but the results of the measurements proved significant variance the average being about 87 mm in the autumn 2003. At places the covering course was totally missing at the sides of the road. See Figure 5.

Figure 5: The thickness of the covering course varies significantly in the autumn 2003, one year after the construction of Pilot 2002. Ramboll Finland Oy 2003.

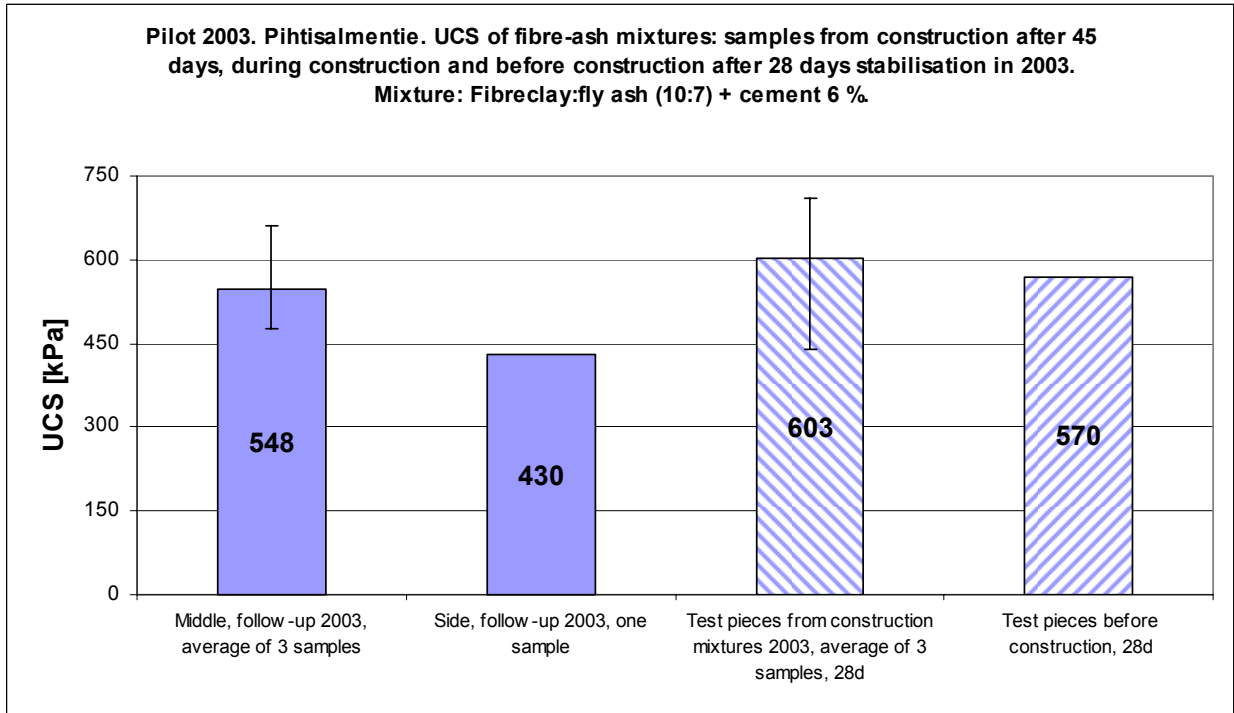
The structural studies have been performed to fibre-ash samples taken from the sites in September - October 2003. Thus, the stabilisation time for the structures has been 30 – 45 days after the construction. The samples were tested for UCS (unconfined compression strength). The results are given in Figures 8 – 10, and can be compared with the results from test pieces made of materials taken from the construction site before construction, and with the laboratory results for the determination of recipes before any construction. Here we can clearly note the effect of compaction efficiency on the stabilisation in the short term; see especially Figure 10 for safety lanes. The results will be completed with results from samples to be taken in the autumn 2004.

Figure 8: Structural studies of Pilot 2003 at Pihtisalmentie (renovation of badly damaged road section) in the autumn 2003. The fibre-ash mixture is FC:FA 10:7 + Ce 6 %; FC = fibreclay, FA = fly ash, Ce = cement.

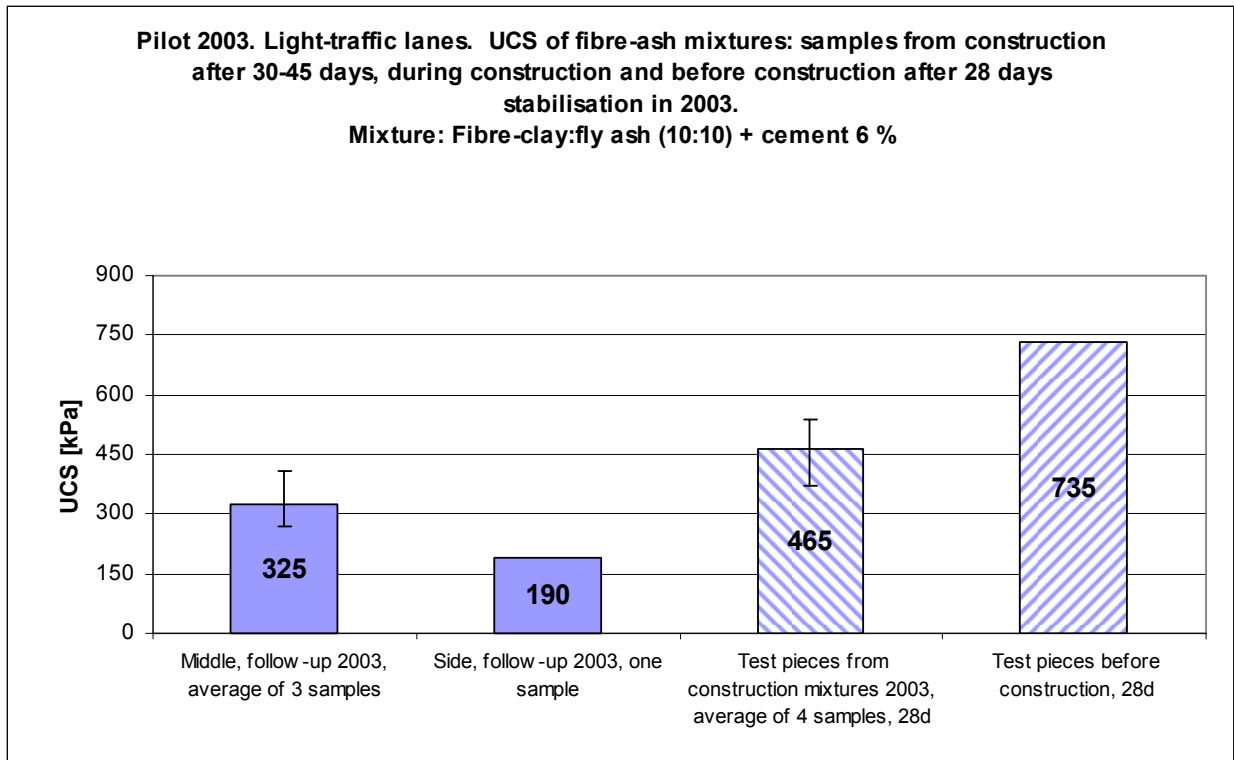
Figure 9: Structural studies of Pilot 2003 light-traffic lanes in the autumn 2003. The fibre-ash mixture is FC:FA 10:10 + Ce 6 %; FC = fibreclay, FA = fly ash, Ce = cement.

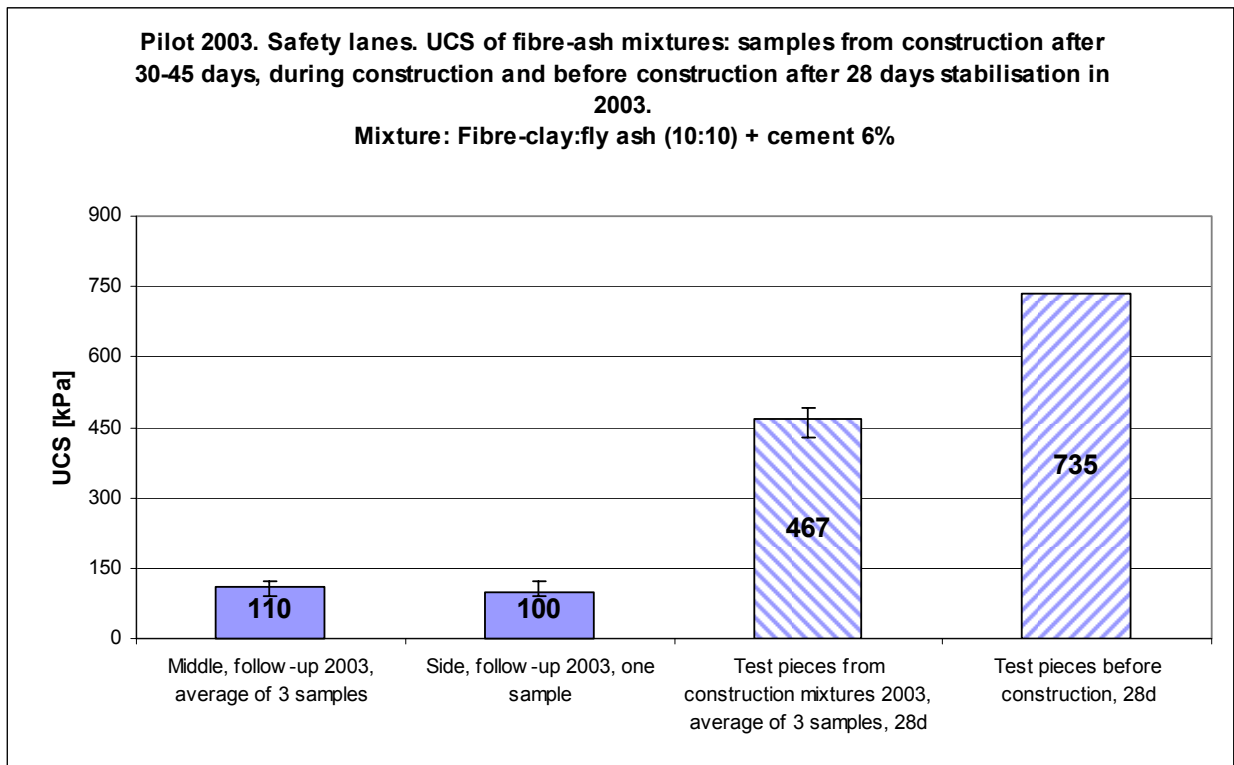
Figure 10: Structural studies of Pilot 2003 safety lanes in the autumn 2003. The fibre-ash mixture is FC:FA 10:10 + Ce 6 %; FC = fibreclay, FA = fly ash, Ce = cement.
