## CASE KIVIKONLAITA

| <b>KIVIKONLAITA</b> | Key words: |
|---|--|
| Kivikonlaita, Helsinki, Finland<br>Construction of an industrial area on<br>a swamp | Mass stabilization, Peat, Clay,<br>Swamp, Test embankment |

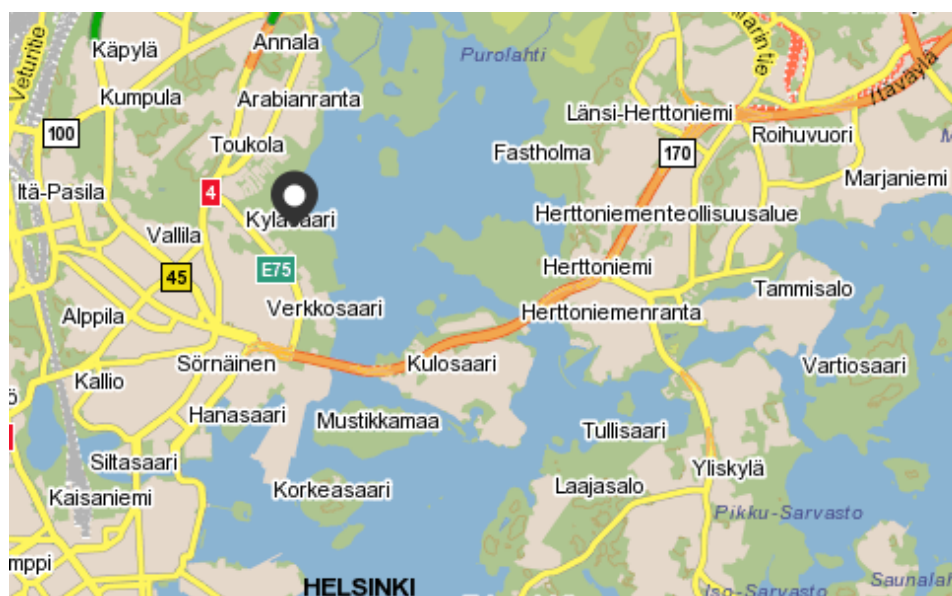
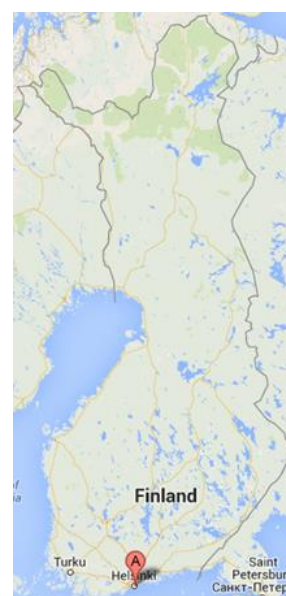
Stabilised areas and stabilization years in Kivikonlaita.

| <b>KIVIKONLAITA</b> | Key words: |
|---|--|
| <b>Project timetable</b> | Stabilizations in Kivikonlaita were as following:<br>Mass stabilization in years 1998 – 2004 and 2007-2009-><br>Column stabilization in 2006 |
| <b>Volumes and dimensions</b> | Approx. 9 hectares was stabilised |

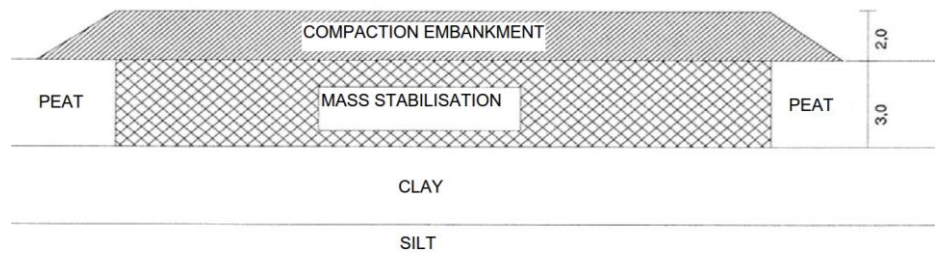
First mass stabilizations in Kivikonlaita – effect of stabilization
