POOLE

United Kingdom
Quay extension

contaminated sediments,
port construction

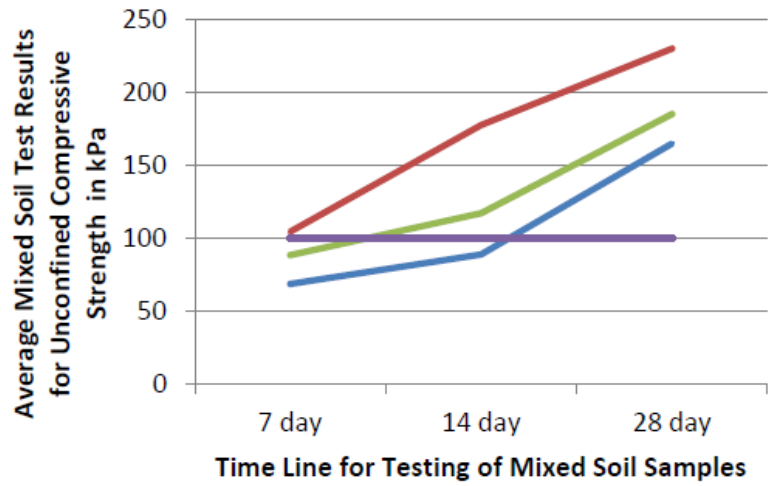
Results of stabilization tests

- Mix 1 @ 8% Binder
- Mix 2 @ 13% Binder
- Mix 3 @ 20% Binder
- Target Strength

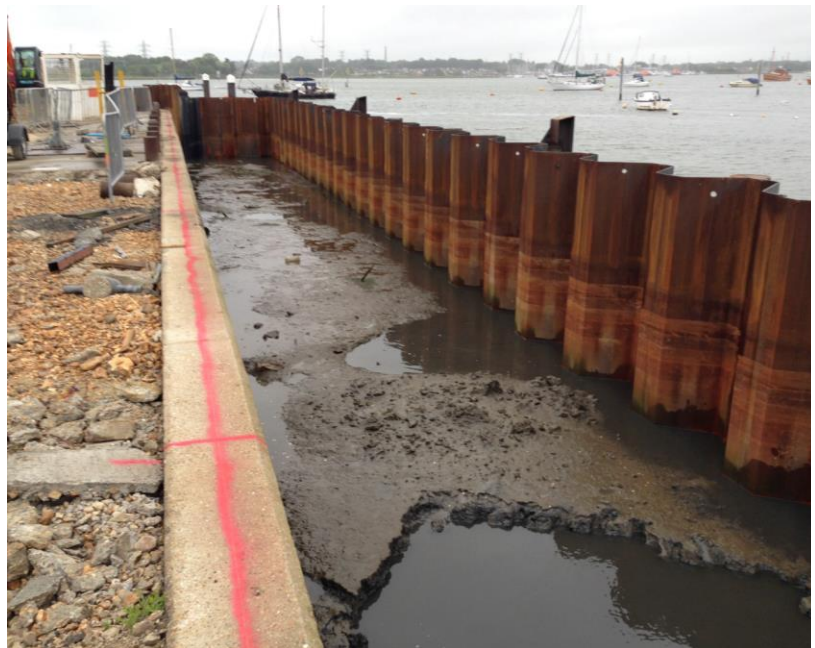
Sediments dredged from the area in front of the quay were disposed into the area between the old quay and the sheet pile wall.

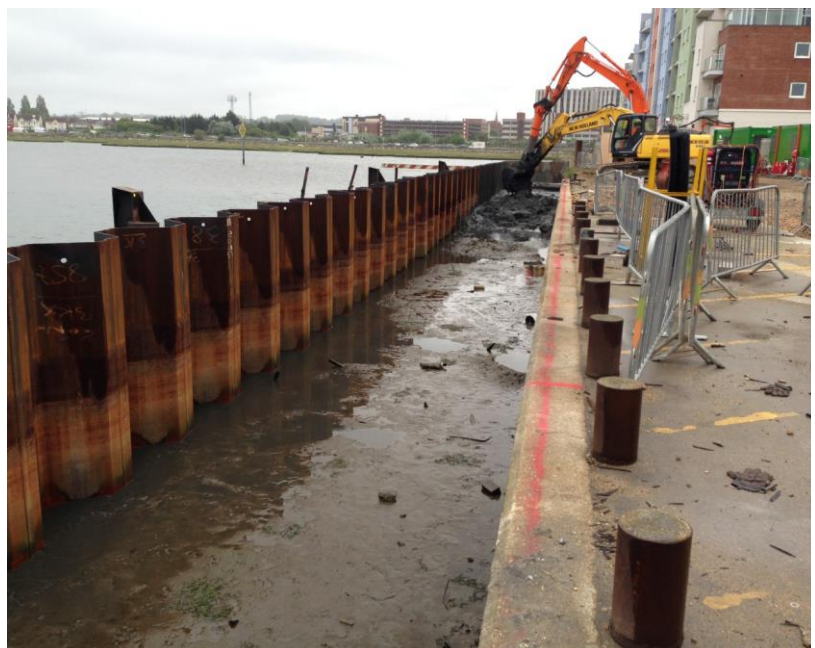
Stabilization of contaminated sediments in progress.
