CASE IKEA VANTAA

IKEA VANTAA Vantaa, Finland Department store subgrade reinforcement	Key words: Subgrade reinforcement, field construction, deep stabilization
General information	The second department store of IKEA in Finland was chosen to be on swamp area between rocky hills. This area had previously been a landfill for secondary soil materials and construction waste. In addition, it includes part of foundation for an old highway. However, the logistical location was more important than the challenging ground conditions.
Advantages of stabilization	The department store could be built on a logistically important area with extremely difficult subsoil conditions. Despite the difficult conditions the work was completed successfully and ahead of the time schedule with mass and column stabilization techniques.
Project timetable	Test stabilization in March 2002, stabilization of parking lot and driveway areas in April 2002 - February 2003

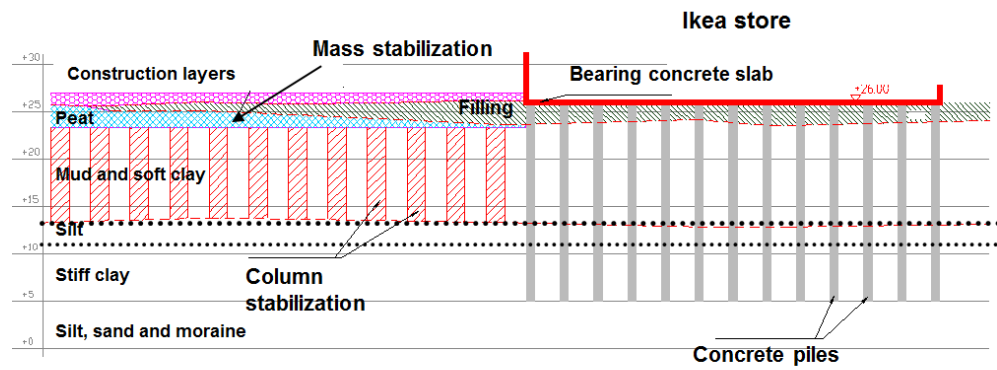
The foundation methods used at the IKEA site

Volumes and dimensions	Mass stabilization 65 000 m ³ , column stabilization 110 km.
Geology and stabilized material	Diverse compressible and soft soil layers between 5 and 13 meters e.g.: peat (w = 50 – 500 %), mud (w= 70 – 290 %), clay from -1 to -3 meters and below (w = 40 -140 %) and silty mid layer (w < 50 %). Under the clay layer at -9 meters there is silt / sand and finally glacial till down to -30 meters. The ground water level has varied at the depth of 1 – 1.5 meters from the ground surface.
Target strength of the stabilized material	Measured shear strengths: columns 90 kPa and mass stabilization 40 kPa after 30 days
Binder(s)	Mass stabilization: Cement; 100 kg/m ³ Column stabilization: Finnstabi® + lime + cement; 90 kg/m ³
Laboratory and field tests	Binder testing in laboratory, test soundings and drillings on the site.
Other	-
Long-term follow-up and lessons learned	Transition slab was retrofitted in 2008 to the entrance area where uneven settlements had been problem due to missing transition structures between the building on driven piles and the deep stabilized parking lot.

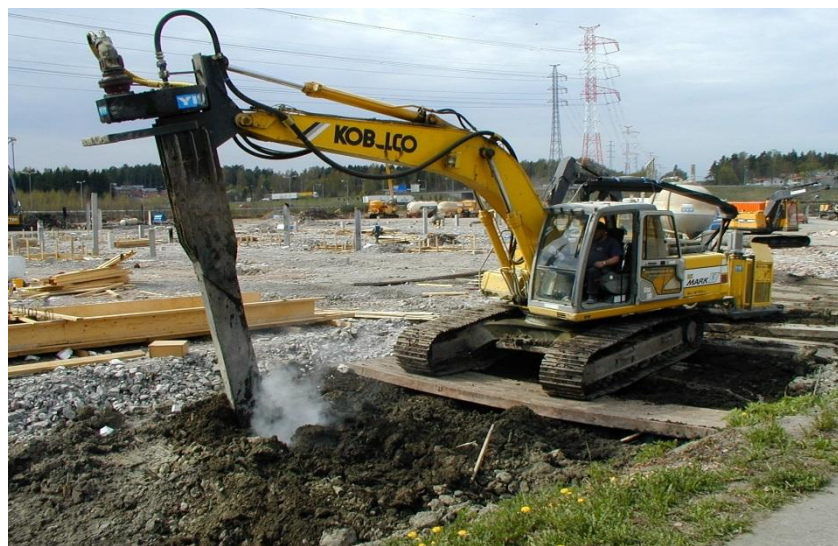
Mass stabilisation works ongoing
