LIFE09 ENV/FI/575 ABSOILS

Final Report on the Pilot Applications and Quality Control of the Absoils project

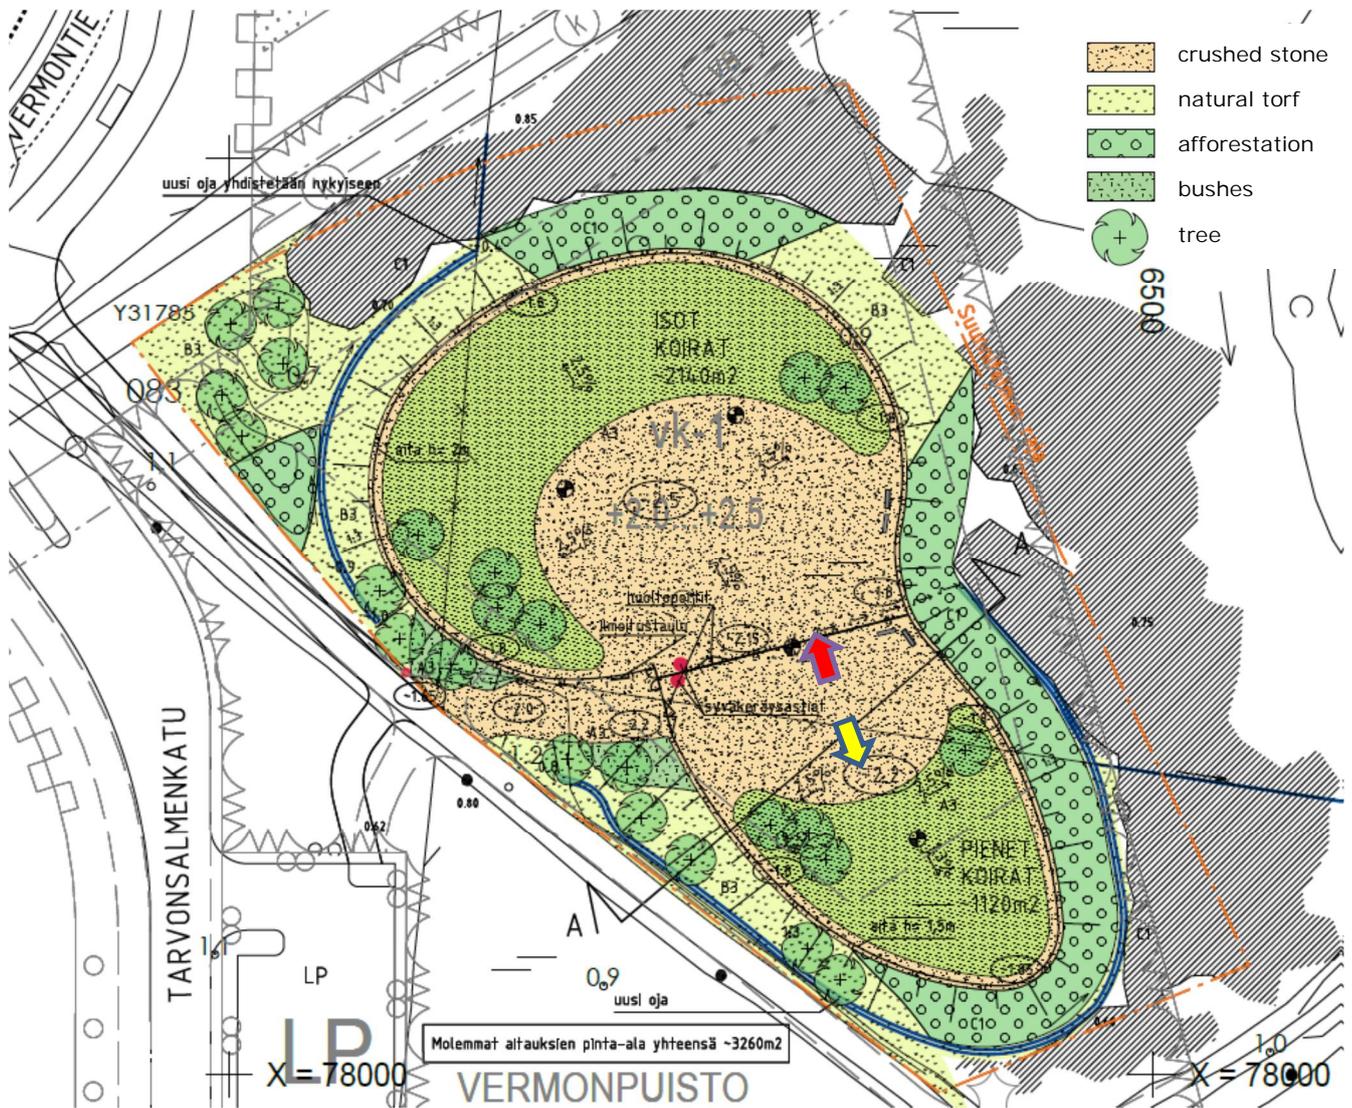
Figure 1.6 Area plan for Dog Park. A $\approx 4500 \text{ m}^2$. The red arrow indicates the area planned for big dogs, the yellow arrow indicates the area planned for small dogs. "ISOT KOIRAT" = big dogs and "PIENET KOIRAT" = small dogs. (Ramboll 2011b)

The ground level of the area is between $+0.7\dots+1$ and it is raised to prevent the flooding. The planned ground level is $+2\dots+2.5$. The raising of the ground level has been done with surplus soil which is stabilised together with the upper part of the original soil. The target is to reduce the occurrence of flooding to less than once in 20 years. The area plan is presented in Figure 1.6.

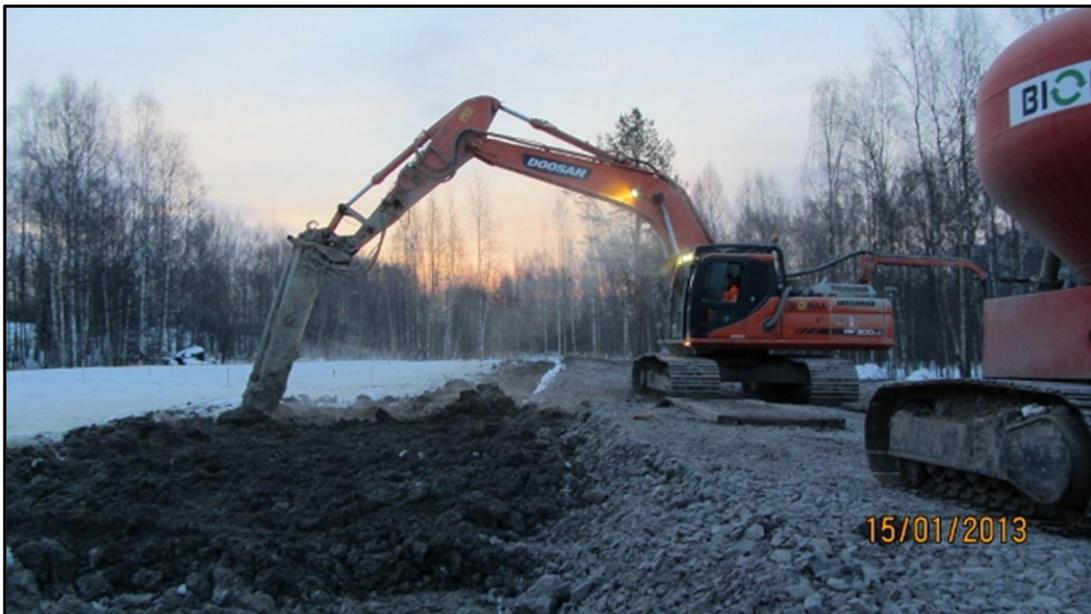
Figure 5.2 Mass stabilisation work carried out in winter conditions in Espoo, Finland (15.1.2013)

Important aspect of stabilisation technology is winter adaptability. The method can be applied in winter conditions such as snow fall and minus temperature (as seen in Perkkaa Dog Park construction site in Figure 5.2).

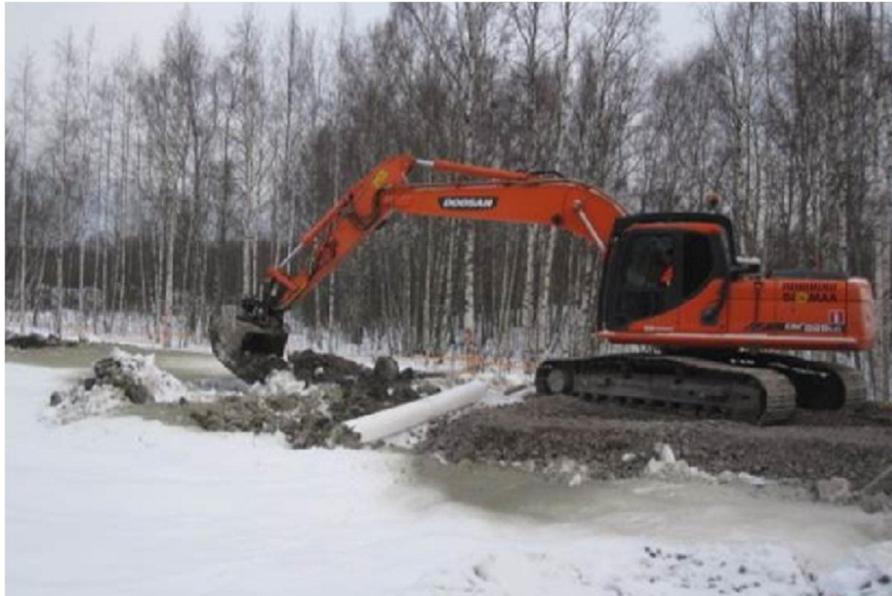
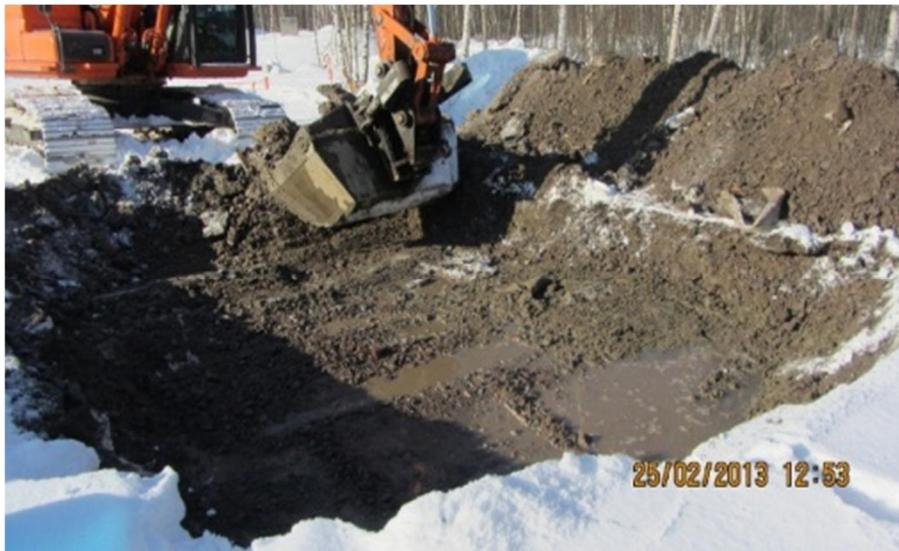
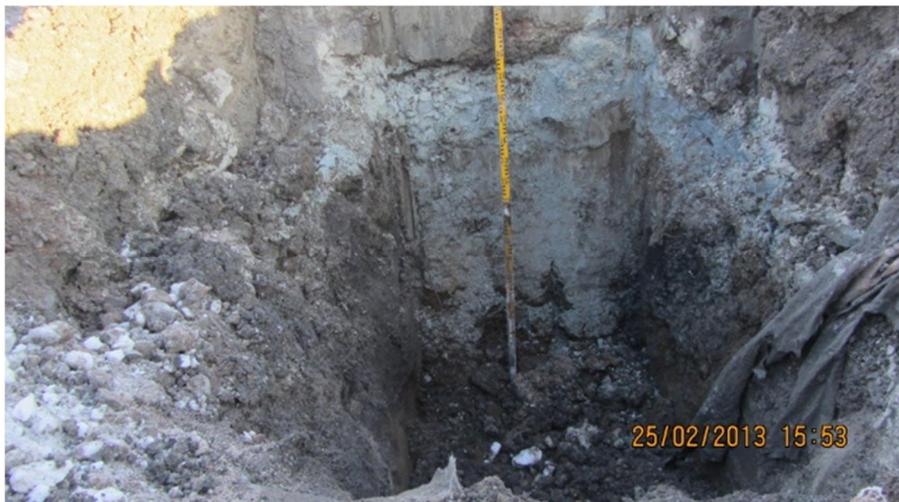
Figure 7.5 Excavating test pits; documentation and depth profiling

The excavation process and documentation (photographing + depth profiling) are shown in Figure 7.5. Material testing and sampling from the grab is shown in Figure 7.6. Niton XRF field measurement process is shown in Figure 7.7. Pocket vane shear apparatus (hand held) is shown in Figure 7.8.a and material testing on a grab is shown in Figure 7.7.b. Hand held penetrometer test equipment is show in Figure 7.9. Sampling work for water content testing in the laboratory is shown in Figure 7.10.

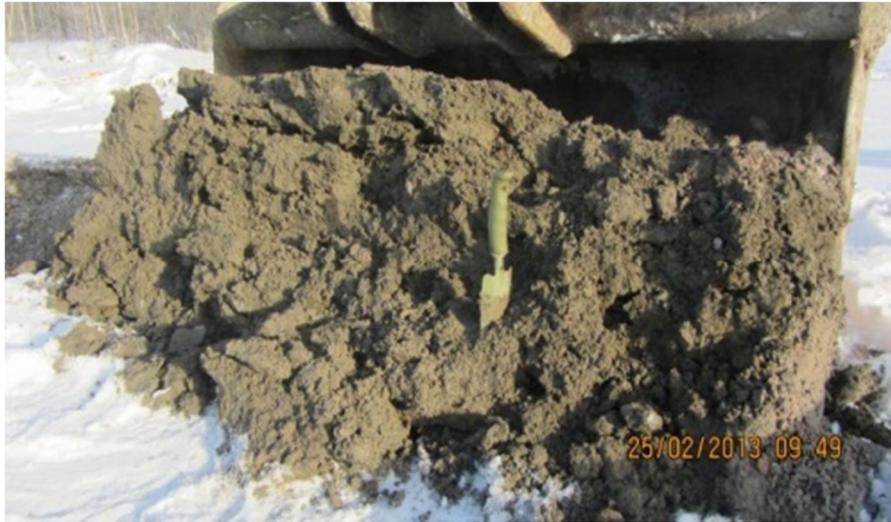
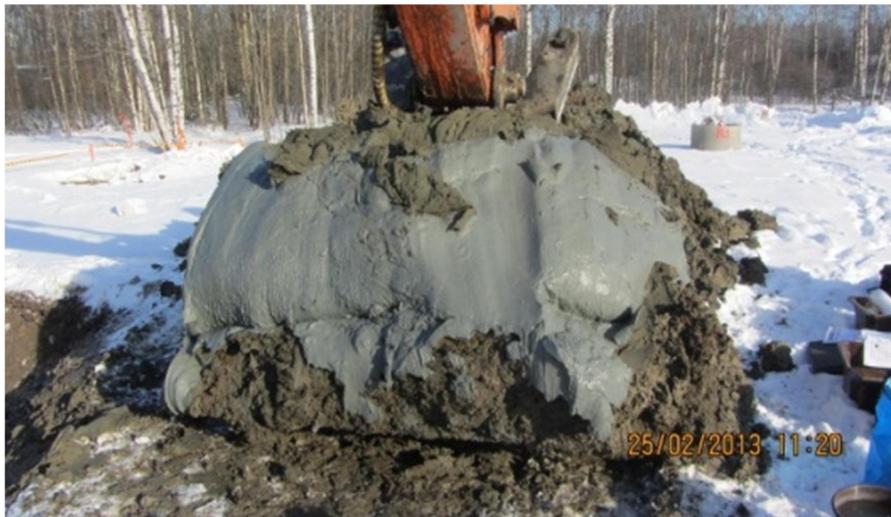
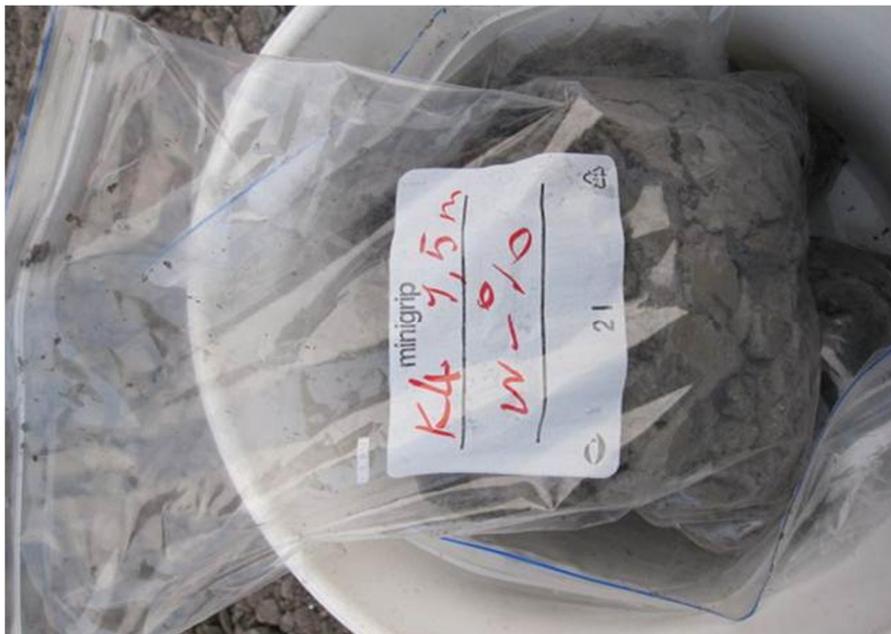
Figure 7.6 Material on grab and sampling

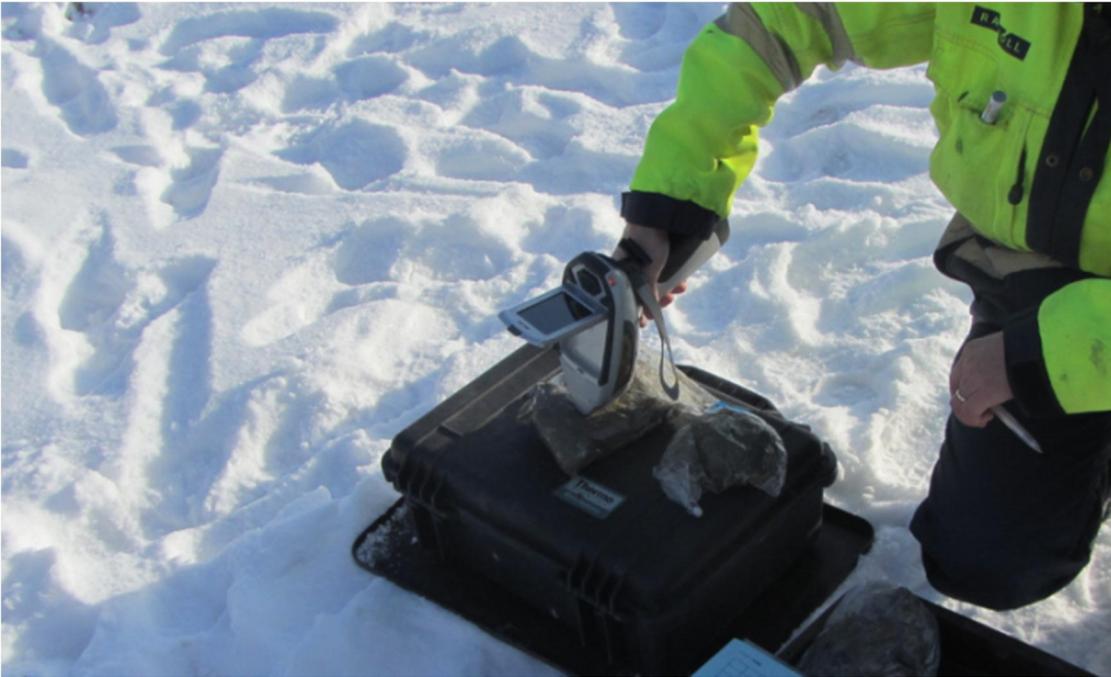
Figure 7.7 NITON XRF - testing in the field

The portable hand held NITON XRF analyser can be used to measure the amount of Ca in the test sample (Figure). These figures give an overall idea of the amount of binder in the stabilised material. The testing can be done in the field (Figure 7.7) or samples can be taken to the laboratory. The average values can be calculated from multiple measurements.

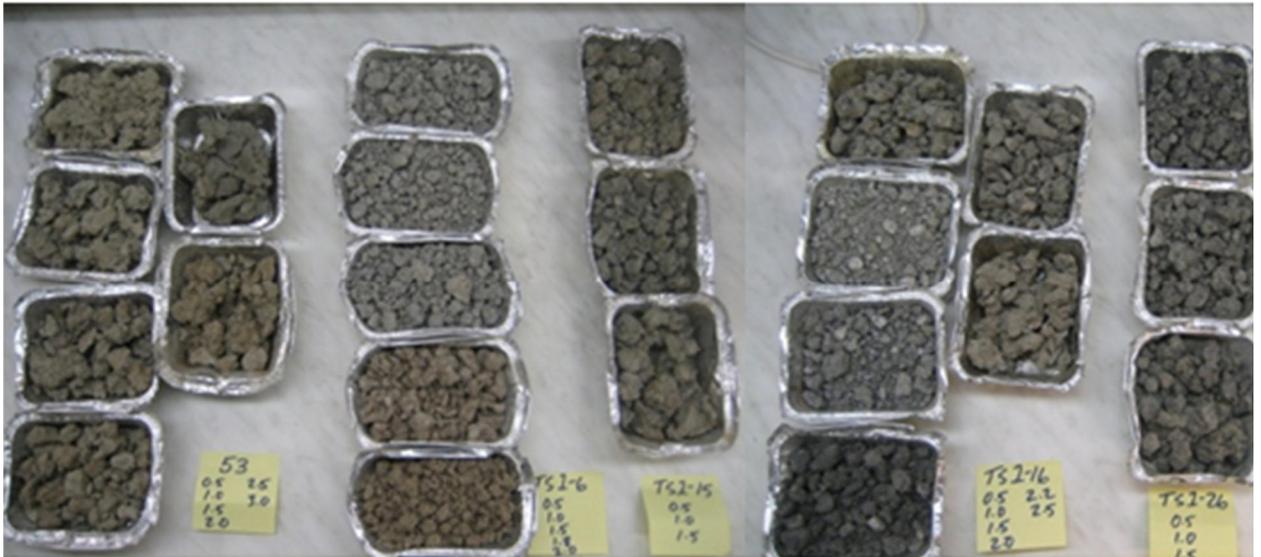
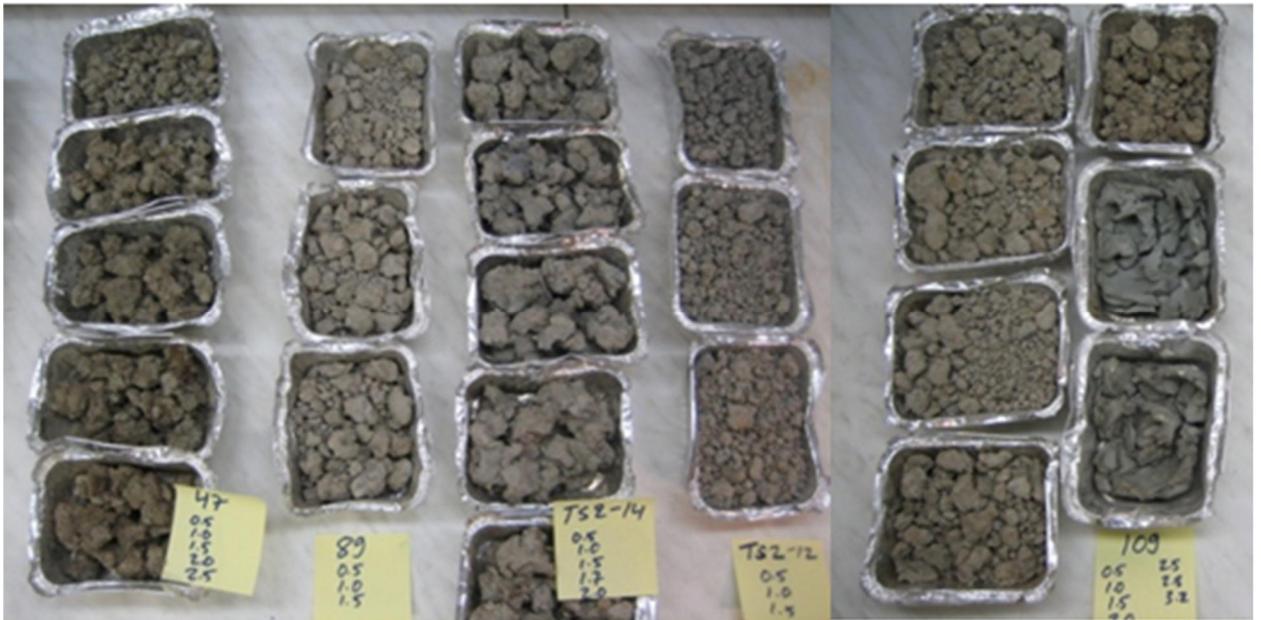
Figure 7.10 Material sampling in laboratory for water content testing a) test pits 53, TS1_6, TS1_15, TS1_16, TS1_26 b) test pits 47, 89, TS2_14, TS2_12, 109

Samples were collected from the test pits and they were their water content and pH were analysed. In addition, this testing was done for the surplus clay before stabilisation. *Figure* shows a step in laboratory water content characterisation testing.

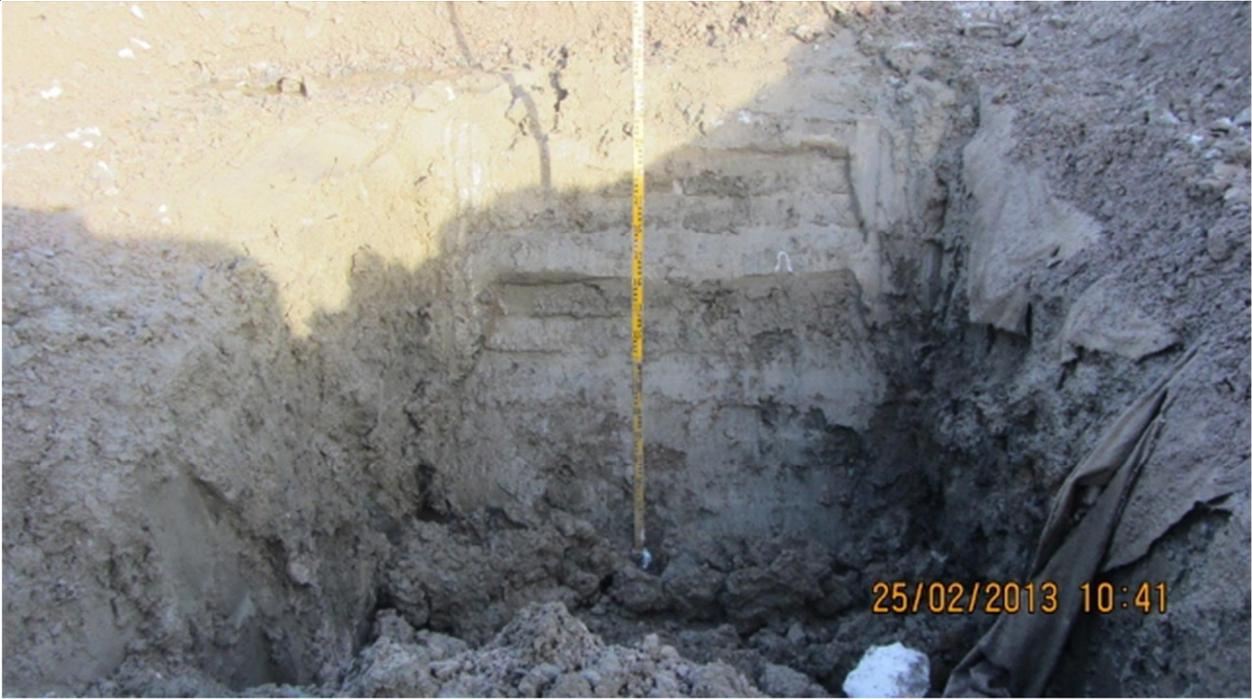
Area A, BLOCK 53:

The excavation pit held form until 2.5 m depth. In depth 1.2 ... 1.4 m the material was more soft but stiff. In 2.0 m the material was sometimes so hard that vane shear apparatus could not penetrate the material. A bad slope failure came when excavating in depth of 3.0 meters. In 2.5 meters the sample in the grab contained a stream of binder. The sampling done in depth 2.5 ... 3.0 m is inaccurate. Here, it was impossible to keep track of exact layers of materials due to uncontrolled mixing.

Figure 8.1 Cement stabilised areas A – one figure from each test pit.

BLOCK 53:
The excavation pit held form until 2,5 m depth. In depth 1,2 – 1,4 m material was more soft but stiff. In 2,0 m the material was sometimes so hard that vane shear apparatus couldn't penetrate the material. A bad slope failure came when excavating in depth of 3,0 meters. In 2,5 meters the sample in the grab contained a stream of binder. The sampling done in depth 2,5 – 3,0 m is inaccurate. Here it was impossible to keep track of exact layers of materials due to uncontrolled mixing.

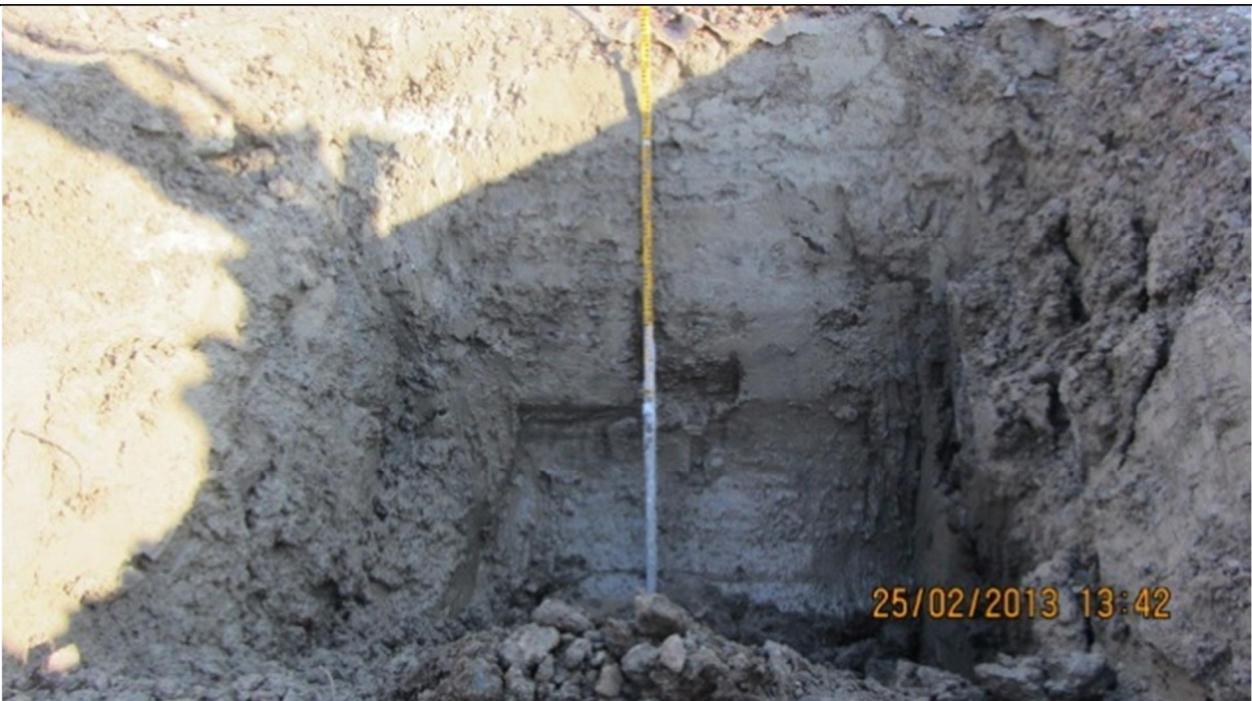
Area A, BLOCK 109:

Every 0.5 meters until 2.5 meters the material can be categorised "hard" throughout the depth layer. Once the material was so hard that vane shear apparatus did not penetrate the material. The first slope failures were detected in level 2.5 m. Stabilisation ended about 2.6 m deep.

BLOCK 109:
Every 0,5 meters until 2,5 meters the material can be categorized "hard" throughout the depth layer. Once the material was so hard that vane shear apparatus didn't penetrate the material. The first slope failures were detected in level 2,5 m. Stabilization ended about 2,6 m deep.

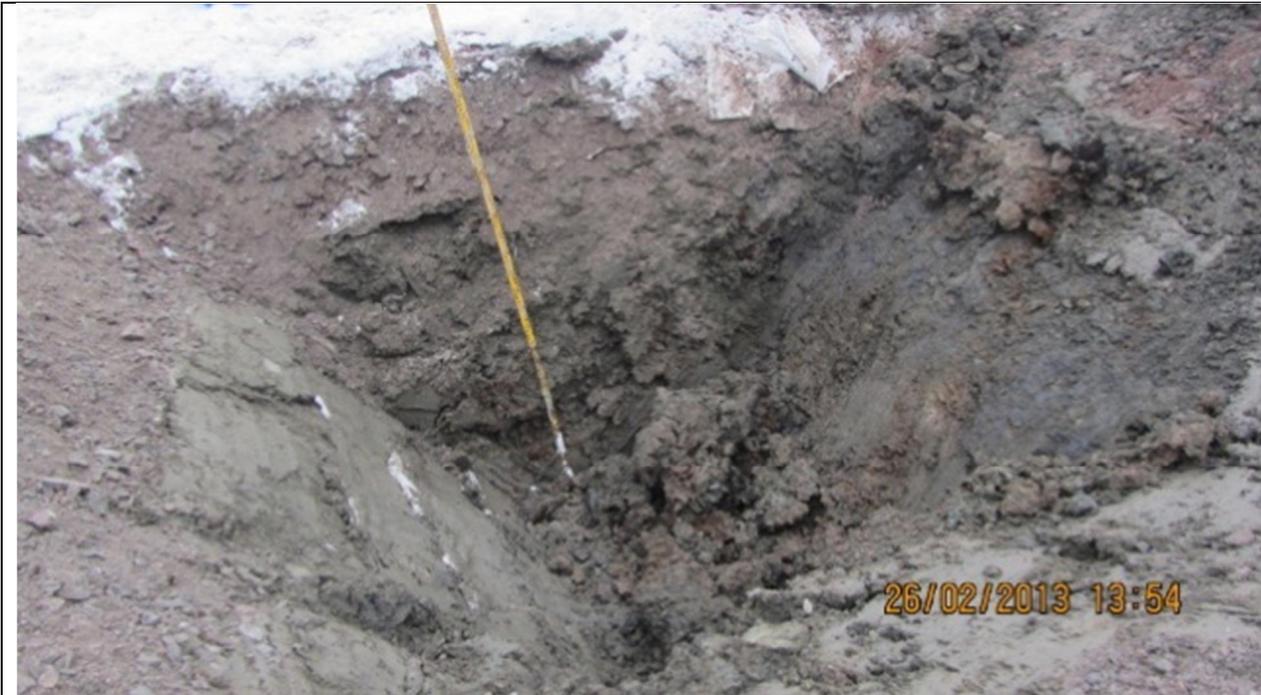
Area B, BLOCK 47:

In the depth of 1.0 m the material was once so hard that vane shear apparatus did not penetrate the material. In general, the material was coarse and seemed more stabilised. In depth 1.0 m were very hard pieces of stabilised material. A clear odour of stabilisation was present. In 1.5 m the material was more sticky. It was hard to make evened surface for penetrometer or vane shear apparatus. The last sample was taken in the depth of 2.5 m since it was clearly seen that the earth pressure was very high.

Figure 8.2 Cement stabilised area B – one figure from each test pit.

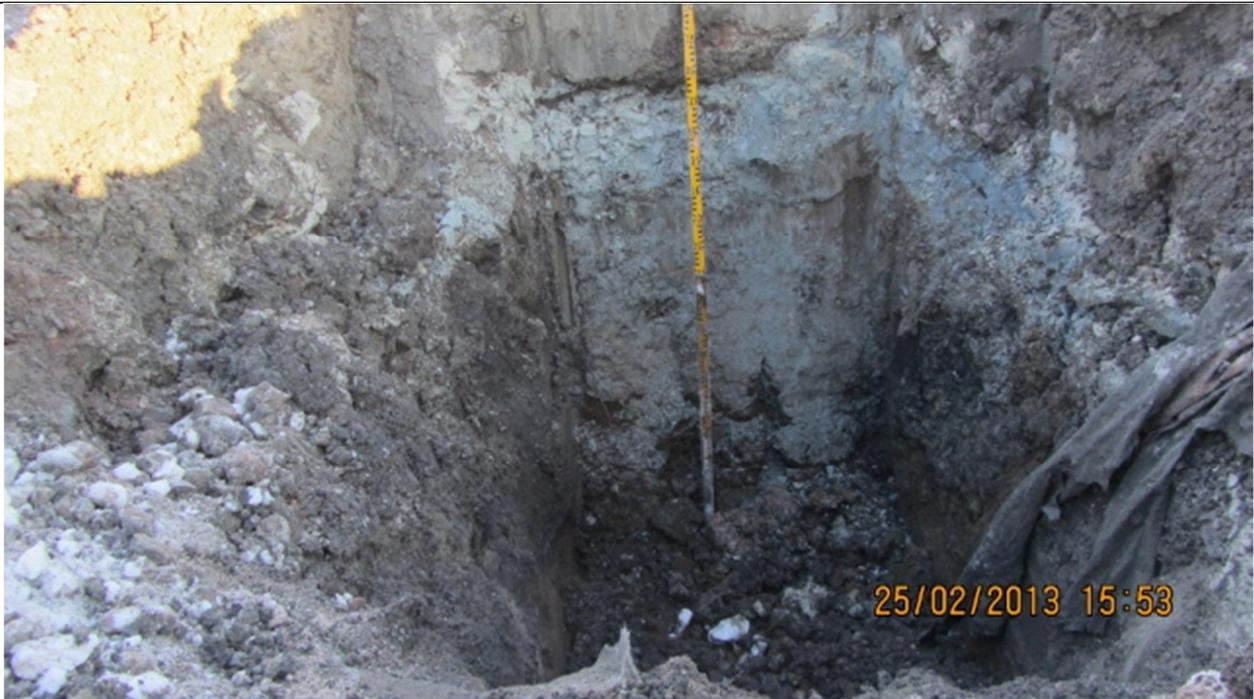
Area C, BLOCK: TS1_16

When opened the stabilised material was still going through stabilisation reactions. The mass was warm and warm water vapor was present in the air. In the depth interval of 0.75 ... 1.5 m a clear white gray (clearly visible) monolithic layer of stabilised material was present. In depth intervals 1.0 ... 1.5 m the material was very unhomogenous. In 1.5 m it was not possible to penetrate the material with vane shear apparatus.

Figure 8.3 Stabilised test area C (TS1 west) - one picture from each test pit.

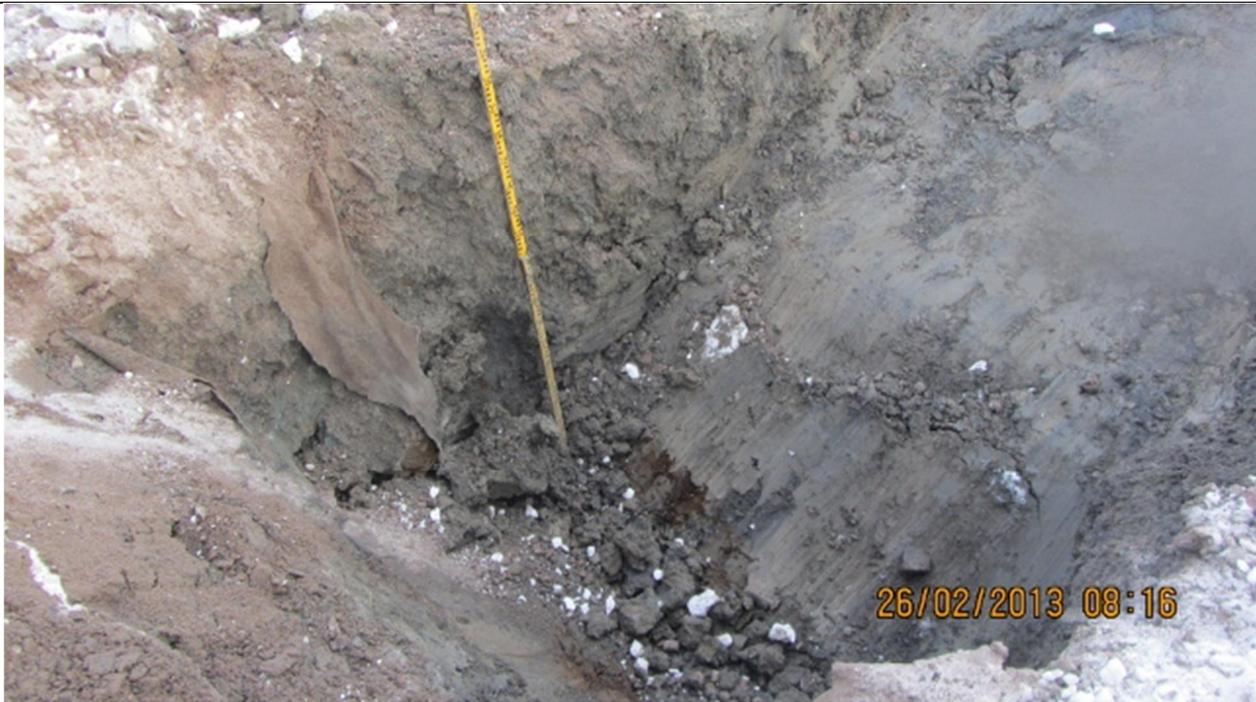
Area D, TS1_6:

The material was fairly homogenous and had characteristics of stiff stabilised material. Water came to the test pit in depth of 1.0 m. The spreading of binder was even – black spots were everywhere. Black spots indicate the presence of fly ash. In 1.5 m the material was stiff and very hard blocks of material were present. In general the excavation pit was very clean and held well its form. The non stabilised ground was visible in depth of 1.6 ... 1.8 m. A test sample was taken in depth of 1.0 m.

Figure 8.4 Stabilised test areas, area D (TS1 east) - one picture from each test pit.

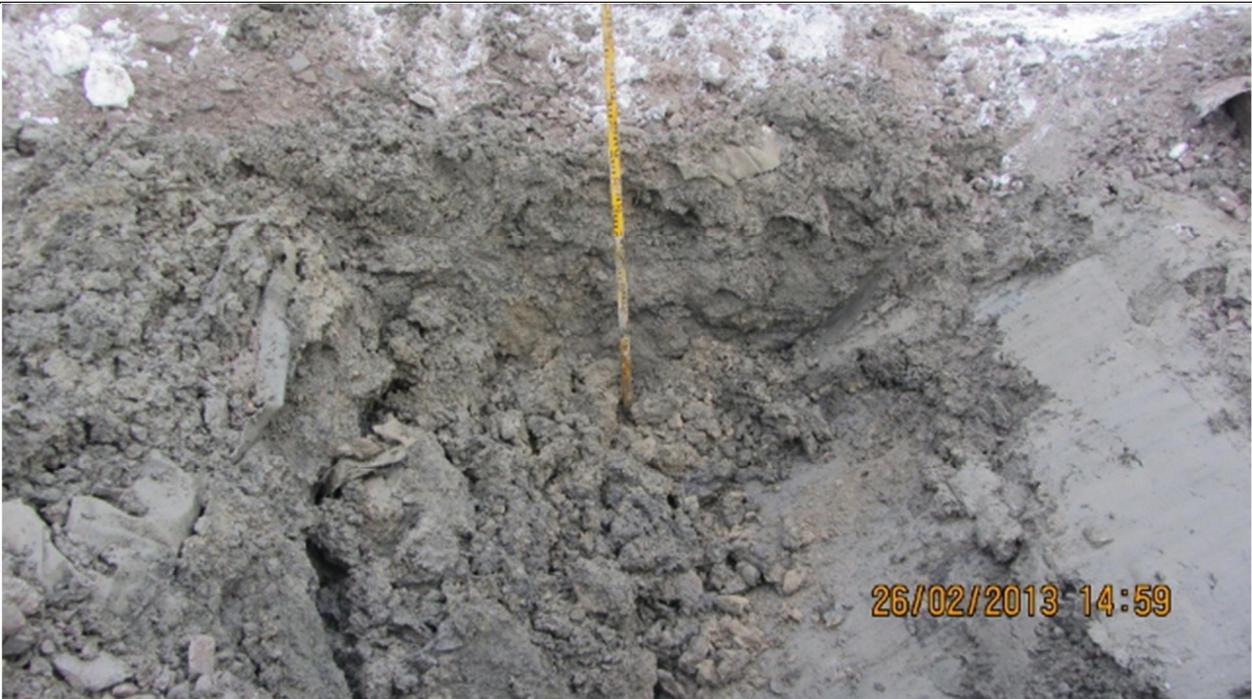
Area E, TS2_12:

The excavation pit and the test materials can be categorized as excellent. The material was hard. The material is black, has excellent stiffness and hard pieces of stabilised materials. Plenty of hard blocks present in the test pit. A sample was taken of a hard piece. Once in depth of 1.0 m and 1.5 m it was not possible to penetrate the material with vane shear apparatus.

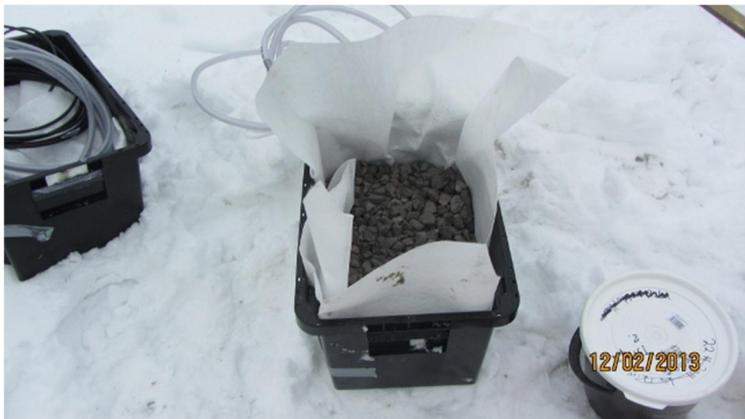
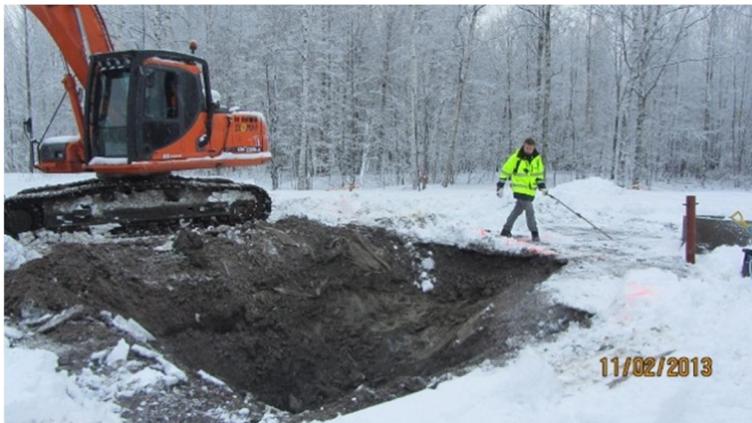
Figure 8.12 Lysimeter installation a) lysimeter device b) excavation of a lysimeter test pit c) compaction of stabilised material to the lysimeter

Five lysimeters were installed in the test field. The basic principle of the lysimeters is shown in Figure 8.12. One set (2 lysimeter boxes) of lysimeters was installed in each stabilisation area. The boxes used in the testing were PE-HD plastic boxes and the installed water tubes were PA plastic. The water sample tubes were covered with protective tubing. The water sample tubes were placed under the 15 cm drainage layer in the bottom of the lysimeter. The surrounding of the aggregate was covered with a geotextile which ensures that the drainage layer does not get blocked. The stabilised material was compacted with a special field compactor to model the natural conditions. The top of the lysimeter was covered with the original stabilised material. Here the excavator was used for gentle compacting of the material on top of the boxes. The tubing was placed in protective casing and transported through the ballast embankment. Finally, the tubing was transported to the concrete well casings. The settlement plates were placed inside the concrete wells. The protective environment inside the concrete casings ensures proper measurement in the future. The final placement of the lysimeters and the protective casings are shown in Figure 8.13.

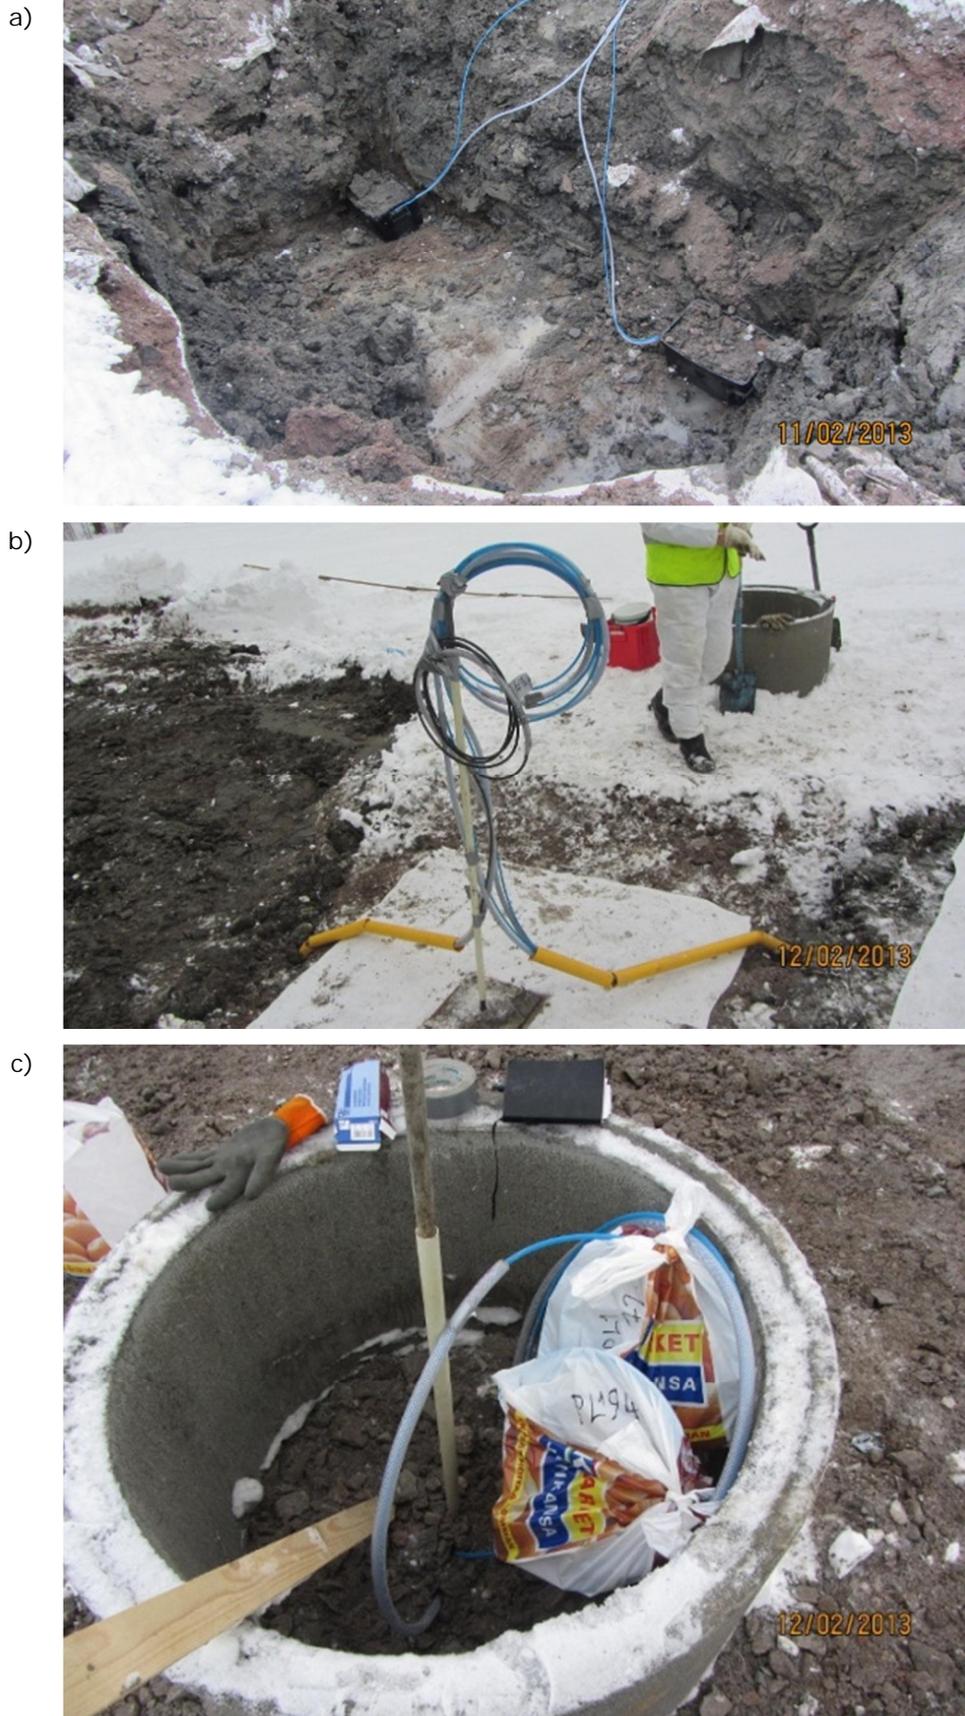
Figure 8.13 Lysimeter installation details a) installed lysimeters before filling b) & c) technical details of lysimeter tubing protection and covering in concrete wells

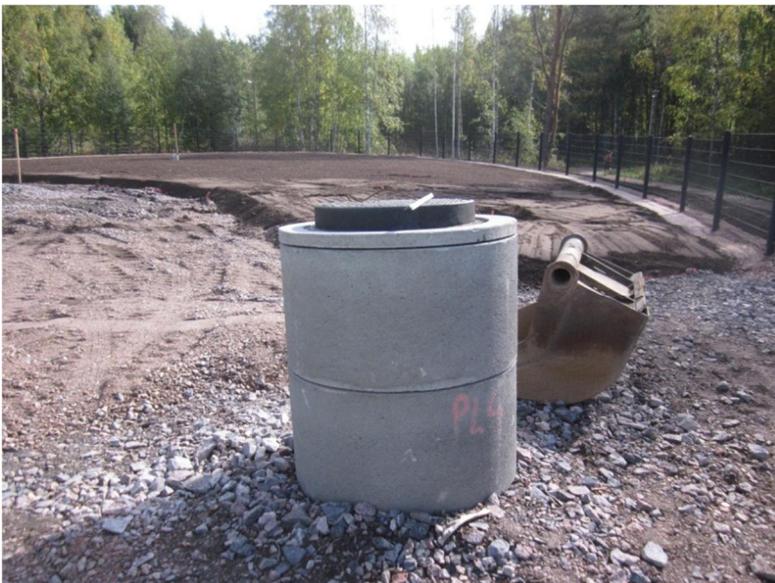
Figure 10.2 Concrete wells for lysimeters and settlements plates.

The park was constructed between 8 ... 10. 2013 by the City of Espoo. During the construction period it was necessary to take into consideration the installed lysimeters and settlement plates.

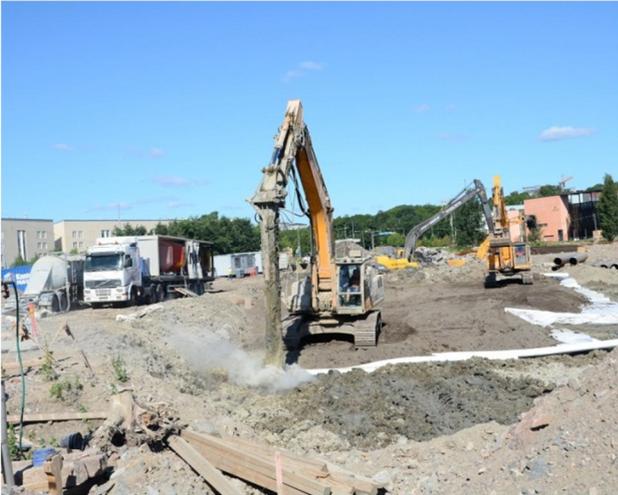
Figure 11.9 Mass stabilisation in progress

After the stabilisation a non-woven geotextile was spread over the stabilised mass and compression embankment was spread over the geotextile. The compression embankment also worked as a stabilisation platform for the stabilisation machine. The mixing of the binder, geotextile and the compression embankment can be seen in Figures 11.9...11.12.

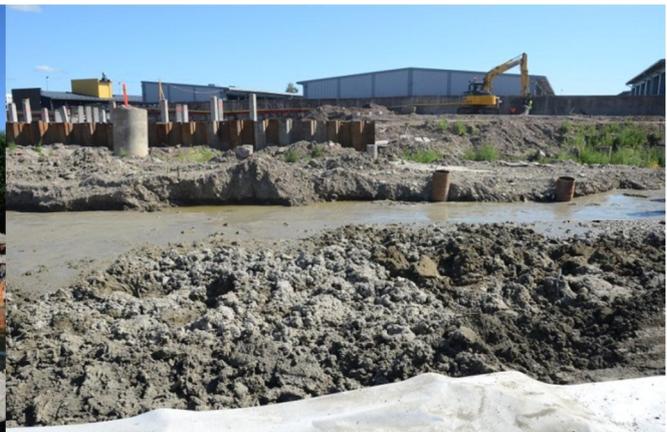
Figure 11.12 Stabilisation basin – satbilised clay in front, clay waiting for stabilisation at the back

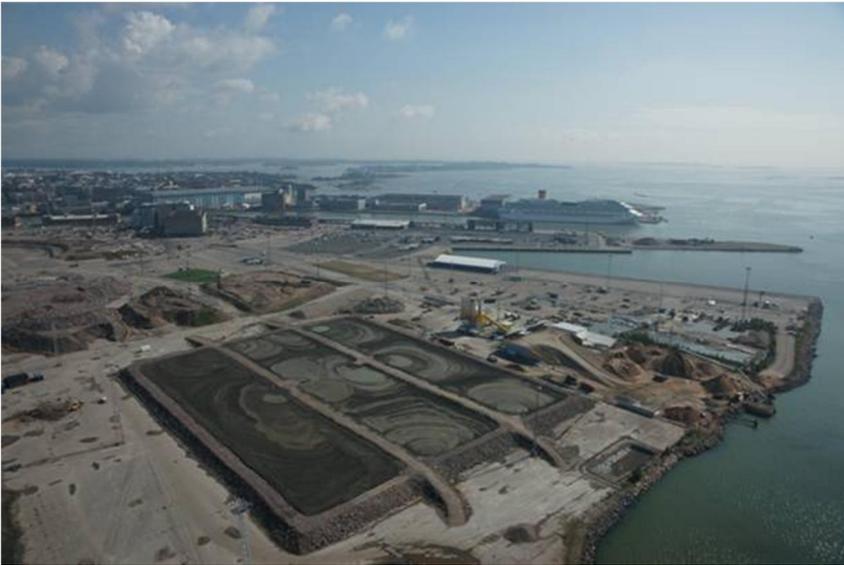
Figure 12.6 Jätkäsaari I – stabilisation basins

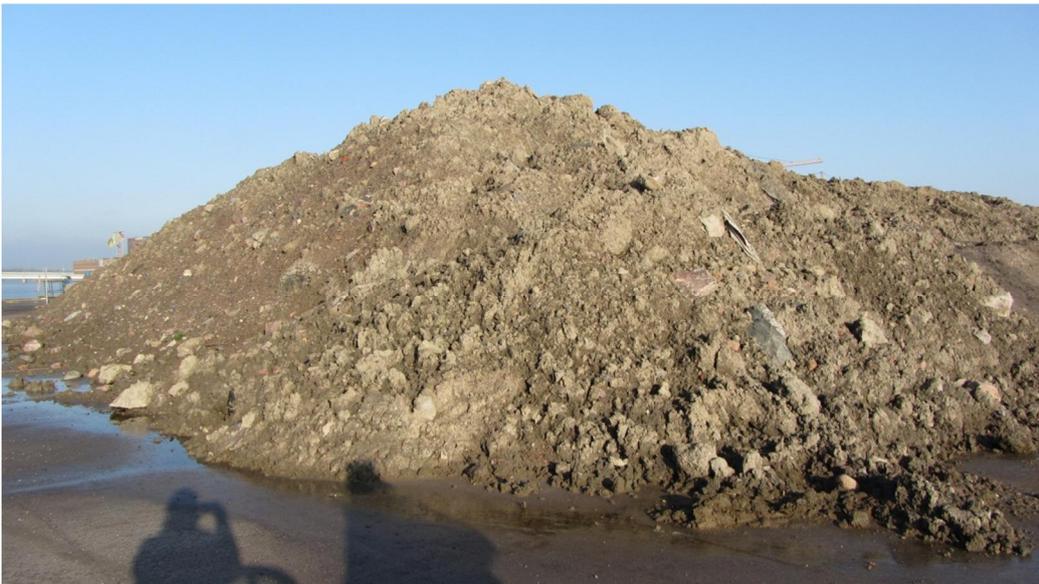
Figure 12.9 Mass stabilised sediments stockpiled and waiting for reuse in 2012

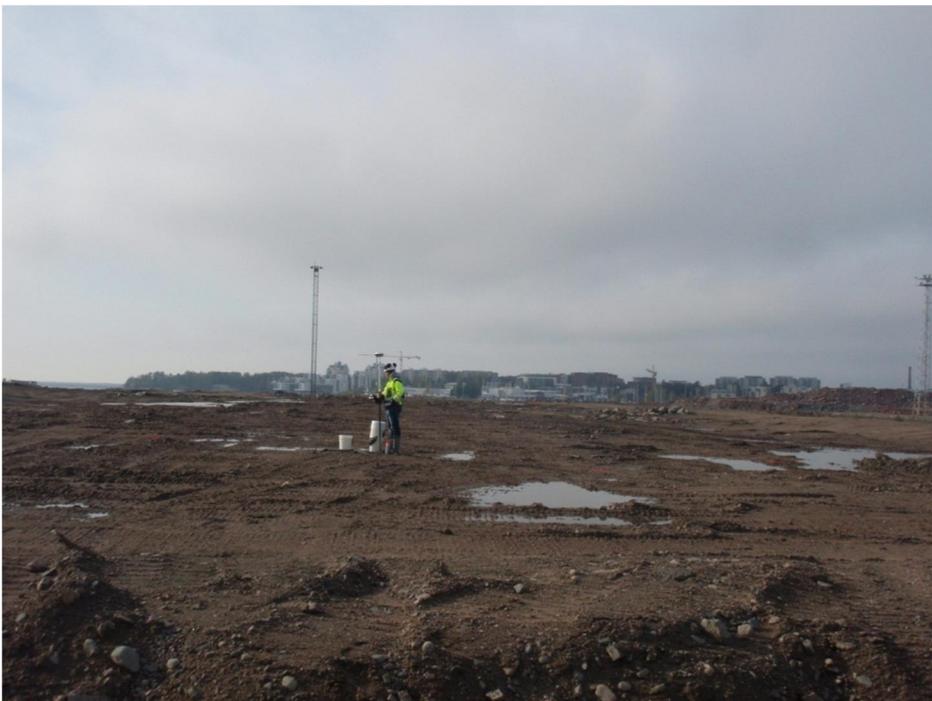
Picture 12.13 Preparations for sampling.

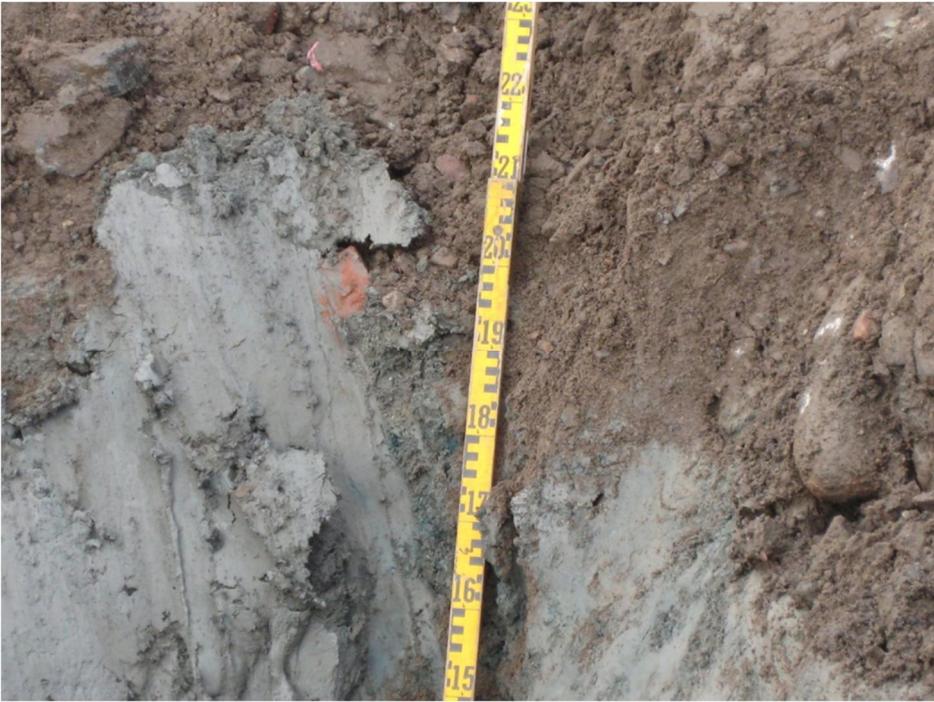
Picture 12.14 Sampling pit in the sedimentation basin. Depth determination

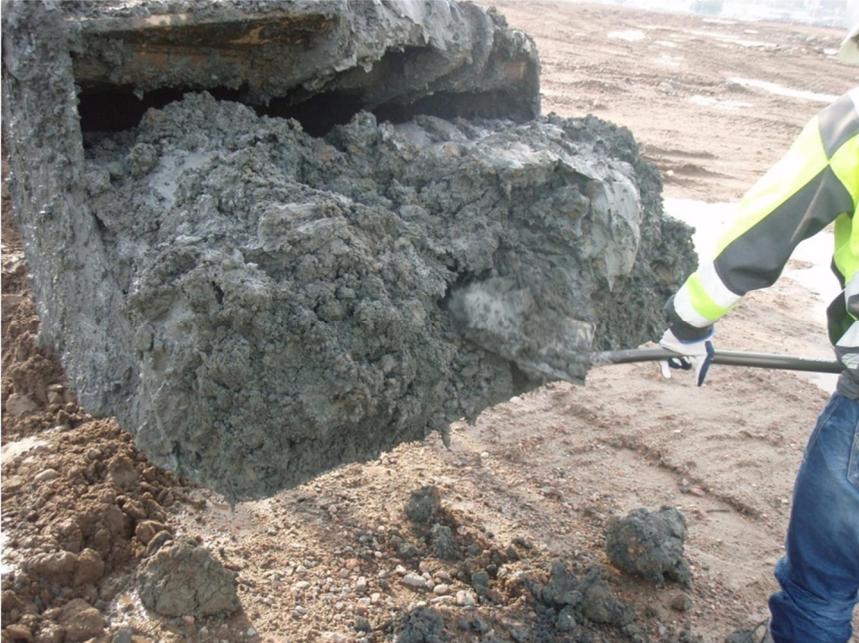
Picture 12.15 Sampling

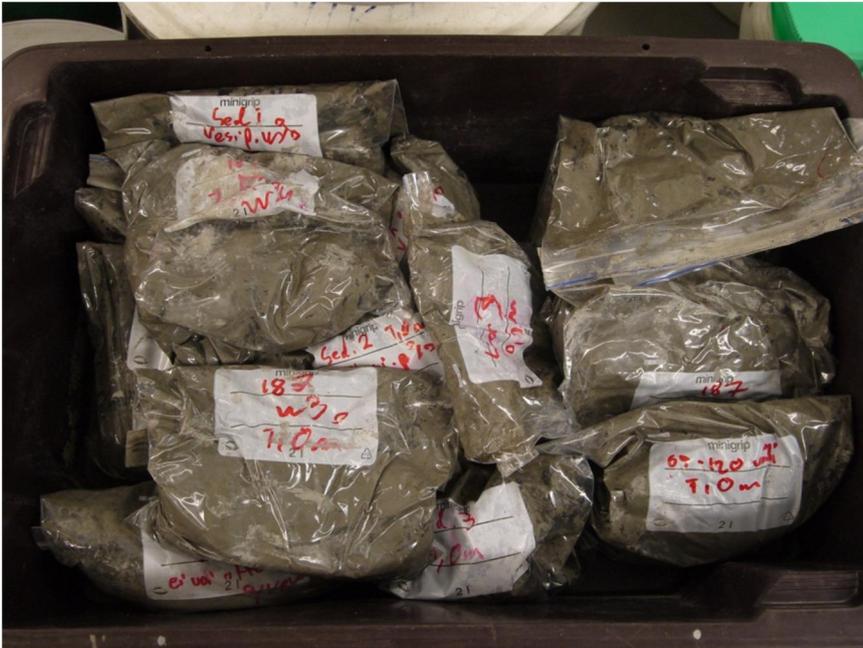
Picture 12.16 Samples ready for laboratory tests

Stabilisation tests were performed in the laboratory in order to determine the most optimal binder mixture. Stabilisation tests were carried out for the sediment samples with two binder mixture variations. Both binders consisted of the Plus cement and dry fly ash – the binder volume in the first case was 40 + 150 kg/m³ (Subplot 3.1T), and in the second case it was 40 + 250 kg/m³ (Subplot 3.2T). The test results after 28 and 90 days for the compressive strength were 55/97 kPa for the first binder mixture and 86/108 kPa for the second binder mixture.

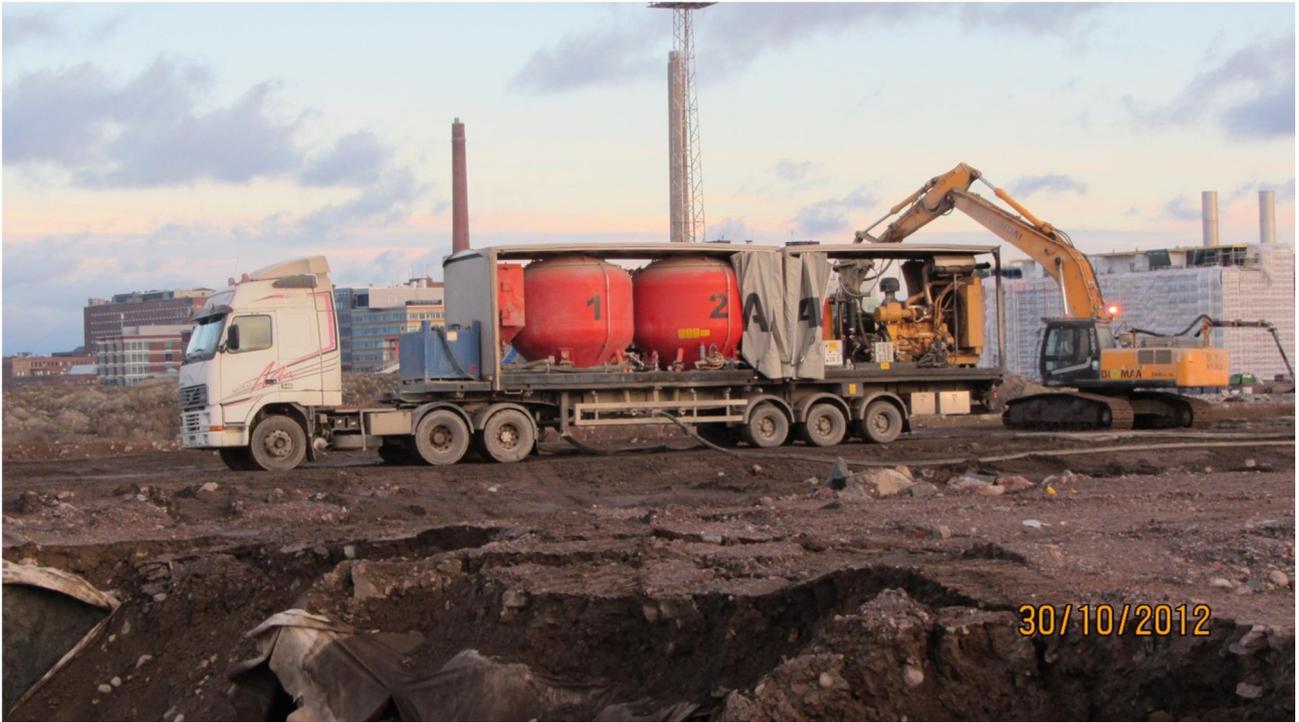
Picture 12. 17 Pressure feeders

The cement used as a binder in the stabilisation process was mixed with the soil in the usual way applied in such cases, that is by using a pressure feeder and a mixing tool attached to the excavator.
