LIFE09 ENV/FI/575 ABSOILS

Final Report on the Pilot Applications and Quality Control of the Absoils project

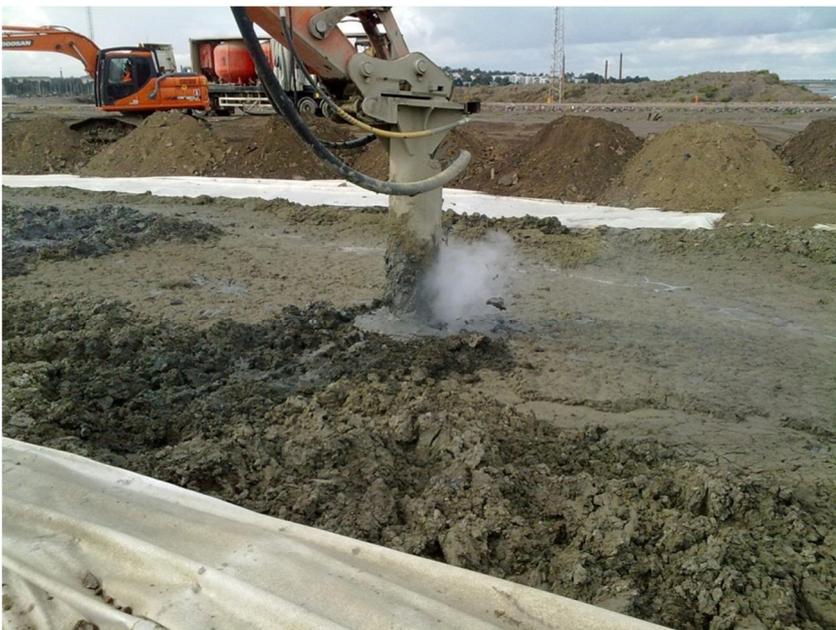
Picture 12.18 Stabilisation in progress

1. it was mixed with the sediment with the use of a pressure feeder and mixing tool– dry ash
2. it was spread on top of the sediment – moistened fly ash

The fly ash spread on top of the sediment layer was carefully mixed with the sediment before mixing cement. After mixing both binders with the sediment, a 1m thick sealing layer was constructed on top of the blocks where fly ash was used for the stabilisation process.

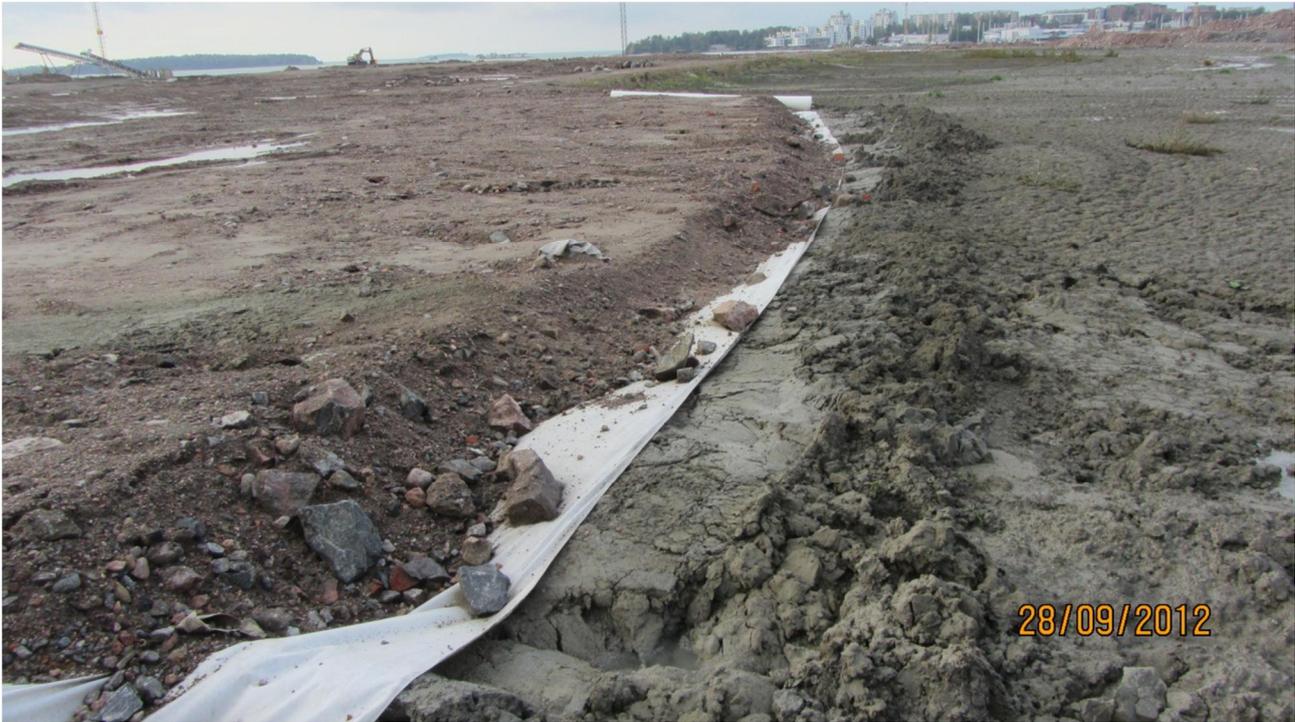
Picture 12.19 Sealing layer on top of the stabilised sediments

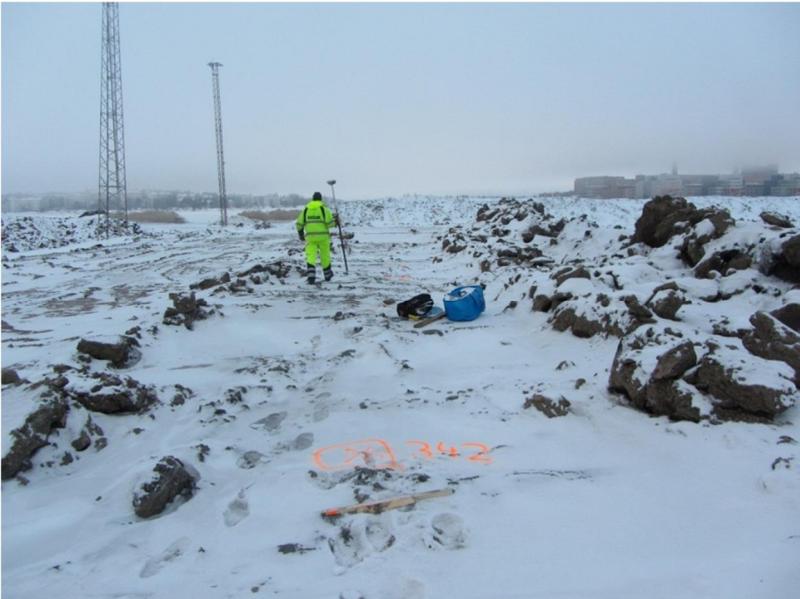
Picture 12.20 Preparations for the quality control soundings

Block	Binder	Column sounding	Vane sounding
3.1T	Ce + FA (dry)	5	2
3.2T	Ce + FA (dry)	5	2
3.3T	Ce + FA (moistened)	5	2
3.4T	Ce + FA (moistened)	5	2
	total	20	8

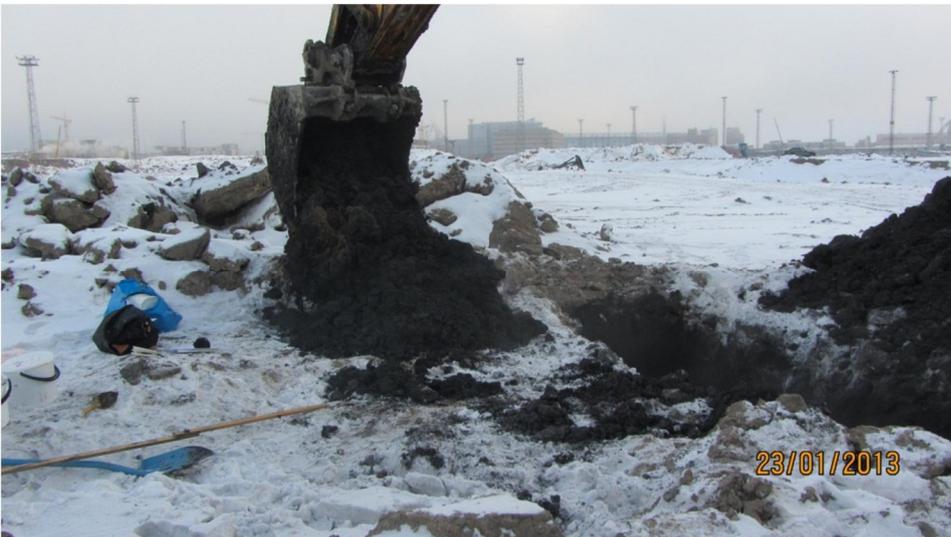
Picture 12.21 Test pit digging

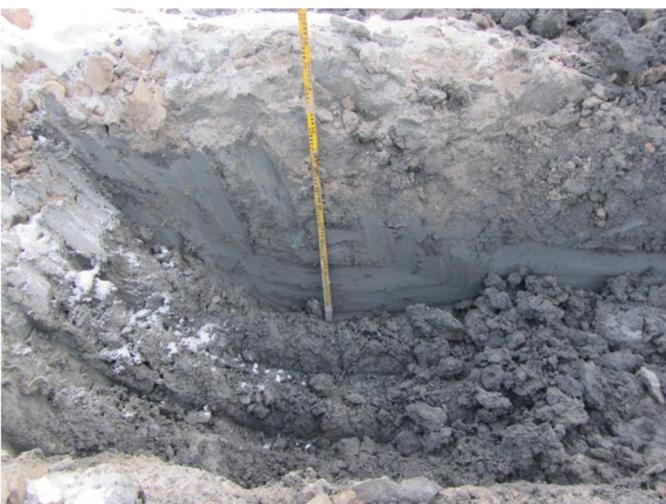
Picture 12.22 Test pit

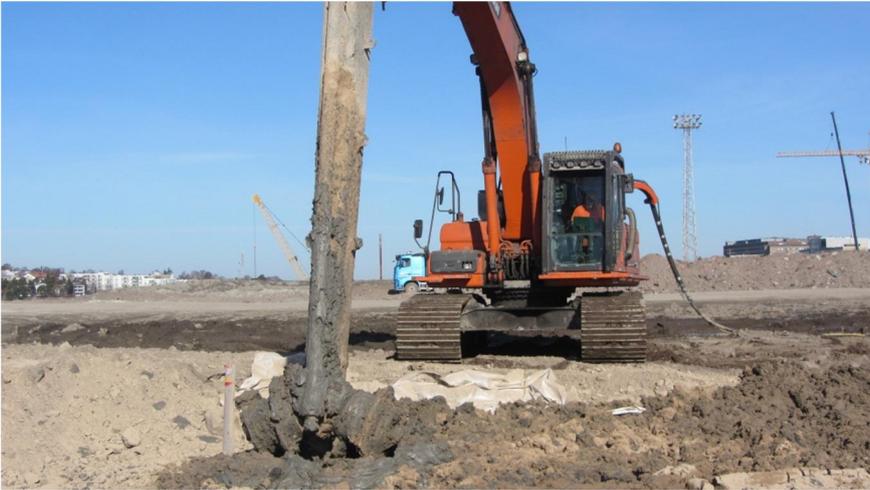
Picture 12.23 Jätkäsaari III : stabilisation work in progress

In the Jätkäsaari III pilot, stabilisation method was used to treat dredged sediments in the basins. Stabilisation works were carried out in spring 2014. Two different methods were used: mass stabilisation and windrow turner stabilisation. Various binders and binders' mixtures were applied. These include also such secondary materials as fly ash, FGD and oil shale ash from Estonia.

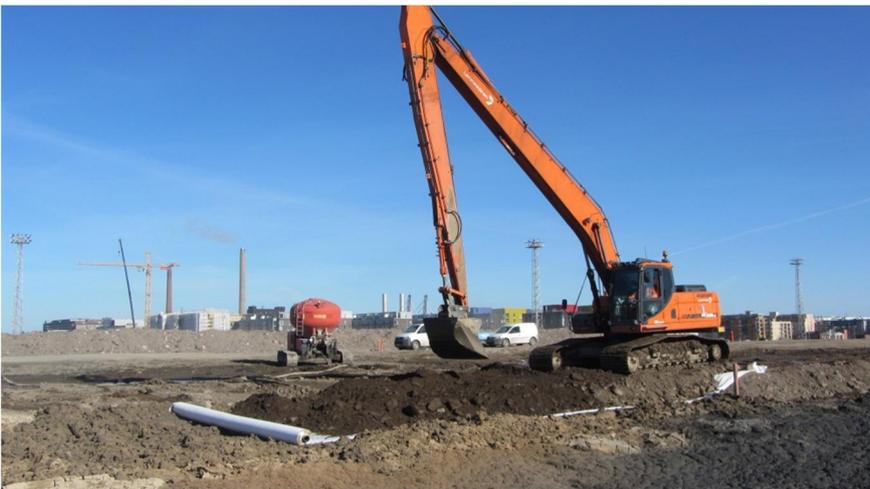
Picture 12.24 Jätkäsaari III : geotextile is spread after stabilisation and the settlement embankment load is placed on top
