LIFE09 ENV/FI/575 ABSOILS

Technical report of piloting 2011

Ramboll Finland Oy

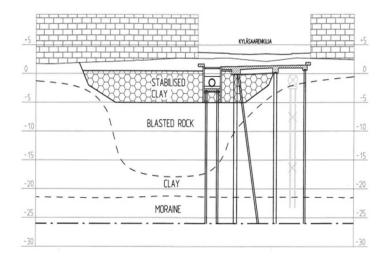
Figure 1. Arcada II cross sectional cut of the site with stabilised clay and steel-pipe columns. Houses are built later on both sides of the road.

In the Arcada 2 project the aim has been to improve the area for construction use by removing contaminated soils, lightening the blast rock structure, installing steel-pipe columns for a pile beam structure on the road Kyläsaarenkuja area to stop the lateral expansion caused by the blast rock structure. The Absoils project includes only the construction stabilised "light weight" structure. A cross section of the embankment and the site is presented in Figure 4.

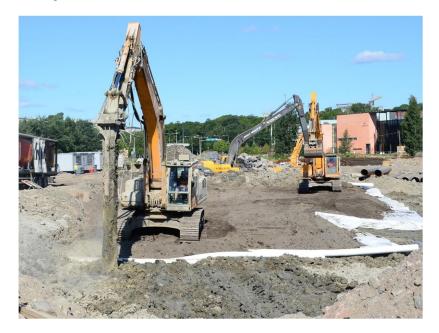
Figure 2. The stabilisation on Arcada 2

from the site were similar and caused no further actions. The stabilisation of the abandoned soil is depicted in Figure 2.

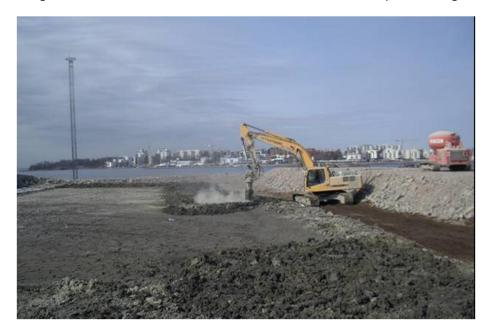
Figure 3. Stabilisation work on Jätkäsaari.

The challenge of the pilot was to stabilise all of the sediments deposited in the basins. In order to mass stabilise the total amount, the access of an excavator the size of 30 tonnes on the basins was necessary. This meant that the stabilisation needed to be stable enough to carry the weight of the excavator. The stabilisation on Jätkäsaari is depicted in Figure 3.

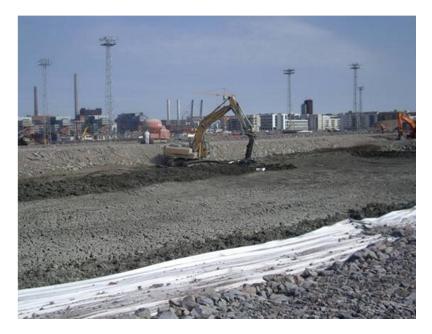
Figure 4. Stabilisation work on basin 2 (in front right corner of the picture one can see the loading embankment and geotextile and on the back of the picture is the stabilisation machine running, leaving the un-stabilised mass in the middle).

The stabilisation work began 13.4.2011 from basin number 1 according to the principle presented in Figure 4. The sides of the basin were stabilised first on 5 m x 5 m area using the supportive banks of the basin. After the stabilisation a geotextile and loading embankment was spread on top of the stabilised layer to create a platform for the excavator. The stabilisation work succeeded from the outer limits of the basin towards the middle of the basin.
