Technical report, piloting cover structure (action B1)

UPACMIC LIFE12 ENV/FI/000592

Project name UPACMIC
Project no. 1510006900-008
Date 17/12/2019
Prepared by Tarja Niemelin, Ramboll

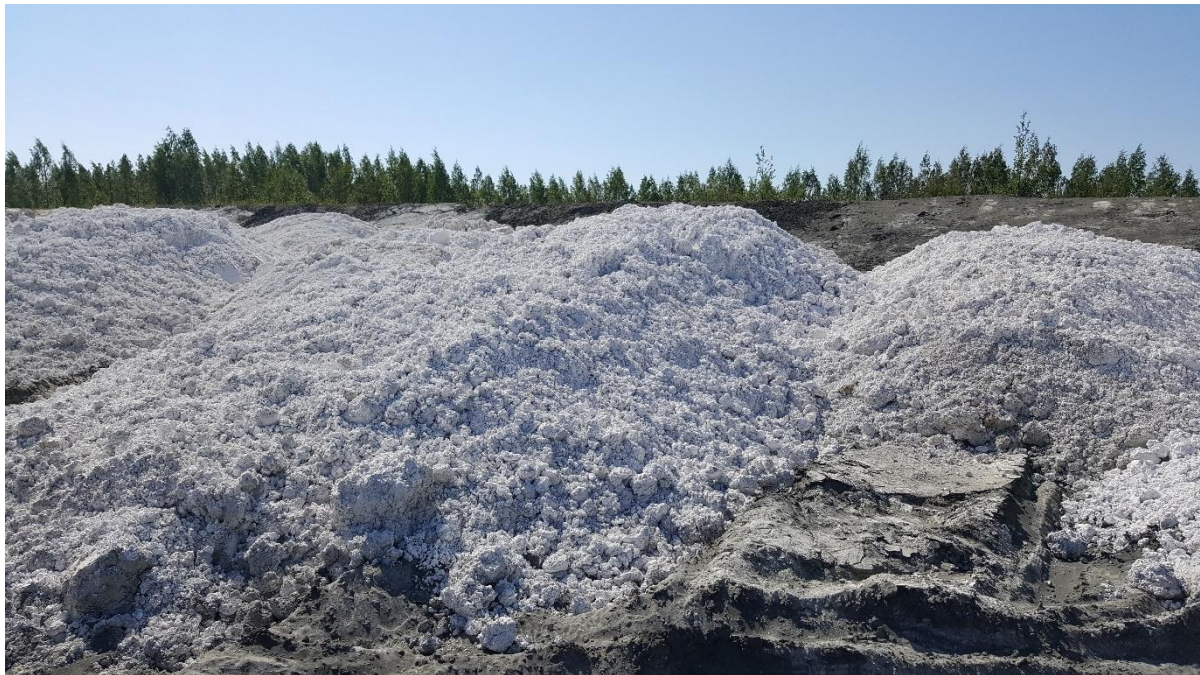
Figure 4. Fibre clay in Hitura construction site before used in the piloting structure.

Fibre clays from Äänekoski, Mänttä and from Oulu (called OPA-sakka) were tested for compactibility, water permeability and environmental properties and the conclusion was that all of those are suitable to use for sealing the enrichment sand basins (see the following chapters for test results). Figure 4 shows fibre clay at the construction site.

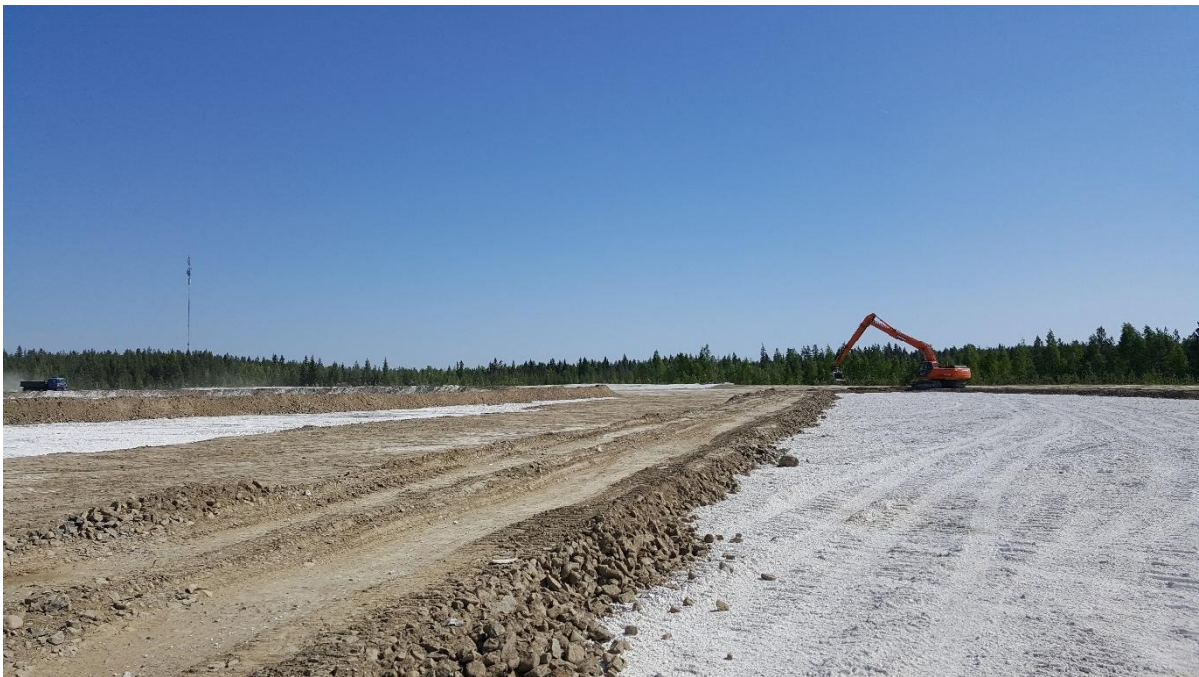
Figure 6. Fibre clay utilisation in Hitura did not require any special vehicle or equipment.

Construction with fibre clay did not need any special equipment. The material was levelled and compacted with crawler excavators (figure 6).

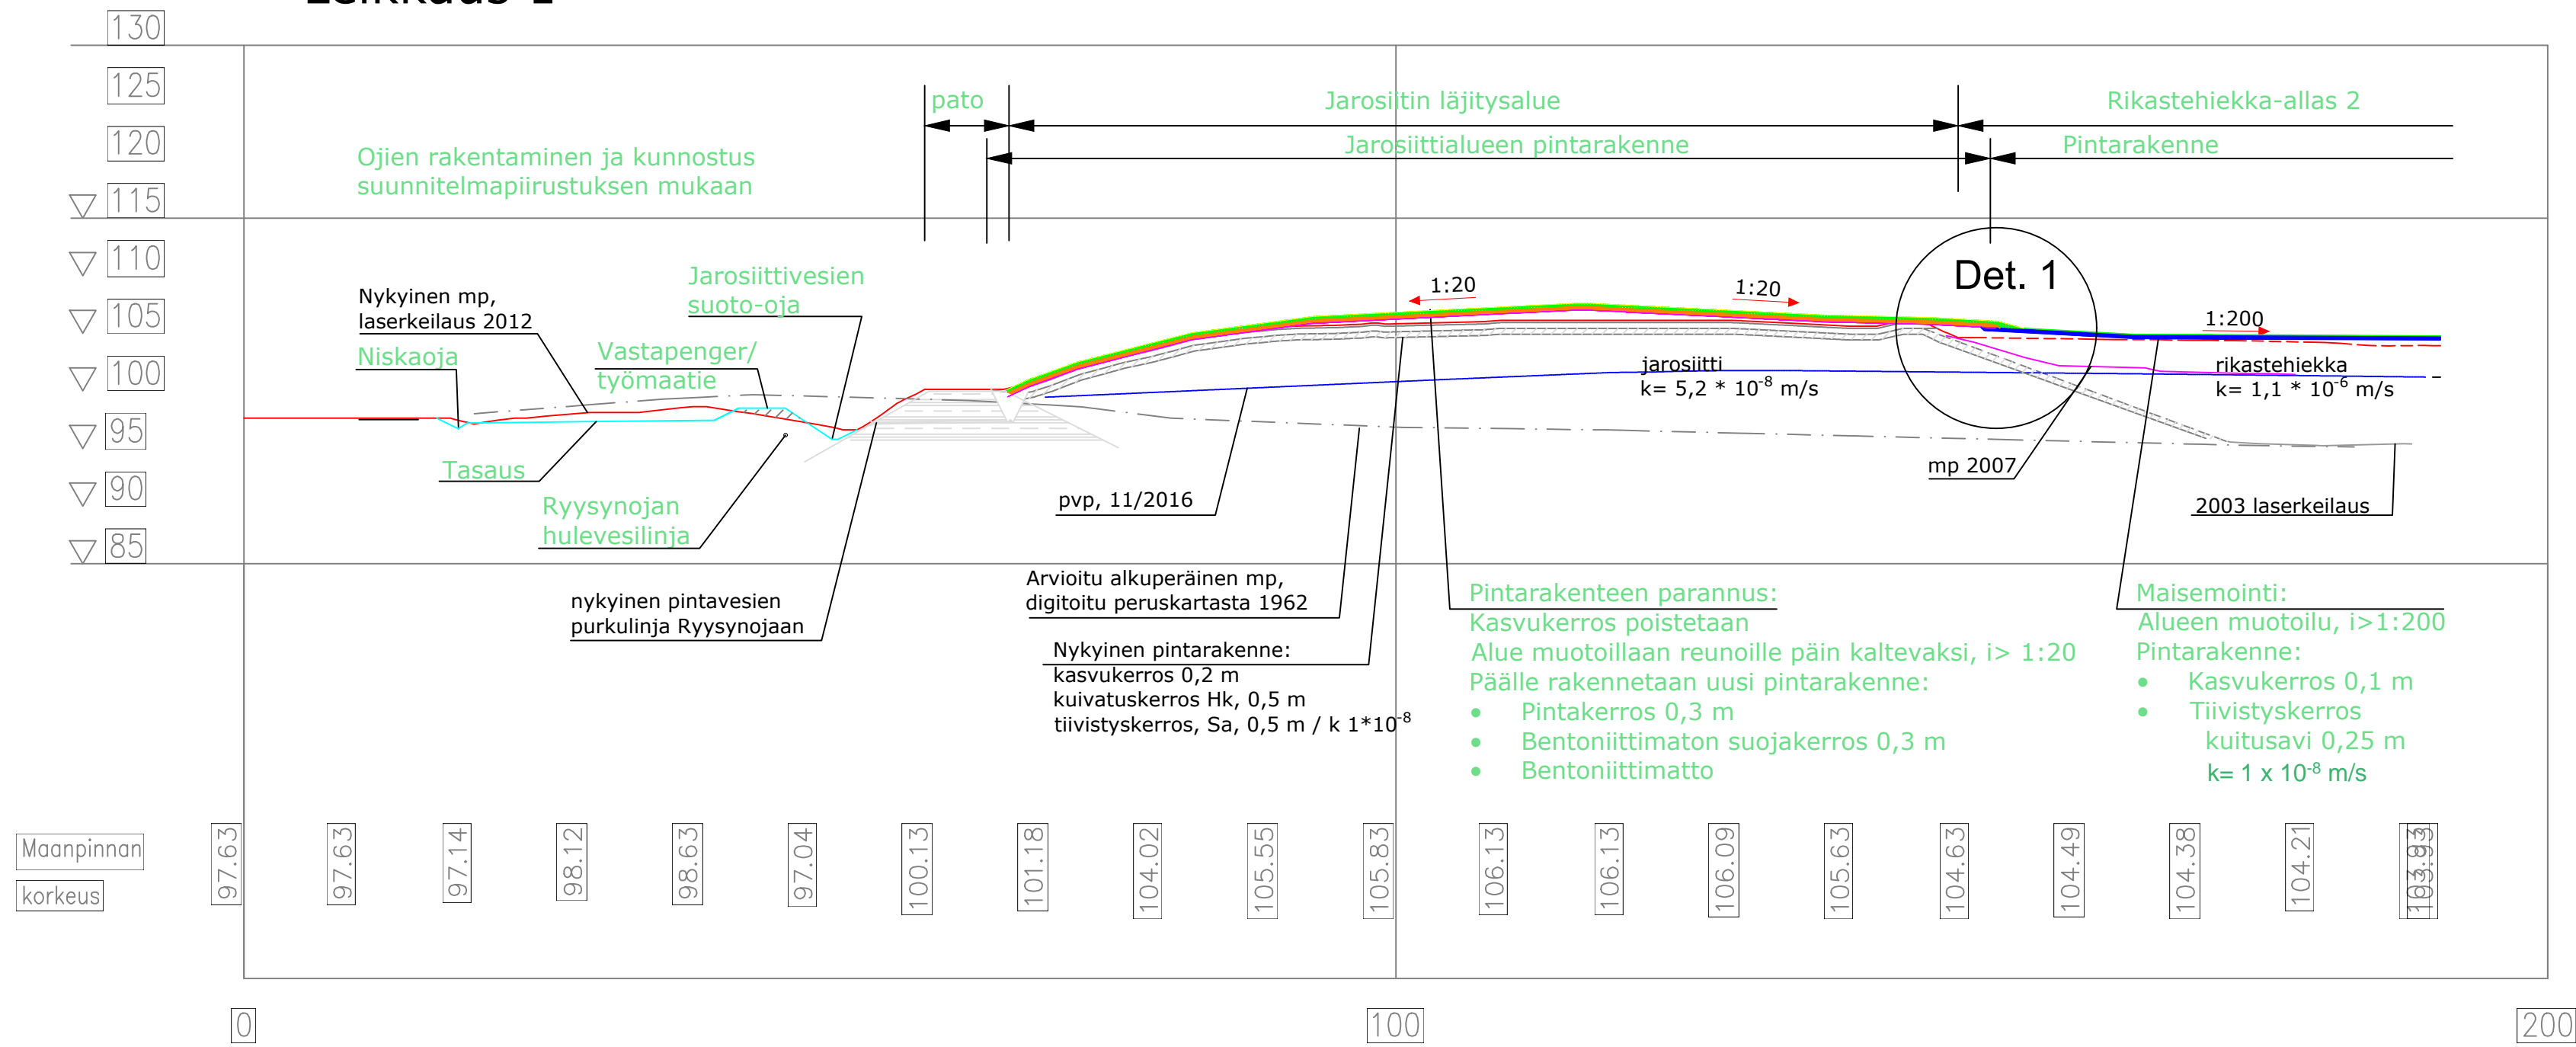
Jarosittialueen pintarakenteen liittyminen rikastushiekka-altaan pintarakenteeseen
Det. 1 1:50
