ARCADA II Kyläsaari, Helsinki, Finland Street and plot area construction

Key words: light weight structure utilization of surplus soils

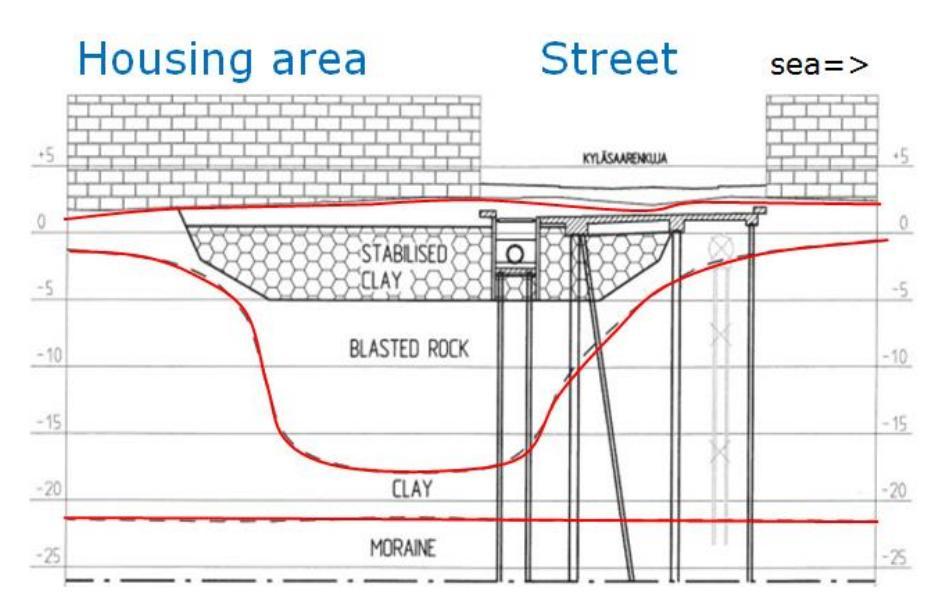
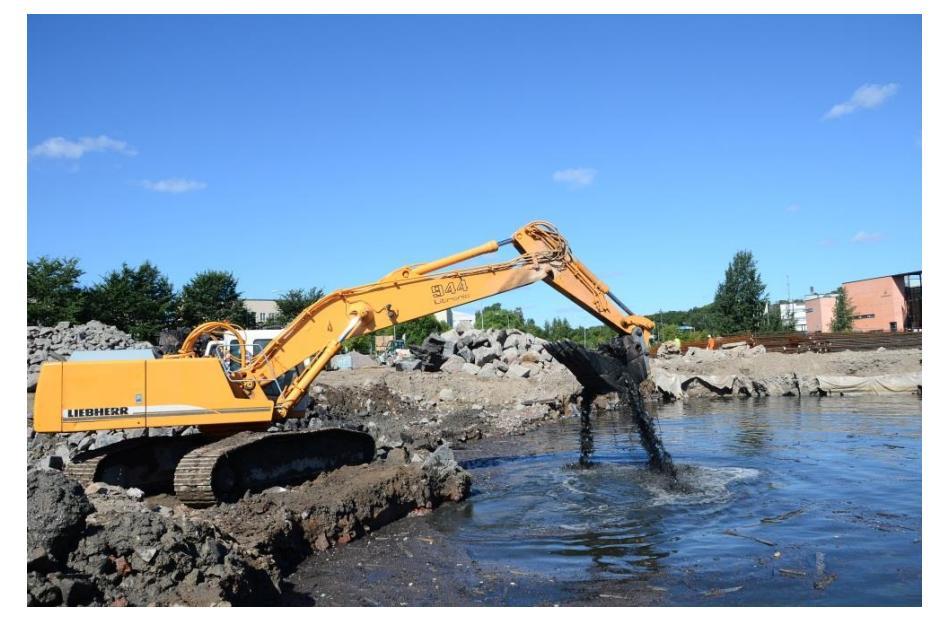
Contaminated aggregate filling made in the 1960's was dug out to the level -5. Ground water in the area is on the level of the sea which is next to the site. After removal of the aggregate, the excavation was filled with surplus clay.

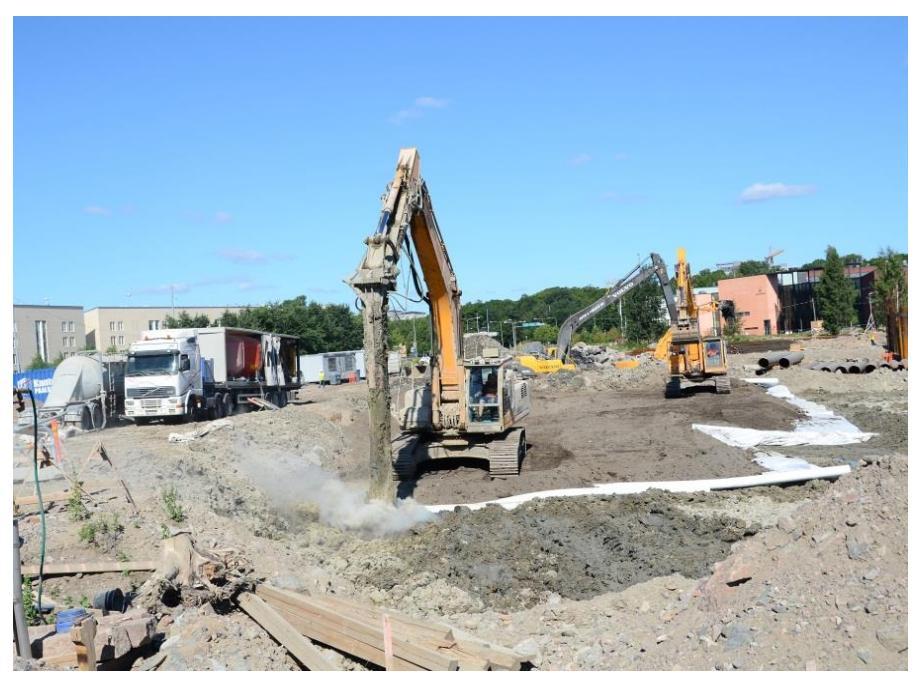
Stabilization of the surplus soft clay placed in the pit. In the back, a loading embankment is constructed. This functions as a working platform for the stabilization equipment, and allows for the compaction of the stabilized soil layer during the curing time.
