LIFE09 ENV/FI/575 ABSOILS

Report of civil engineering and environmental survey

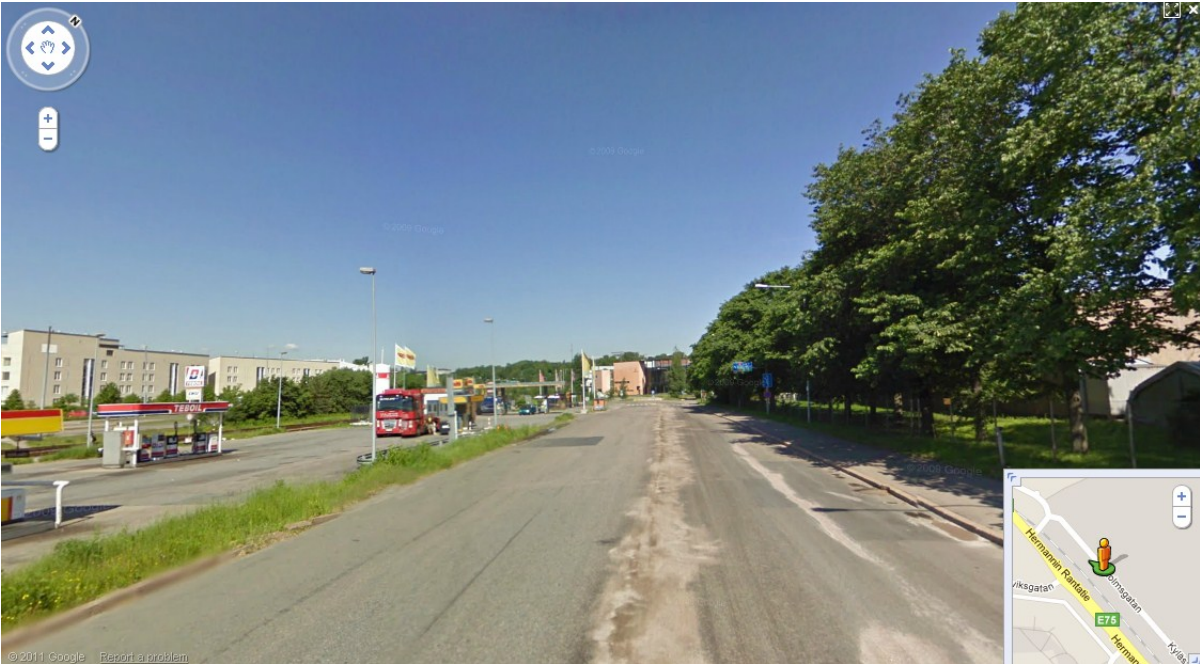
In the Figure 1 is represented the Arcada 2 area before construction.

Figure 1. Arcada 2 before construction. (Google maps)

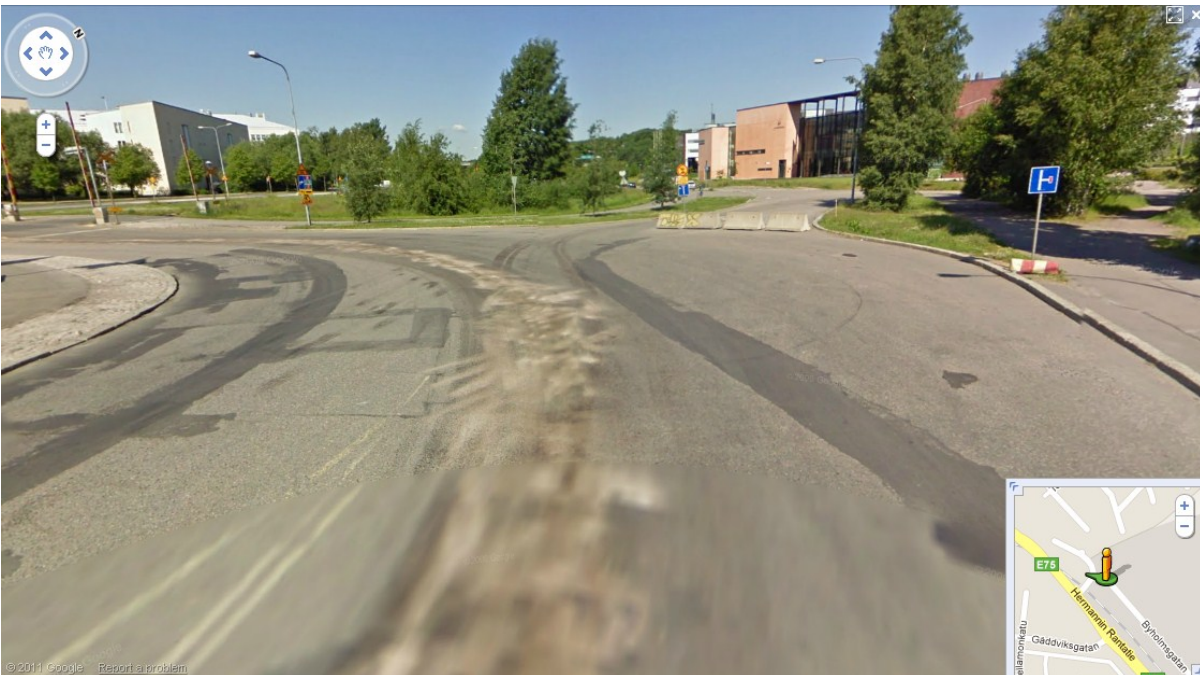
On Figure 2 it can be seen that some of the road has been "pached" with asphalt and the last part of the road has been blocked for entrance.

Figure 2. The last part of the road blocked for entrance and the road has been pached with asphalt. (Google maps)

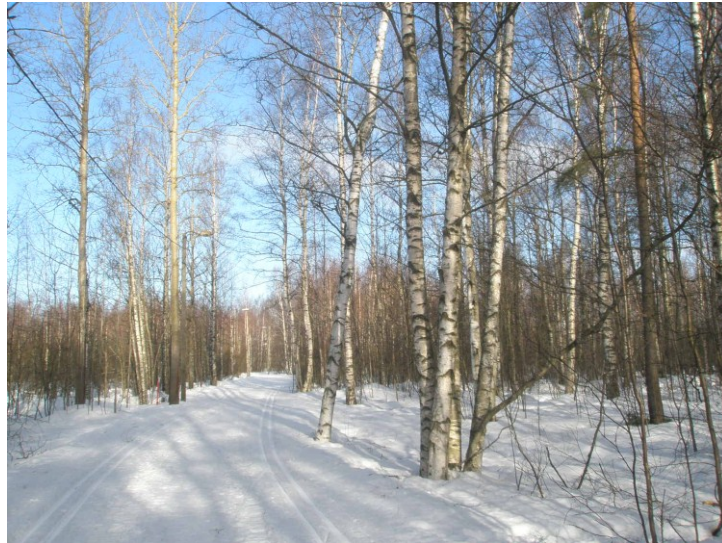
On the Figure 3 the outdoor route surrounding the Dog park area can be seen. It can also be seen that the vegetation of the area is quite bushy with young trees.

Figure 3. Outdoor route surrounding the dog park area.

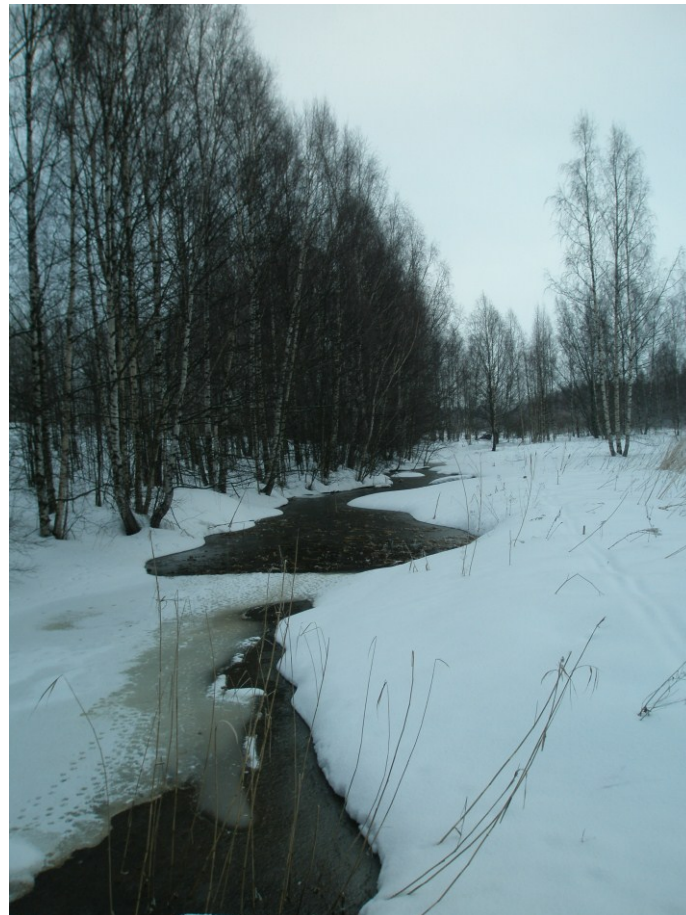
On the Figure 4 is the ditch surrounding the dog park area.

Figure 4. Ditch surrounding the dog park area.

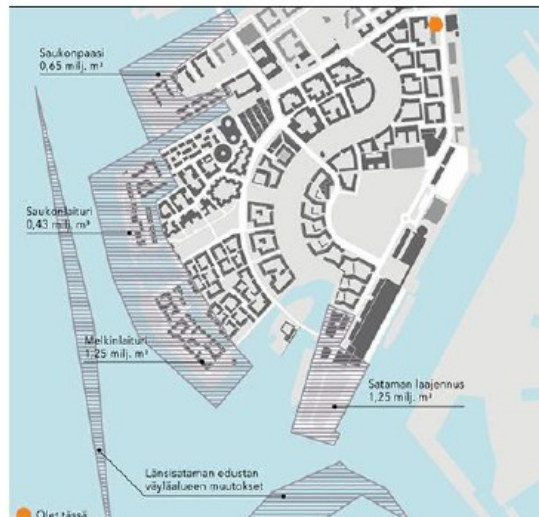
Figure 5. Jätkäsaari area plan. The striped areas in the end of the peninsula are new areas that are filled in to the sea and the striped areas in the sea are being dredged.
